Technical Service Bulletin

96 High beam assist or traffic sign detection limited, DTC C12B3FD stored in the driver assist systems control module

96 20 51 2059201/2 April 23, 2020. Supersedes Technical Service Bulletin Group 96 number 20-49 dated April 9, 2020 for reasons listed below.

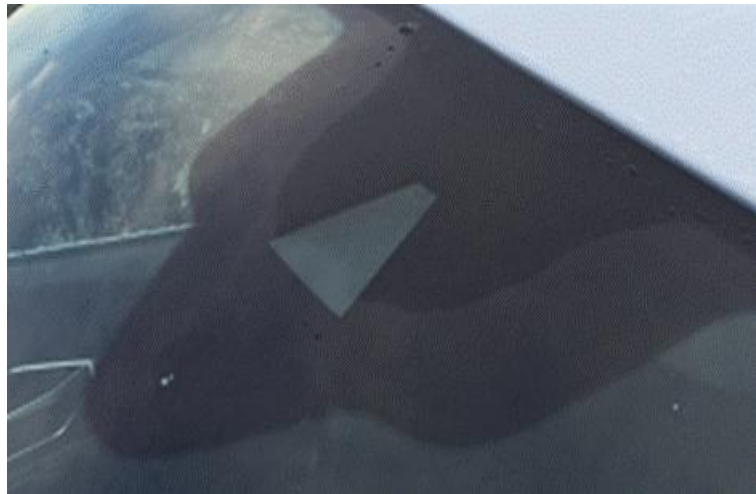
If the front camera recognizes a visibility restriction for more than 77 seconds, the DTC C12B3FD with symptom code 221284 is logged and a message appears in the instrument cluster.

The viewing area of the front camera can be fogged up both on the inside and/or on the outside (Figure 1 and 2).

Figure 1. Viewing area fogged up from outside.

1. Explain to the customer how the camera heating works.
2. Ask the customers to inspect the viewing area of the front camera the next time they have this message.

3. The customer cannot see this from the interior of the vehicle. Often it is enough to switch on the wiper system to fix the concern.
4. If the front camera is fogged up from the inside fairly often, it can help to remove its lens hood then to clean and dry the viewing area of the camera.

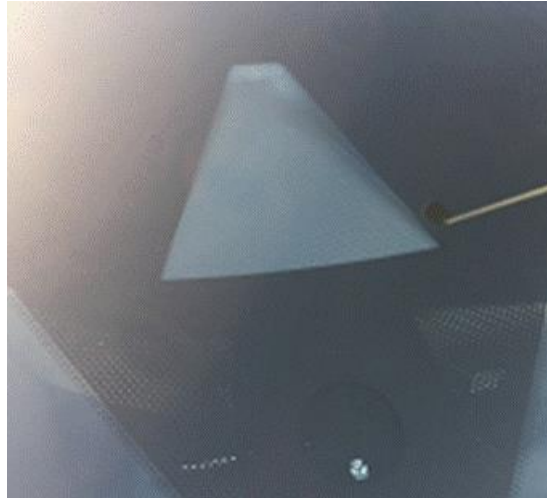
Figure 2. Viewing area fogged up from inside.
