ITB19-041b

April 7, 2020

2020 Q50; BOTH CENTER DISPLAY SCREENS ARE BLANK

APPLIED VEHICLE: 2020 Q50 (V37)

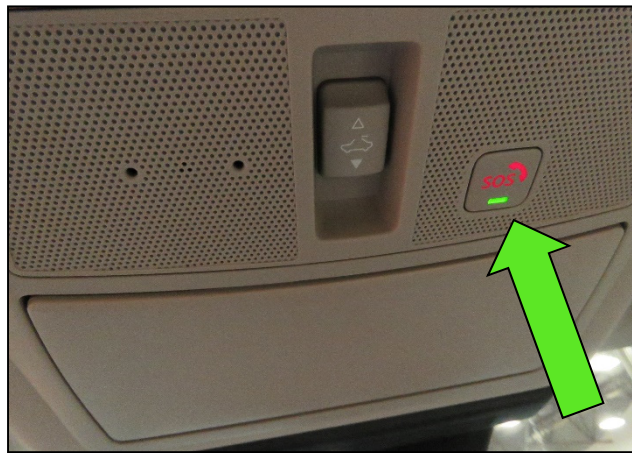
Figure 1

APPLIED SYSTEM: Vehicles equipped with factory navigation system (Vehicles equipped with navigation will have an SOS button in the overhead console assembly).

- Both the upper and the lower center display screens are blank at all times (not intermittent),
- And**
- The HVAC controls are inoperative at all times (not intermittent).

Perform the **SERVICE PROCEDURE** starting on the next page to configure the TCU.
