GROUP
Product Improvement

NUMBER
PI1803Y/Z (Rev 1, 04/09/2020)

PRODUCT IMPROVEMENT CAMPAIGN

**SUBJECT: ENGINE REPLACEMENT INSTRUCTIONS
FOR DTC P1326 (PI1803Y/Z)**

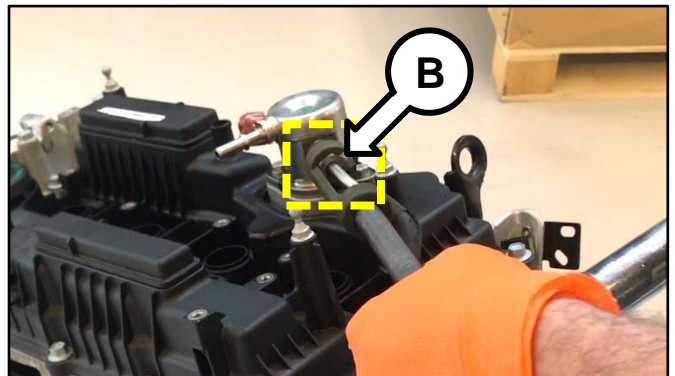
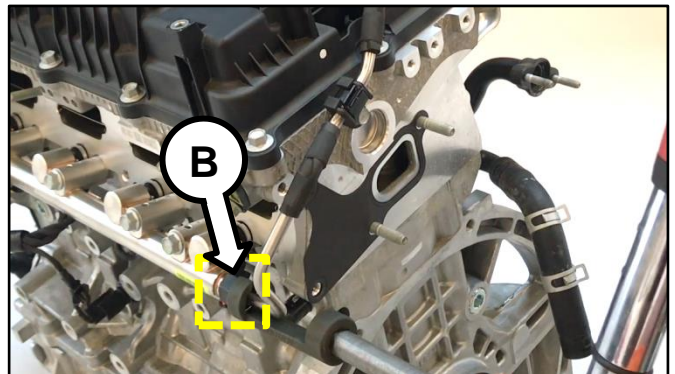
The high pressure fuel pipe bracket and bolt must be installed **AND** properly torqued prior to torquing the high pressure fuel pipe flare nuts.

3. Using a click-type/electronic torque wrench and SST 09314-3Q100, torque both flare nuts (B) to specifications.

Tightening torque (flare nuts):
19.5 – 23.9 lb.ft (26.5 – 32.4 N.m,
2.7 – 3.3 kgf.m)

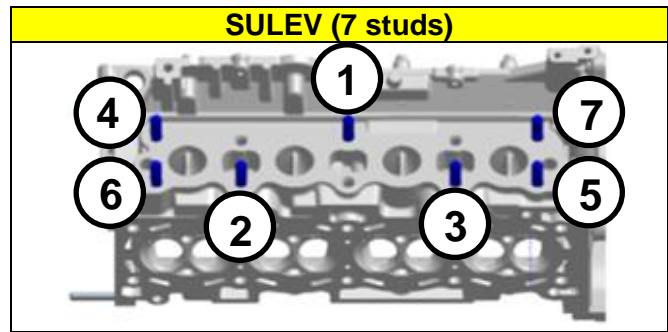
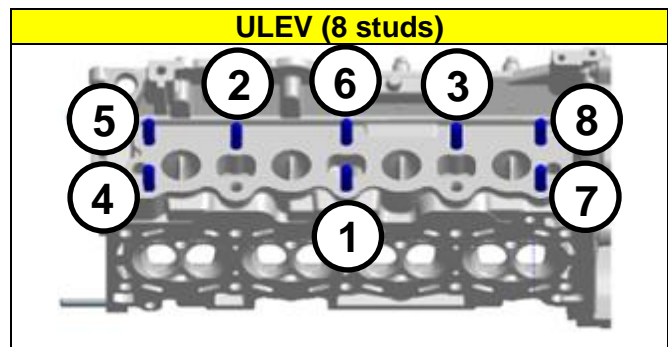
- All engines supplied under this Product Improvement Campaign have the exhaust manifold studs configured for SULEV engines.
- Using the pictures to the right, check the exhaust manifold stud location and quantity. Relocate as required for ULEV engines and obtain one (1) extra from the removed engine.
- Prior to installation, replace the exhaust manifold gasket and front muffler gasket.
- Torque nuts in the sequence shown.

Tightening torque of nuts:
 36.2 – 39.7 lb.ft (49.0 – 53.9 N.m,
 5.0 – 5.5 kgf.m)

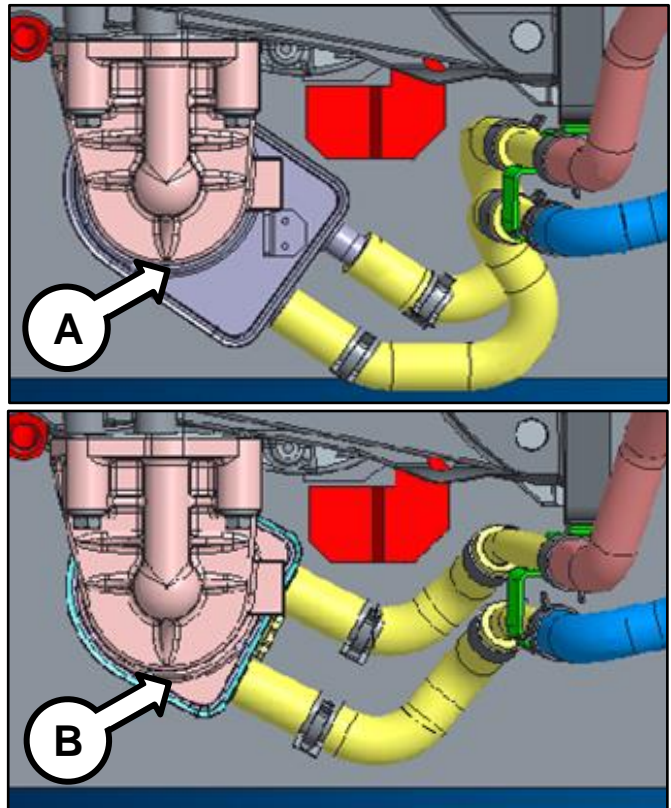
New engines may be supplied with a different oil cooler. Use steps below to determine the need for a replacement oil cooler tube assembly.

- If the new engine's (bigger) oil cooler (A) does not match the old engine's (smaller) oil cooler (B), replace the oil cooler tube assembly with the improved part. See parts table on page 24.
- If the new engine's (bigger) oil cooler (A) matches the old engine's (bigger) oil cooler (A), reuse the old engine's oil cooler tube assembly.
- If the new engine's (smaller) oil cooler (B) matches the old engine's (smaller) oil cooler (B), reuse the old engine's oil cooler tube assembly.

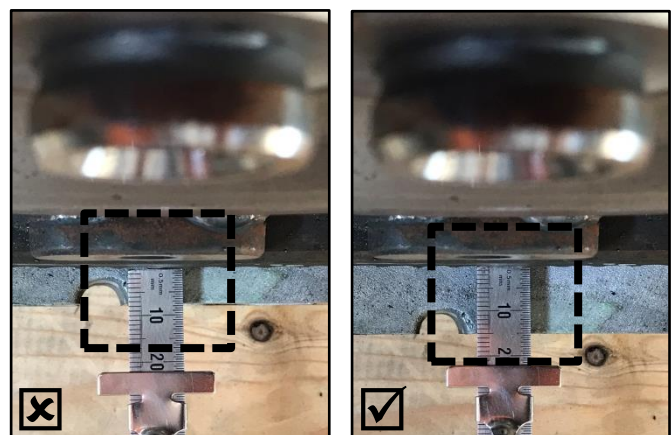
Not Fully Inserted

Fully Inserted

- If the torque converter has moved from the fully inserted position, carefully push inward while rotating the torque converter until it is recessed approximately 9/16 – 5/8" (14 – 16mm) (☑) into the transaxle case when reinstalling the automatic transaxle.
