# LATEST VEHICLE CONCERN FIXES

### Idle Surging After Timing Cover Removal

13-17 MY Discovery Sport, RR  
Evoque, XE, XF equipped with 2L  
GTDi engine

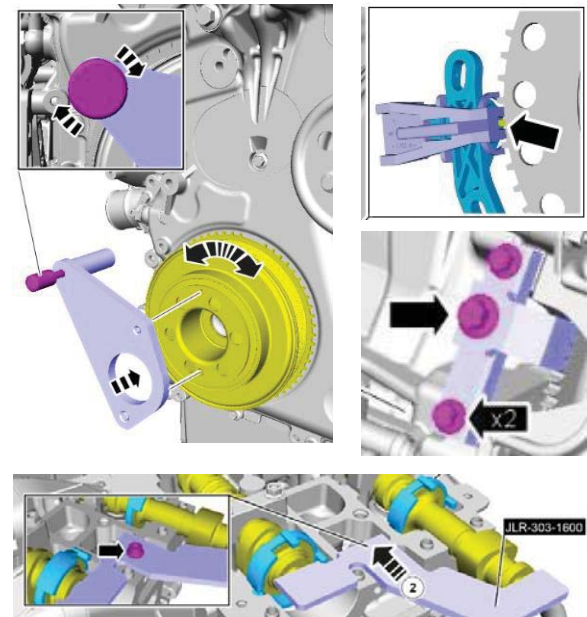
- The engine timing was set during a previous repair and the vehicle now exhibits a surging idle and/or P0505 stored.

- The mechanical timing of the engine needs to be confirmed as correct.
- TOPIx instructions must be completely adhered to.
- ALL tools outlined in the TOPIx work instructions must be used.
- Damaged tools must be repaired or replaced to complete the repairs properly.
