Service Campaign

Volvo CarPlay Update with Hardware

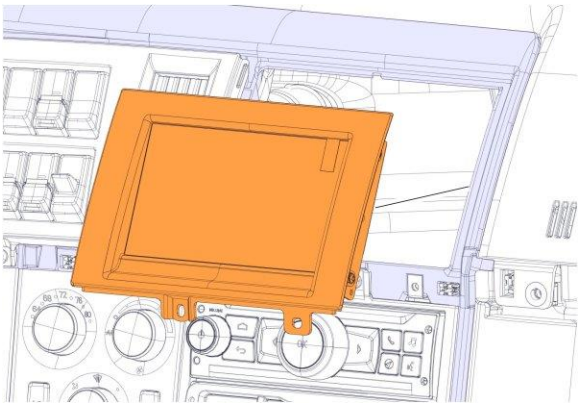
Some Volvo trucks were built with an infotainment unit that does not support Apple CarPlay. To enable CarPlay, the infotainment hardware must be replaced and additional software must be installed directly to the infotainment unit. The software update process does not use TechTool. This update also includes updated navigation maps.

Replace the infotainment display and SEM (Service and Entertainment Module). Refer to Special Tools Bulletin STB20-002V and use the USB stick to update the software according to the campaign instructions. The USB stick is preloaded with the appropriate software.

4. Remove the display. Disconnect the connectors.
