Title	Particulate Matter (PM) Sensor Diagnostic Trouble Codes (DTC) Illuminating The Malfunction Indicator Lamp (MIL) - US14+OBD16, US17+OBD16 And Newer Emissions, Model Year 2017 And Newer - To Be Used For EVERY Visit
-------	--

Title Mack Chassis - Vehicles Equipped With A Vertical Selective Catalytic Reduction (SCR) System - Diagnostic Trouble Codes (DTC) P1031 With Possible P24DA Lighting The Malfunction Indicator Lamp (MIL) - US17+OBD16 (GHG17, Common Rail Fuel System) Emissions, Commonly Model Year 2018

Title Volvo Chassis - Vehicles Equipped With A Vertical Selective Catalytic Reduction (SCR) System - Diagnostic Trouble Codes (DTC) P1031 With Possible P24DA Lighting The Malfunction Indicator Lamp (MIL) - US17+OBD16 (GHG17, Common Rail Fuel System) Emissions, Commonly Model Year 2018

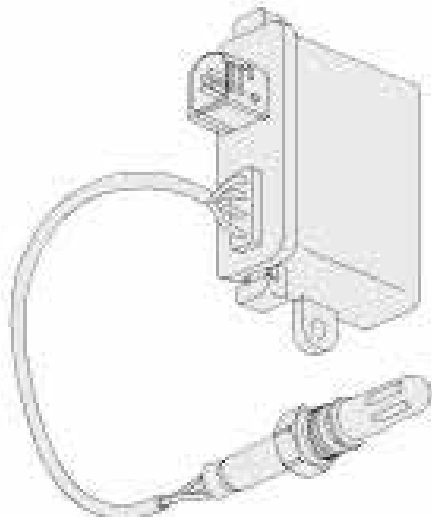
1. The PM sensor is a smart sensor (12V supply and CAN lines) **with an orientation tab as seen below:**

Installation torque of 50 Nm +/- 5

3. NEVER (DO NOT) apply anti-seize to install the PM sensor. *If for some reason someone applied it before this repair, thoroughly clean the threads and sealing surfaces while replacing the sensor.*
