Title	Particulate Matter (PM) Sensor Diagnostic Trouble Codes (DTC) Illuminating The Malfunction Indicator Lamp (MIL) - US14+OBD16, US17+OBD16 And Newer Emissions, Model Year 2017 And Newer - To Be Used For EVERY Visit
-------	--

Title Mack Chassis - Vehicles Equipped With A Vertical Selective Catalytic Reduction (SCR) System - Diagnostic Trouble Codes ( DTC ) P1031 With Possible P24DA Lighting The Malfunction Indicator Lamp ( MIL ) - US17+OBD16 (GHG17, Common Rail Fuel System) Emissions, Commonly Model Year 2018

Title Volvo Chassis - Vehicles Equipped With A Vertical Selective Catalytic Reduction (SCR) System - Diagnostic Trouble Codes ( DTC ) P1031 With Possible P24DA Lighting The Malfunction Indicator Lamp ( MIL ) - US17+OBD16 (GHG17, Common Rail Fuel System) Emissions, Commonly Model Year 2018

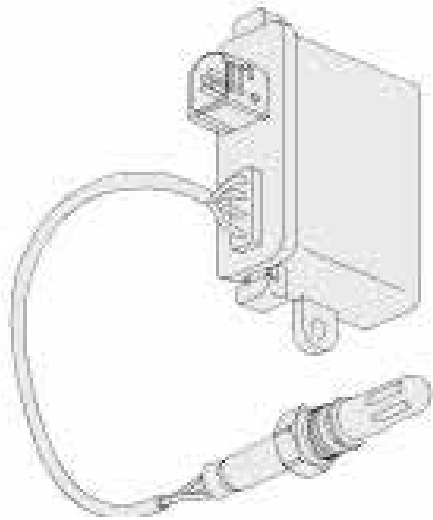
1. The PM sensor is a smart sensor (12V supply and CAN lines) **with an orientation tab as seen below:**

**Installation torque of 50 Nm +/- 5**

**3. NEVER (DO NOT) apply anti-seize to install the PM sensor.** *If for some reason someone applied it before this repair, thoroughly clean the threads and sealing surfaces while replacing the sensor.*
