## Technical product information

<b>Topic</b>	Buzzing/vibration from the left and/or right headlamp and/or DTC's C119C01-C119D01 stored - Matrix beam headlamp only
<b>Market area</b>	Bentley: worldwide (2WBE)
<b>Brand</b>	Bentley
<b>Transaction No.</b>	2059246/1
<b>Level</b>	EH
<b>Status</b>	Approval
<b>Release date</b>

Buzzing/vibration from the left and/or right headlamp and/or DTC's C119C01-C119D01 stored - Matrix beam headlamp only

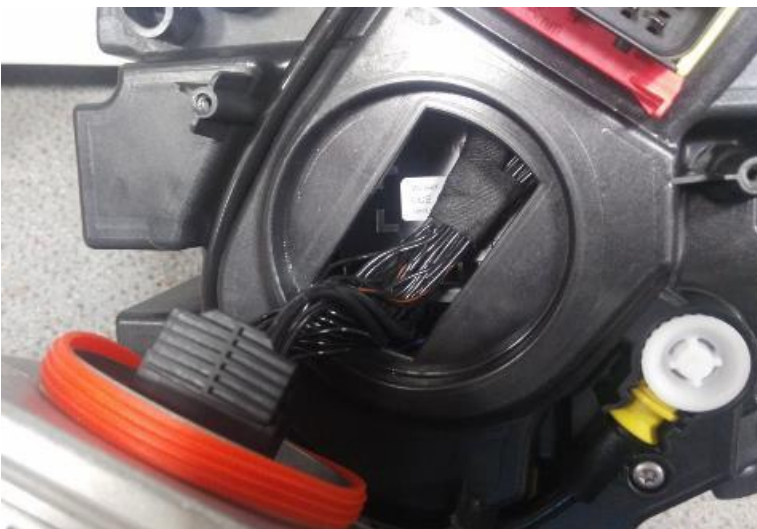
Wiring harness routed incorrectly within the headlamp module at the rear of the headlamp, the noise and DTC's are evident due to the harness contacting the headlamp cooling fan

3) Referring to Figure 3– Gently pull up the module and slightly pull the harness to make it free as shown in Figure 4

4)IMPORTANT: Inspect the wiring harness, should any damage be evident the headlamp should be replaced, Refer to Rep.Gr 94 NOTE: Should no damage be evident continue as instructed from step 5
