Preliminary Information

PIP5724 SES Lamp With Camshaft or Oil Pump System Related DTCs

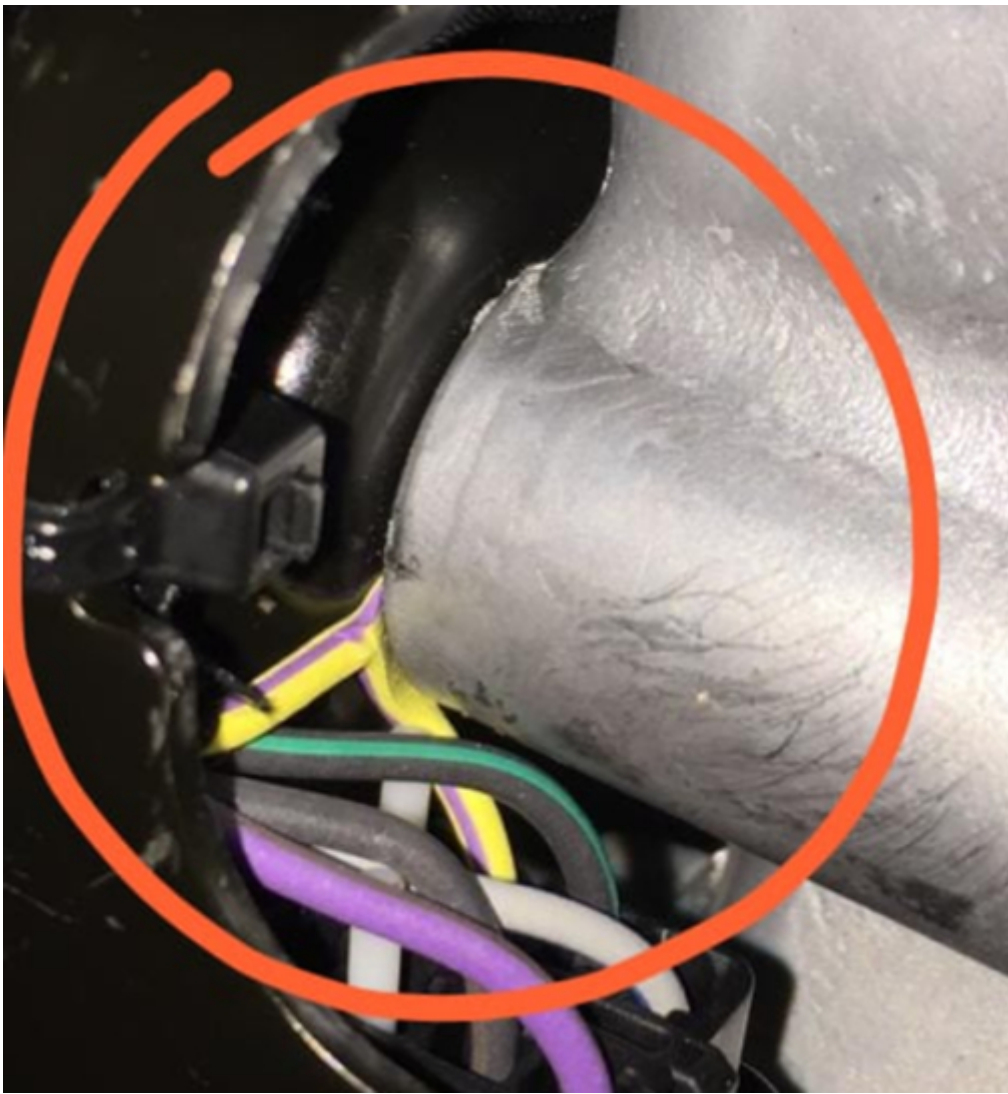
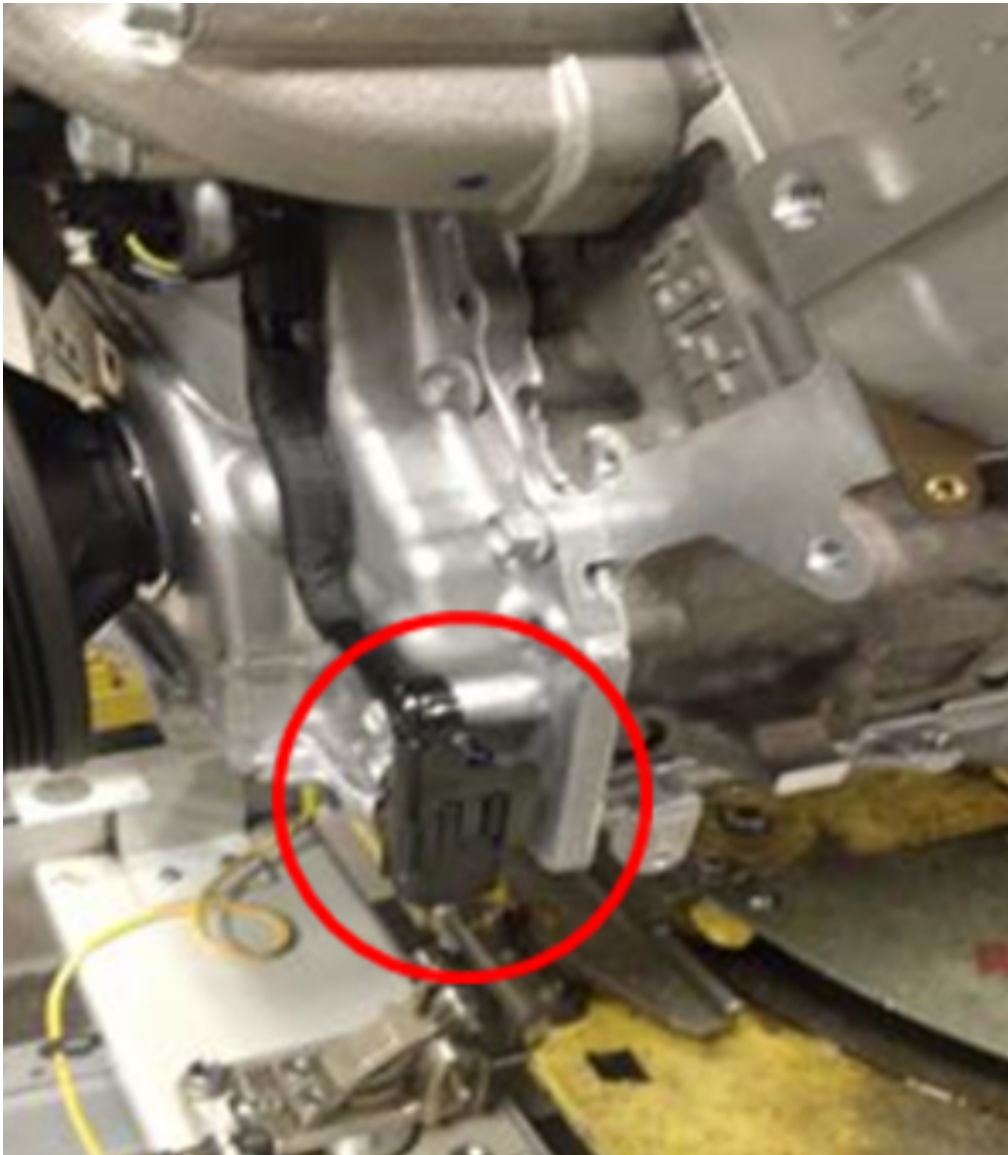
Involved Region or Country	North America
Condition	The vehicle may have an SES lamp with any of the following DTC P06DA, P06DB, P06DC, P250A, P0300, P0340, P0341, P0335, P0336, P0641, P0011, P0010, P2088, P2089, and/or P2230. Possible crank no start or a stall.
Cause	Possible wiring jumper harness pinched between the X154 connector bracket and the front engine cover on lower left side of the engine.

Inspect for the wiring harness being pinched under the bracket on the location below.
