Sliding Roof Binds When Opening or Closing

Service Category Vehicle Exterior

Section Sliding Roof/Convertible

Market USA

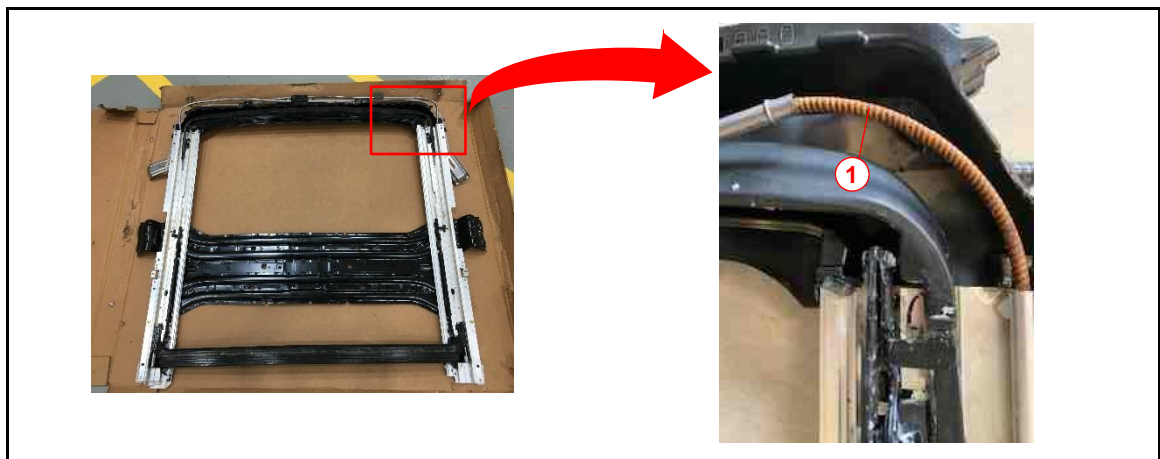
Figure 1.

Some 2018 – 2020 model year Sequoia and Tundra vehicles equipped with a sliding sunroof or moonroof may exhibit a binding, seizing, or sticking condition when attempting to open or close. In some cases, a clicking noise is present when the sliding sunroof or moonroof is stuck open or closed. This condition may be caused by rusted or seized sliding roof cables. Follow the Repair Procedure in this bulletin to address this condition.

1	Corroded Sliding Roof Cable
----------	------------------------------------

2. Replace BOTH the sliding roof housing sub-assembly AND the sliding roof cables.
 - A. Remove the sliding roof housing sub-assembly AND sliding roof cables.
 - 2018 – 2020 Sequoia:
Vehicle Exterior – Sliding Roof/Convertible – [“Sliding Roof / Convertible: Sliding Roof Housing: Disassembly”](#)
 - 2018 – 2020 Tundra:
Vehicle Exterior – Sliding Roof/Convertible – [“Sliding Roof: Sliding Roof Housing \(for Crew Max\): Disassembly”](#)
 - B. Install the NEW sliding roof drive cable sub-assembly AND the NEW sliding roof cables.
 - 2018 – 2020 Sequoia:
Vehicle Exterior – Sliding Roof/Convertible – [“Sliding Roof / Convertible: Sliding Roof Housing: Reassembly”](#)
 - 2018 – 2020 Tundra:
Vehicle Exterior – Sliding Roof/Convertible – [“Sliding Roof: Sliding Roof Housing \(for Crew Max\): Reassembly”](#)
