Mercedes-Benz

Campaign No. 2020020018, March 2020

SUBJECT: **Model 907 (Sprinter), Model Year 2019**
Tie-down Rails

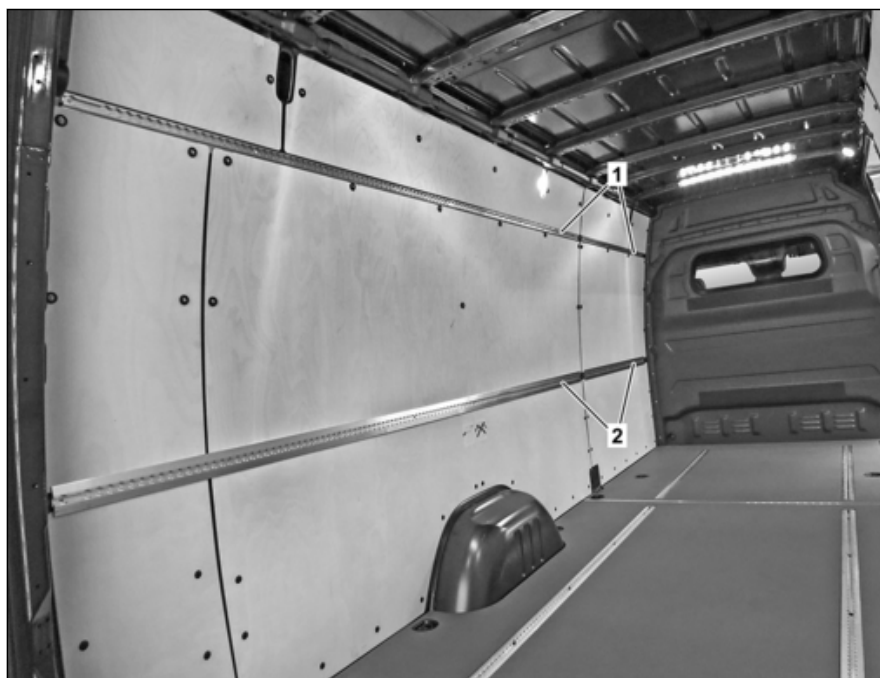
D68.50-A025-06

Shown on model 907.6 with code VA2 (load compartment interior trim up to roof height (wood))

- 1 Tie-down rail
- 2 Tie-down rail
