Mercedes-Benz

Campaign No. 2020030012, April 2020

SUBJECT: **Model 907 (Sprinter), Model Year 2019
Flange Connection**

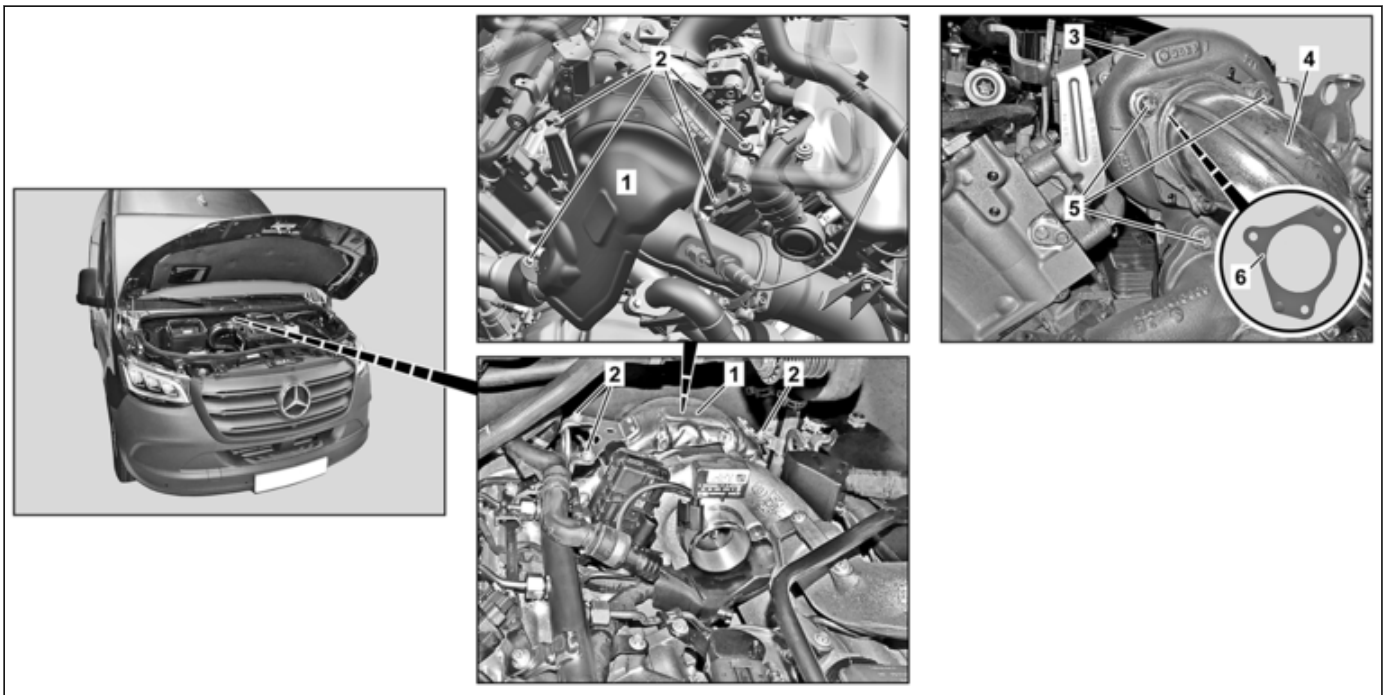
D09.40-A014-09

Mercedes-Benz AG (“MBAG”), the manufacturer of Mercedes-Benz and Freightliner vans, has determined that on certain Sprinter vehicles from platform 907 (VS30), the flange connection between the exhaust gas turbocharger and the exit to the diesel particulate filter may not have been attached properly. If the flange connection is not attached properly, high-temperature exhaust gas could potentially leak into the engine compartment, increasing the risk of a potential thermal reaction as well as thermal damage to the immediately surrounding components. An authorized Mercedes-Benz or Freightliner Sprinter dealer will replace the flange seals and will apply the correct torque to the screw connection.

AR	Remove heat shield (1).

To do this, remove screws (2).	
4	Remove bolts (5).

Screws (5) are replaced.	
5	Remove seal (6) between exhaust gas turbocharger (3) and exhaust pipe (4).

Install		
7	Position new seal (6) between exhaust gas turbocharger (3) and exhaust pipe (4) then fit new screws (5).

Check seal (6) is in correct installation position. Otherwise, leaks can occur in the exhaust system.	
8	Tighten bolts (5).

Number	Designation		Engine 642 in model 907
BA09.40-N-1008-02TSV	Bolt, exhaust pipe to turbocharger	Nm	20
