Mercedes-Benz

Campaign No. 2020040014, April 2020

SUBJECT: **Model 907 (Sprinter), Model Year 2019**
Tire Running Direction

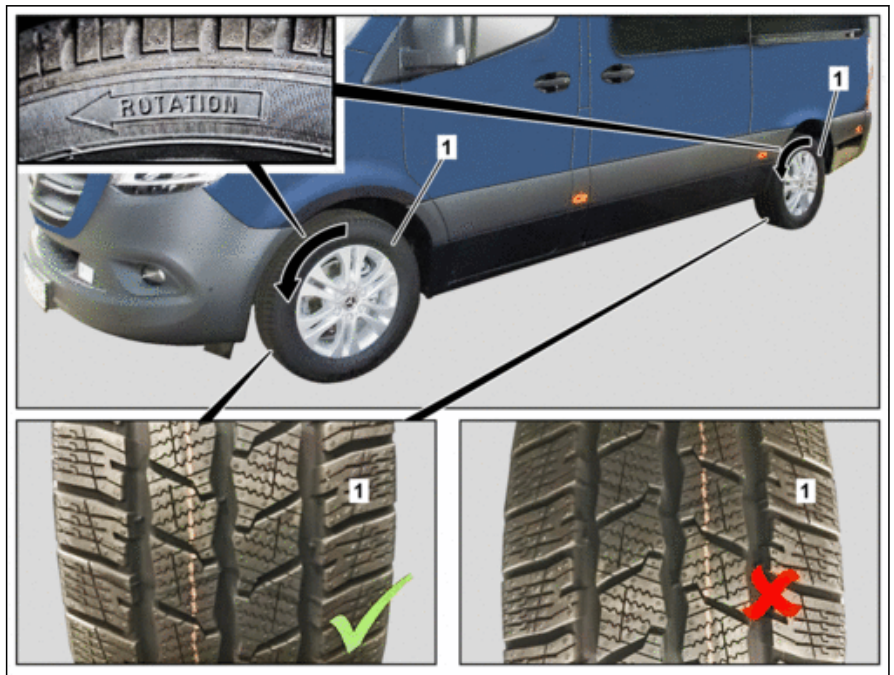
D40.10-A005-76

Shown on model 907, left side of vehicle

1 Tires

Pay attention to alignment of tire profiles and running direction arrows. If the running direction is correct on all tires (1), ↓ end the measure. If the running direction is incorrect on one or more tires (1), ↓ Continue with operation step 3.
