# Technical Service Bulletin

## 93 Problems charging at home and/or after the DC charging plug is not releasing

93 20 25 2057353/4 May 4, 2020. Supersedes Technical Service Bulletin Group 93 number 20-21 dated March 27, 2020 for reasons listed below.

Model(s)	Year	VIN Range	Vehicle-Specific Equipment
Audi e-tron quattro	2019 - 2020	All	e-tron
A8, Q5	2020	All	TFSI e

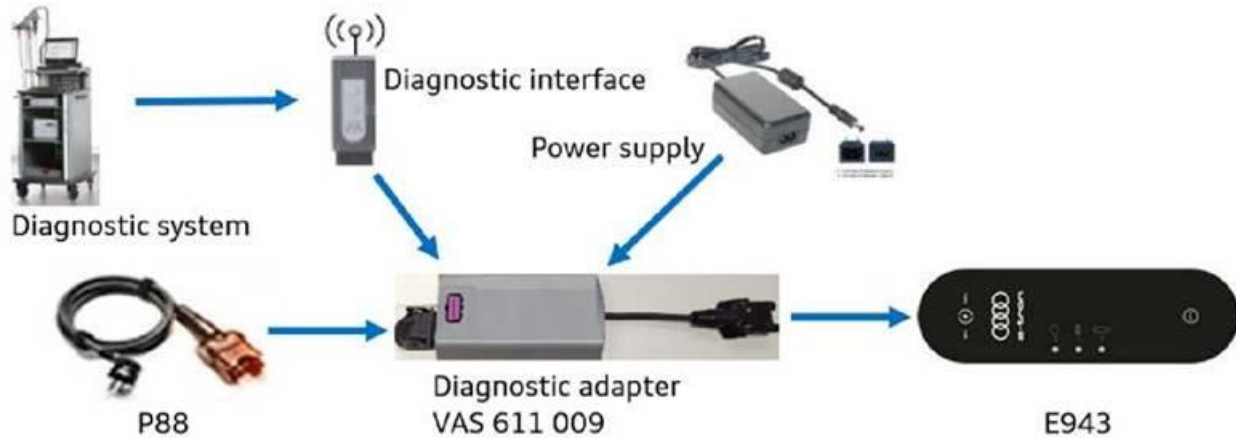
Figure 1. VAS 611 009.

5. Update Audi mobile charger E943 using the SVM action code as listed in the table below, if necessary after following the instructions for setting up.

Set up using VAS 611 009.
