91-19-04TT - Car Net 2.0 - Telematics Control Head Green Light Does Not Come On After Switching OFF Transport Mode

Release date: 5/01/2020

Applicable Vehicles					
Model(s)	Year	Eng. Code	Trans. Code	VIN Range From	VIN Range To
Tiguan LWB, Cross Sport, Atlas, Jetta, Golf, GTI, Arteon	2020, 2021	All	All	All	All

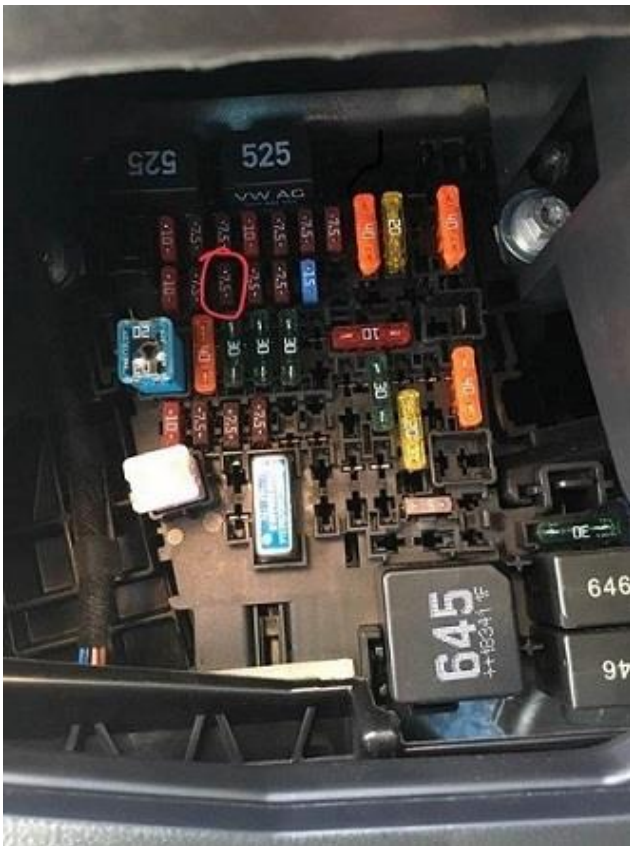
Figure 1.

If the green light of the Telematics Control Head -**E264**- above the rear-view mirror does not come on within approximately 15 minutes after completion of the ePDI process and has been taken outside with clear line of sight to the sky, reference the following.

1. Open the driver door.
2. To the left and below the steering wheel, open and remove the pull out compartment door (Approx 4"x 6") by pressing the detent lever inside/above, exposing the fuse box.
3. Remove the 7.5 amp fuse in position SC17 (for all MQB platform vehicles).The instrument cluster losing power is an indication that the proper fuse was pulled. (Figure 1.)
4. Wait 5 minutes with the fuse out to allow the Control Module for Emergency Call Module and Communication Unit -**J949**- internal backup battery to completely discharge.
5. Re-insert the fuse into the slot and reinstall the pull out door.
