STAR ONLINE PUBLICATION

Case Number: S2018000001

Symptom/Vehicle Issue: Malfunction Indicator Lamp (MIL) Illumination. Diagnostic Trouble Code (DTC) P26FB – EGR Cooler Bypass Control Stuck Closed Bank 1 Set.

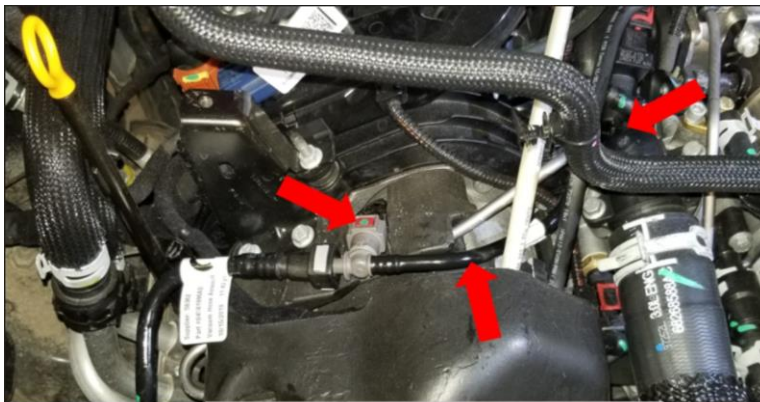
Fig. 1

1. Before clearing any DTCs, obtain a current Vehicle Scan Report. Email the scan report to Michael.russell1@fcagroup.com.
2. Perform normal published diagnostics for P26FB.
3. During your diagnosis, closely inspect the vacuum supply tube to the EGR Cooler Bypass Valve remote solenoid for blockage (See Fig. 1)

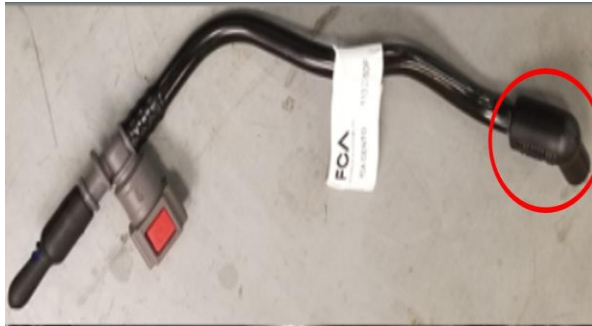
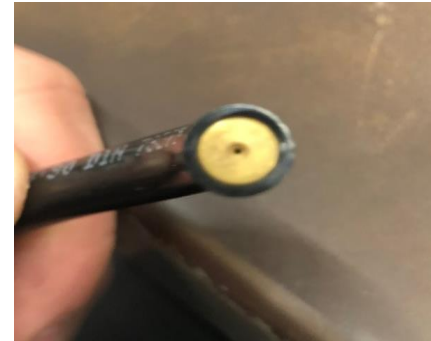
NOTE: There is a .6mm brass orifice in the vacuum tube assembly at the elbow connection. Some resistance in air flow is normal (See Fig. 2 and 3).

4. Carefully inspect the vacuum tube for the presence of a blockage in the orifice. This can be done by attempting to blow light air pressure through the tube assembly.
5. If the orifice in the tube is found blocked, please replace the tube assembly. **DO NOT** attempt to remove the blockage.
6. Inspect the internal integrity of the bypass valve by performing the following steps:
 - a. Gain access to the bypass valve vacuum actuator, and using your thumb, actuate the actuator in and out. (See Fig. 4). Ensure that the valve operates smoothly without sticking.

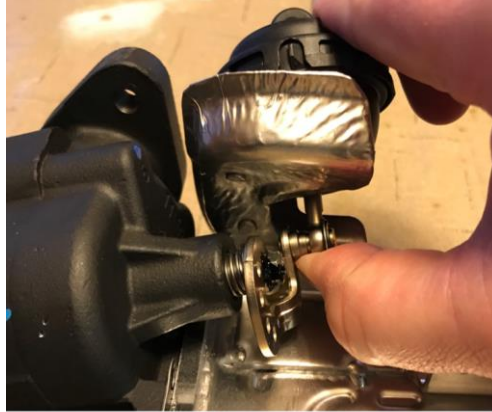
Fig 4.

- b. With the valve actuator pushed in, quickly release the valve, and allow spring pressure to rapidly close the bypass valve. As it closes, listen for an audible, metallic “snap” sound as the internal valve contacts the internal housing. This indicates that the internal valve is properly intact. If the metallic “snap” sound is not heard, the bypass valve will have to be replaced which is part of the EGR cooler.
7. If all of the steps have been followed, and no issue has been found, the DTC may have been a false failure. Engineering is currently investigating possible software improvements to prevent these false failures.
