**NUMBER:** 23-001-20 REV. B

Leather Instrument Panel (IP) Cover Delaminating - X81 Warranty Extension

2011 - 2014 (WK) Jeep Grand Cherokee

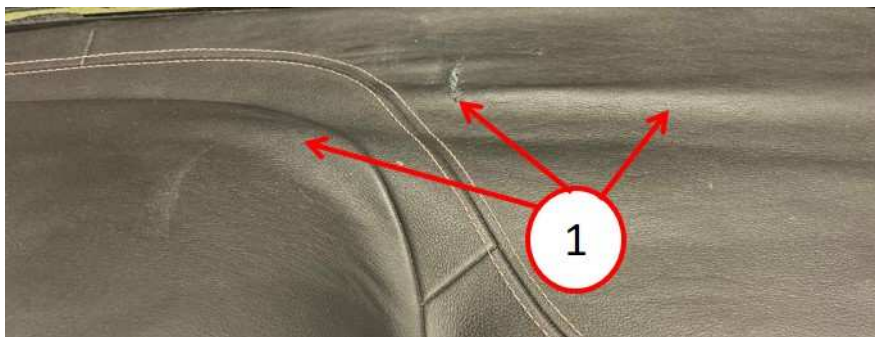
- The upper leather IP cover is delaminating or separating.

**Fig. 1**  
**IP Upper Cover Delamination**

This bulletin involves replacing upper leather IP covers that have suffered delamination issues.
