SIB 12 28 18

MALFUNCTION INDICATOR LAMP (MIL) MULTIPLE MOTOR POSITION SENSOR FAULTS STORED IN EME

E-Series	Model Description	Production Date	Engine
F15	X5 40e PHEV Sports Activity Vehicle	All	With N20 engine

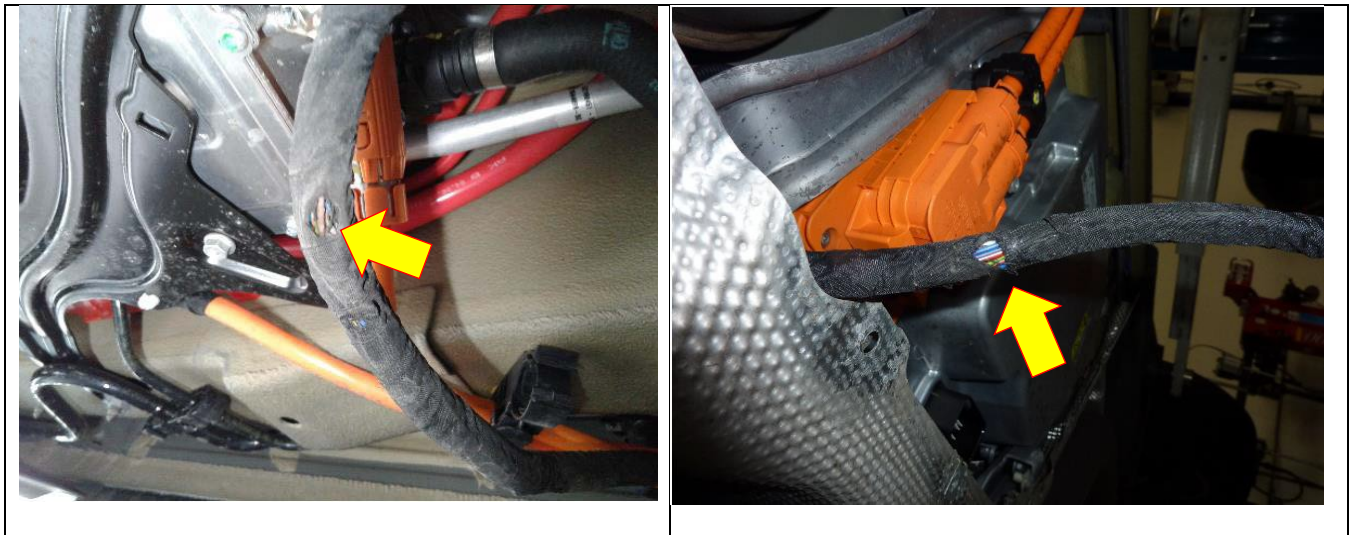
If there are chafe marks on the wiring harness (arrows) per the examples below, the harness must be repaired. Go to Step 3.

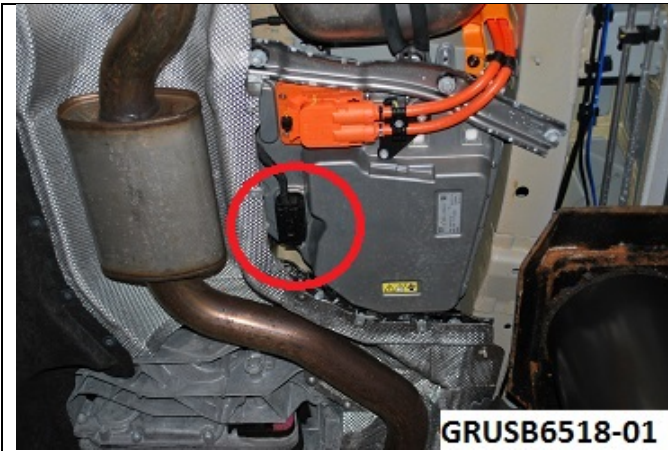
6. Perform a visual inspection of connector A190*1B on the bottom of the EME.

If there are noticeable problems (e.g. damage, traces of water, etc.) contact BMW of North America's Technical Service Department by submitting a **TSARA** case.

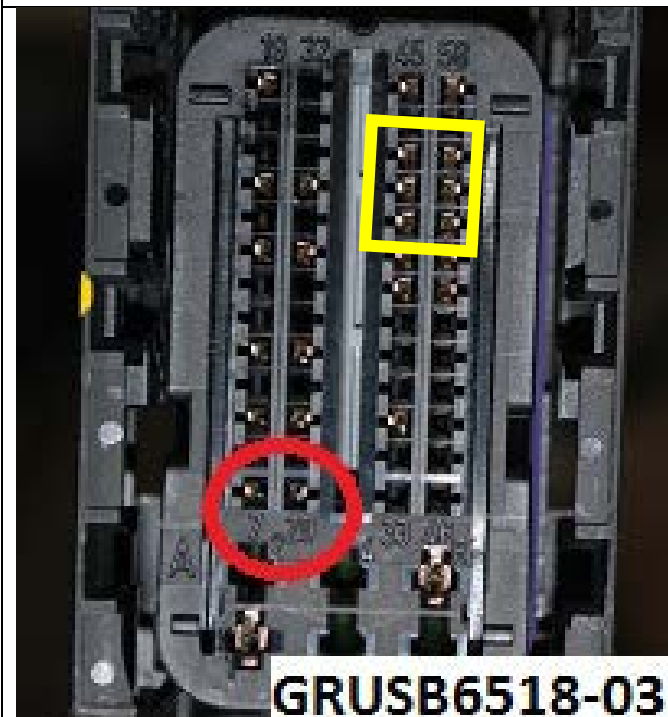
- Examine pins 41, 42, 43, 54, 55, and 56 at the EME connector (outlined in yellow)
- Also examine pins 7 and 20 (outlined in red) which are for the ACSM signal
- **Notify technical support via a TSARA case if there is visual/water damage to these pins.**

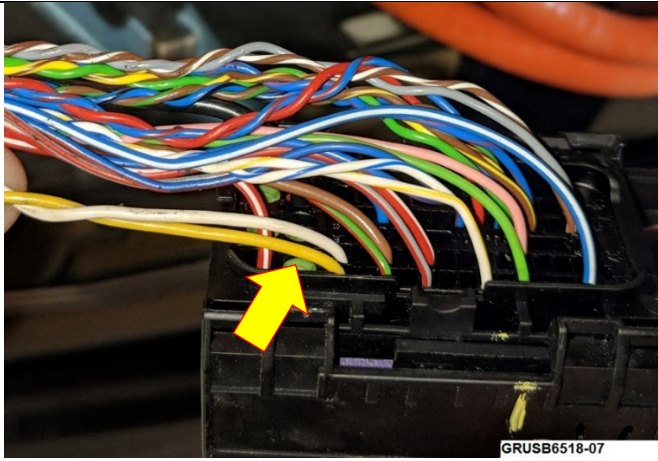
GRUSB6518-07

1. Chafing damage on the wiring harness leading to the EME connector.
2. Contact resistance at the EME's 58-pin signal connector A190*1B is too high.
3. The wires going to pins 41, 42, 43, 54, 55, and 56 in connector A190*1B are under tension. Vibrations may sporadically increase the resistance values of these connections outside of the acceptable range, leading to the activation of the Malfunction Indicator Lamp.

Note: The two wires white and yellow are under strong tension, thus are entering the connector at a tight angle (arrow).

10. Remove the last 8" of tape from the harness at the EME connector to reduce the pull tension of this connection at the EME.

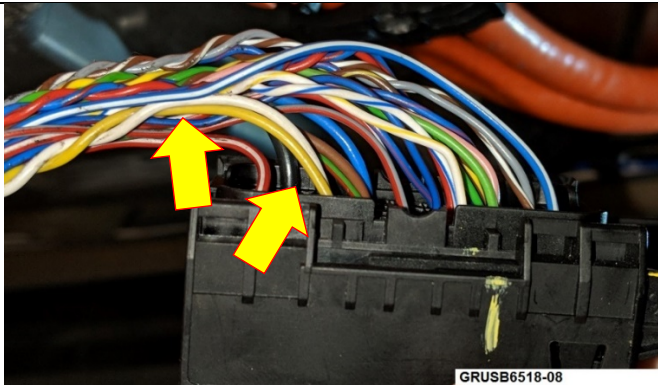
GRUSB6518-08

11. The wires between the cable tie location and the EME electrical connector/pins should NOT be under tension!

The white and yellow wires have been reformed in a larger radius (arrows) to enable a partial relief bend. This eliminates tension on the electrical pins.
