# Technical Service Bulletin

## 10 Oil loss from the filler cap

10 20 18 2059446/1 May 12, 2020.

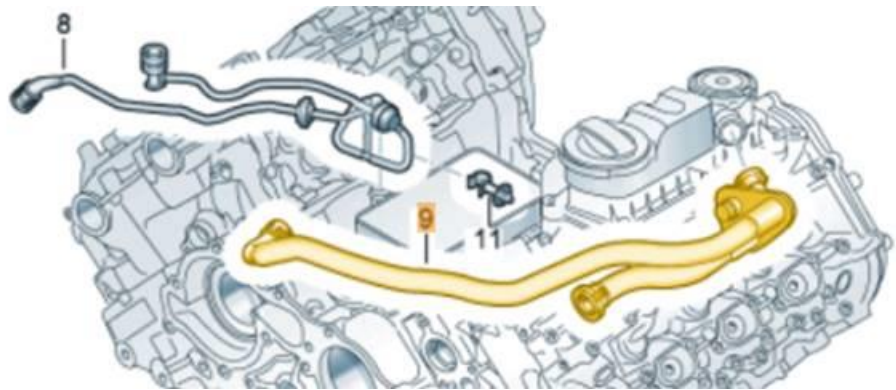
A faulty membrane in the breather line 06M 103 210 \*\* can result in excess pressure in the crankcase and therefore some oil loss through the filler cap.

**Figure 1.** Breather line that needs to be replaced.

Replace the breather line 06M 103 210 \*\* (different variants available, only order by VIN).
