DTC (Code) P0402 - 00 Codigo:	Bulletin: RD18-002 Date Fecha: August 12, 2018
Description:	Engine Exhaust Gas Recirculation Differential Pressure - Mechanical system not responding properly
Application:	US13 – US20 Emissions

EGR Differential Pressure Sensor, Replacement

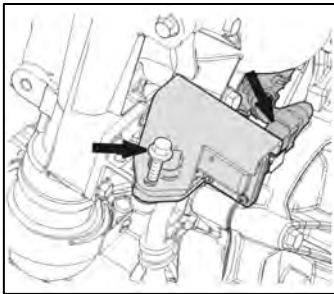
**Old Style EGR
Differential Pressure**

**New Style EGR
Differential Pressure**

3. Disconnect the wiring harness lead from the connector terminal on the EGR pressure differential sensor. Loosen and remove the mounting bolts and remove the EGR pressure differential sensor from the venturi tube. *Note: Install new sealing rings when replacing the sensor.*

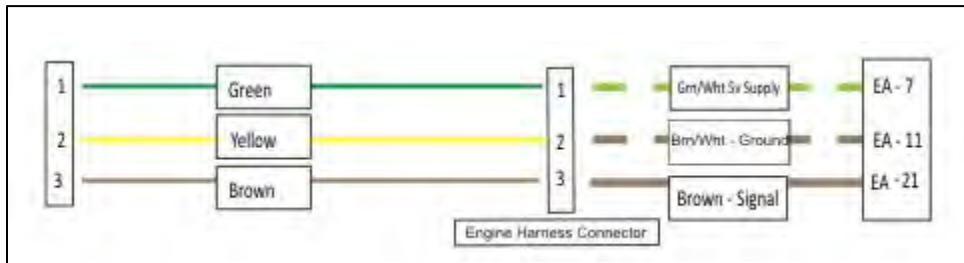
Note: When installing the kit for the updated EGR differential pressure sensor for the D13 engine, the engine harness connector pins will need to be relocated. The previous pin locations were:

- Pin 1 — Green/White
- Pin 2 — Brown
- Pin 4 — White/Brown

Note: The new engine harness connector pin locations when replacing old style EGR differential pressure sensor with the new style sensor in kit are:

- Pin 1 — Green/White
- Pin 2 — Brown/White
- Pin 3 — Brown

1. Clip applicable cable ties and remove P-clamps securing the EGR differential pressure sensor harness leg.
2. Use extractor tool (part number 9812483) in kit 88890037 to relocate the engine harness connector pins.
Special tools: 9812483
3. Connect the EGR differential pressure sensor jumper harness to the engine harness.
