| DTC (Code) P10CE-97 Codigo: | Bulletin: RD18-002 Date Fecha: June 13, 2018 |
| Description: | Reductant Return: No Flow Detected - Component or System Operation Obstructed or Blocked |
| Application: | US13 – US20 Emissions |

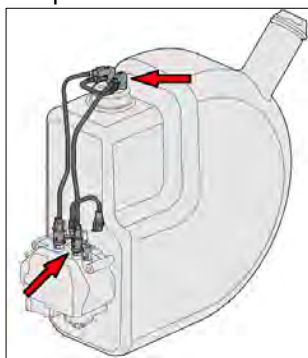
Before replacing the DEF Pump Unit please check for damaged return hoses and connectors.

1. Disconnect and clean the aftertreatment DEF lines between the DEF tank and the DEF pump using water and compressed air. If the line is broken then it will have to be replaced.
