STAR ONLINE PUBLICATION

Case Number: S1508000480

Symptom/Vehicle Issue: Speed Control Operates Intermittently

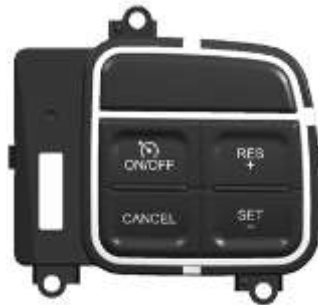
Fig 1

1. Using Wi-tech measure the S/C input voltages for S/C voltage inputs 1 and 2 signals while pushing and holding the on button (see [Fig 1](#) and [Fig 2](#), [Fig 3 for voltage monitoring](#)).

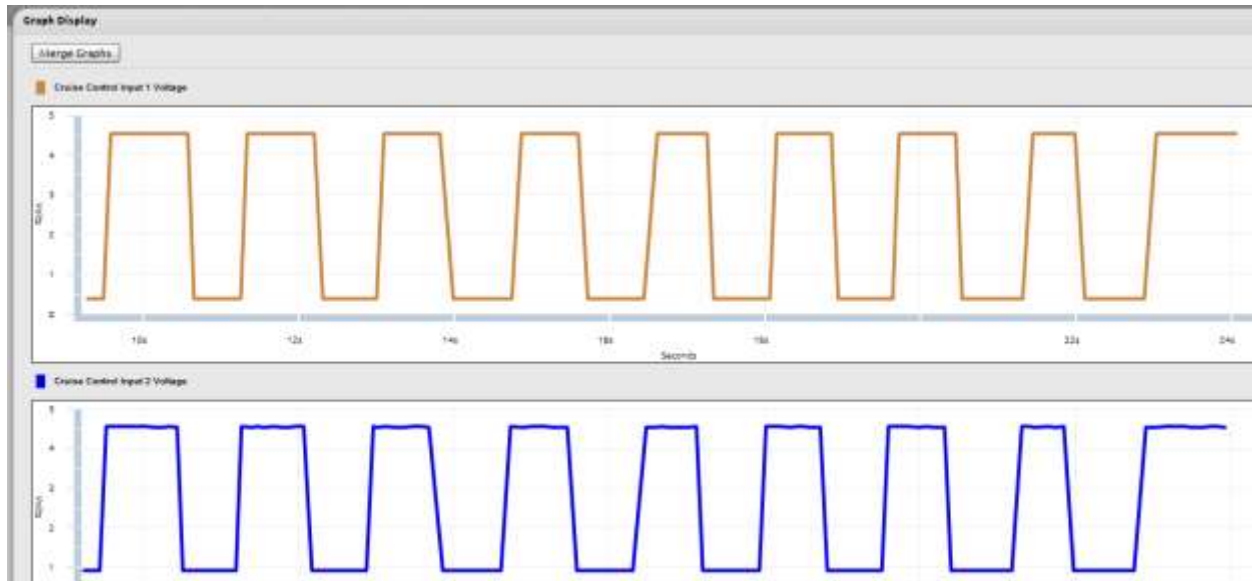
Fig 4

4. If the cruise control Signal voltages are at V_{nom} , graph the speed control input voltages on the same screen while pushing and releasing the on button. If the switch is performing correctly, the input voltages will be almost a mirror image of each other as shown below in Fig 4.

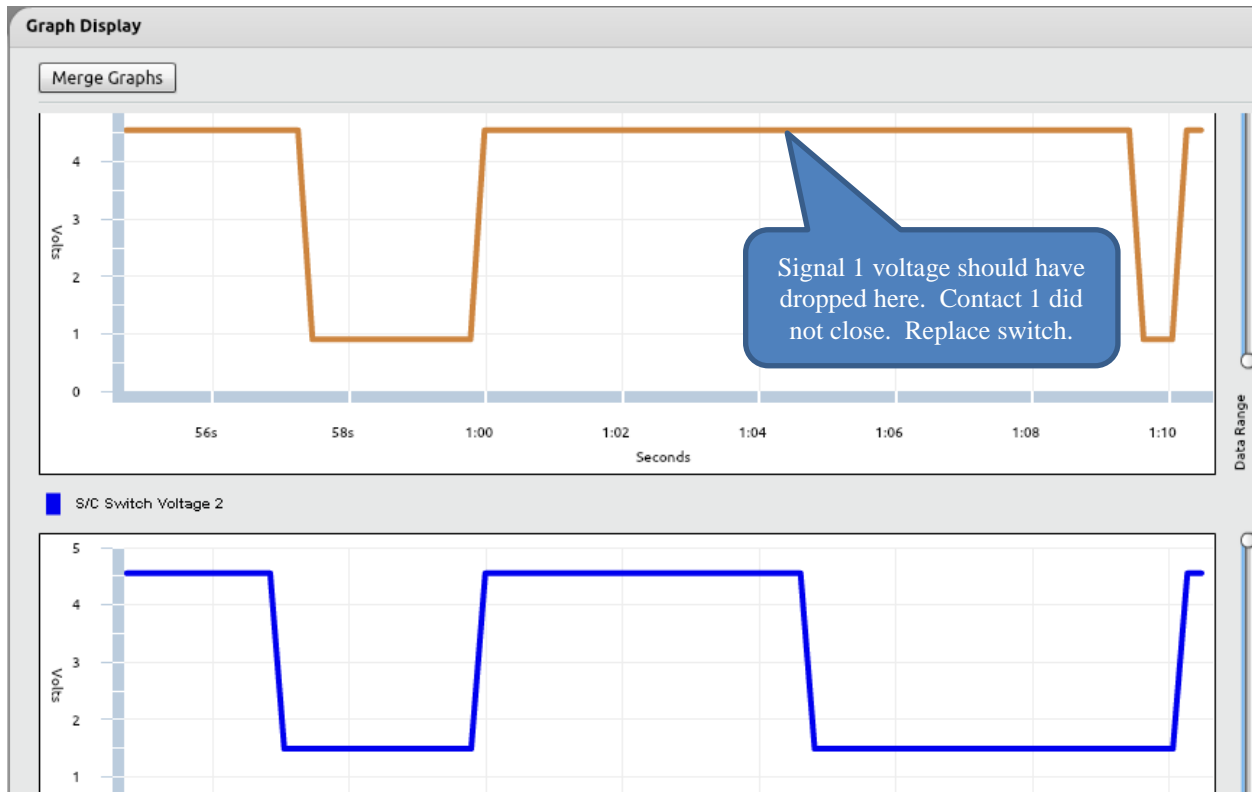
Fig. 5

If the switch is not performing correctly, the switch voltages may not be a mirror image of each other as shown below in [Fig 5](#).

Signal 1 switch contact did not close when signal 2 closed. This can cause a P0579 and the cruise will not turn on. In this case, the S/C switch should be replaced.
