JTBO0662NAS2

**TECHNICAL BULLETIN**

Transmission Fluid Cooler Pipes - Fluid Leak

MODEL:	MODEL YEAR:	VIN:	APPLICABILITY:
F-PACE (X761)	2017 Onwards	045145 Onwards	INGENIUM I4 2.0L Petrol/INGENIUM I4 2.0L Diesel

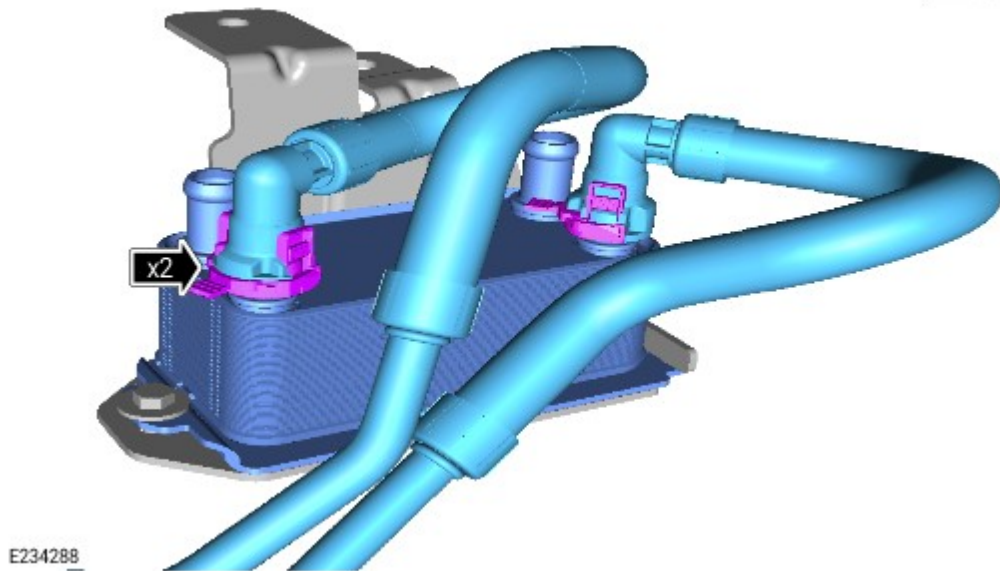
7.

Excessive vibration transmitted through the transmission fluid cooler pipes while the engine is running, causing the weld joints to fracture.

Remove and discard the transmission fluid cooler pipes.
