Service Bulletin

Bulletin No.: 20-NA-071

Subject: Service Engine Soon Lamp Illuminated and/or Service Power Brake Assist Message Displayed, with DTCs P0557 or P0558 Stored

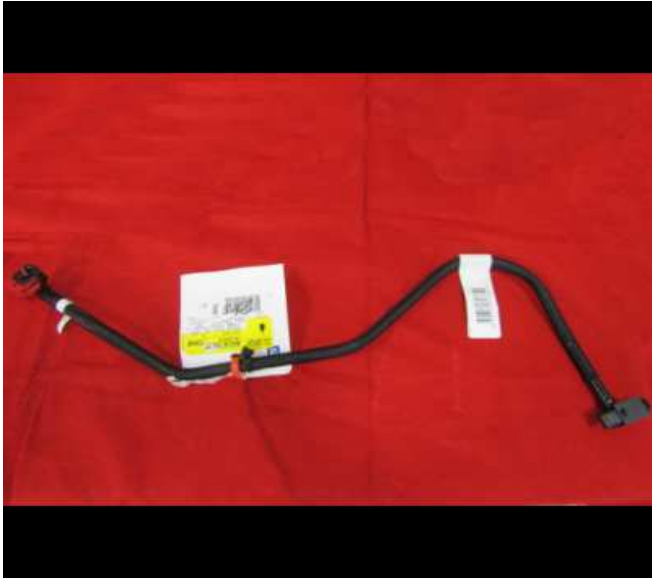
5549611

LGX Hose

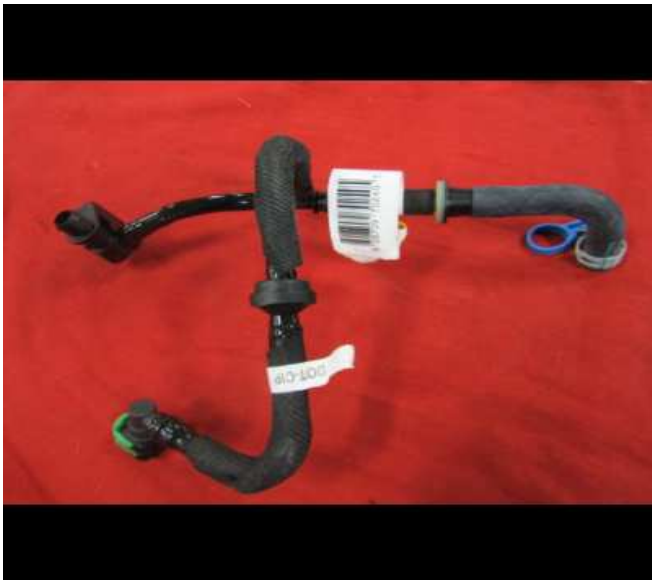
5549612

LFY Hose

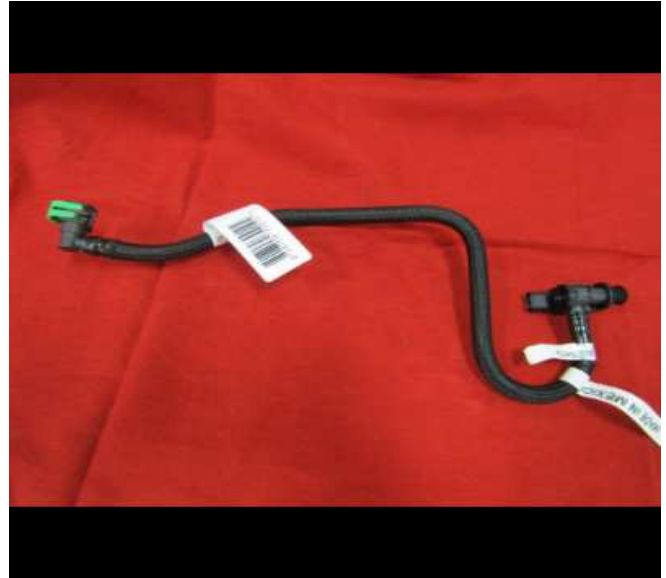
5549615

LCV Hose

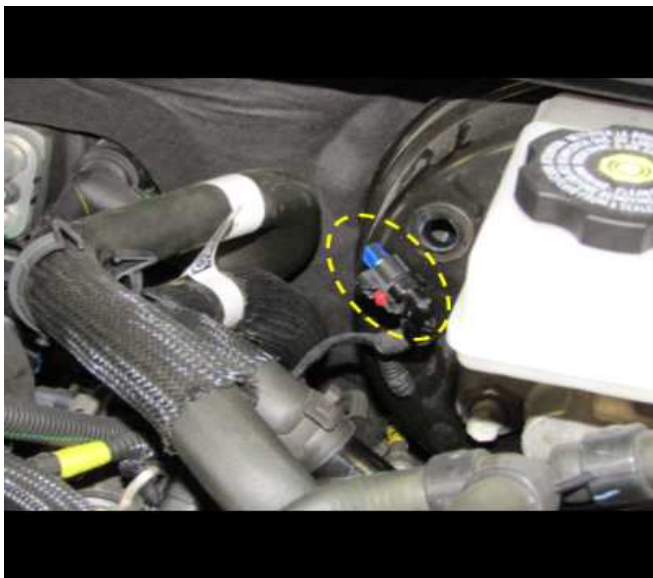
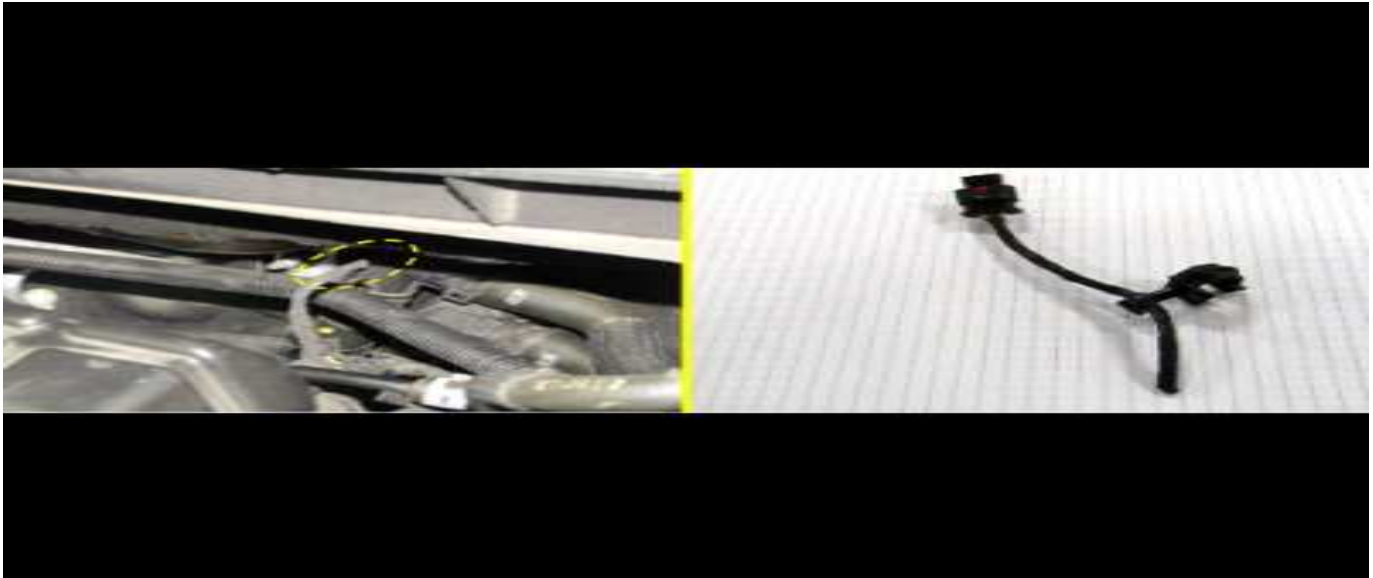
5549617

Note: The top graphic shows the LGX connector intact; the bottom one shows the LFY wiring already cut.

2. Locate the power brake booster vacuum sensor electrical connector. Fold conduit back and cut off connector, leaving approximately 5.0 cm (2.0 in) of wiring on the engine harness side.
3. Tape the cut wiring end to the engine harness. These wires will no longer be used.

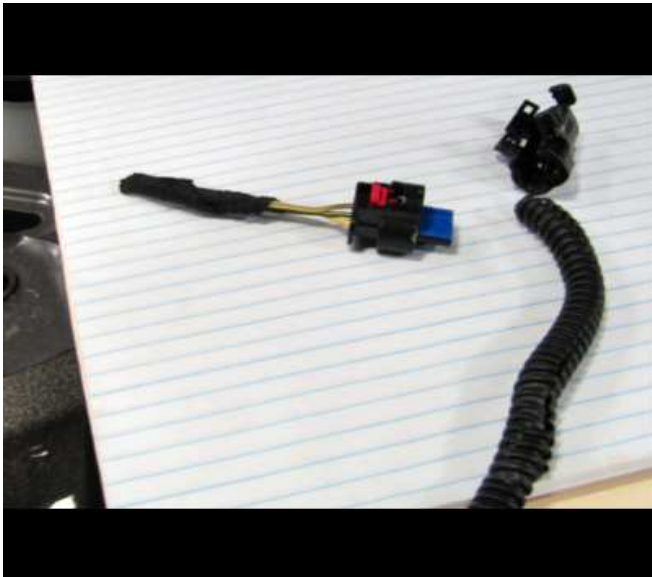
5549619

Note: Not all applications will have a cover on the connector.

4. Remove conduit and cover from the old connector.

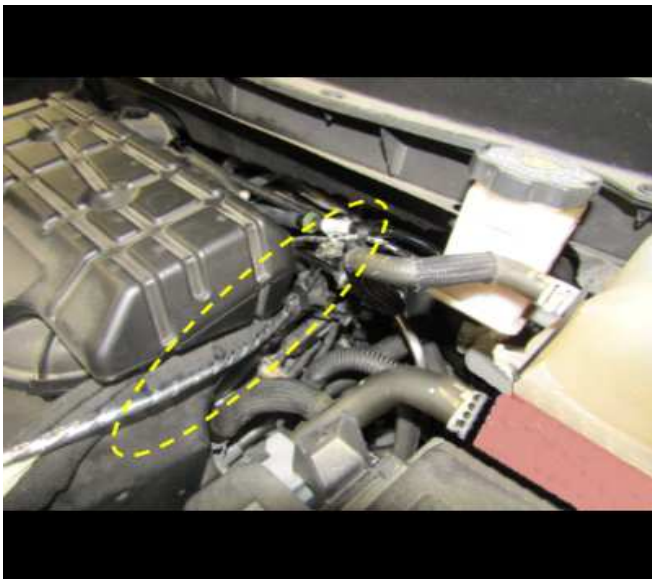
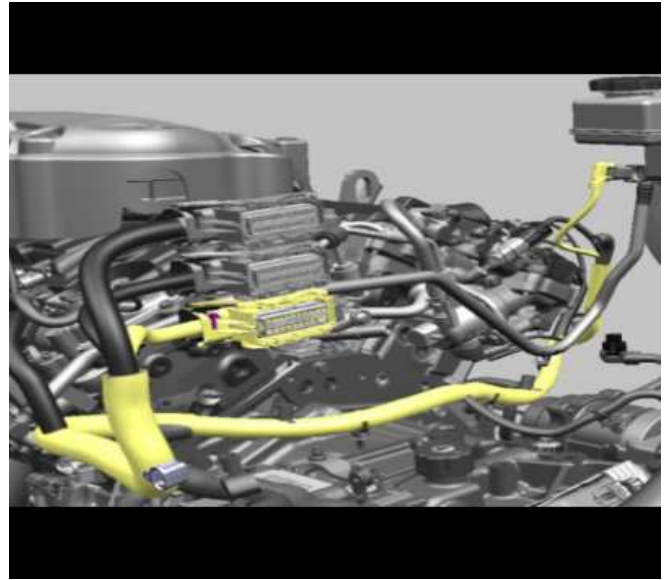
Note: The LFY harness routing is shown in the top graphic, the LGX routing is shown in the bottom math file. The routing for LCV is similar to the routing of the LGX.

10. Start routing the new harness alongside the engine harness.

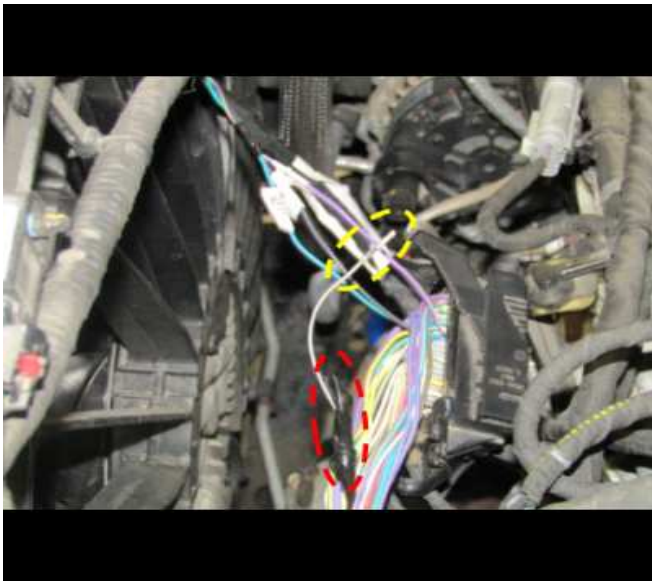
5549629

Note: In this step, do NOT cut the terminal off of circuit #6032 (circled in yellow in the graphic above).

15. Cut off the terminated leads that were in circuits #6030 and #6031 and fold and tape off the ends (circled in red in the graphic above). These circuits will no longer be used.

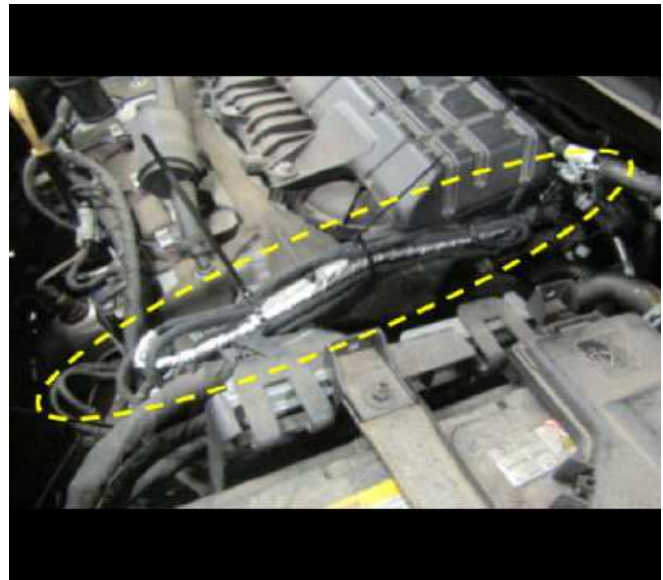
5549633

Note: Graphic shown above is LFY harness routing.

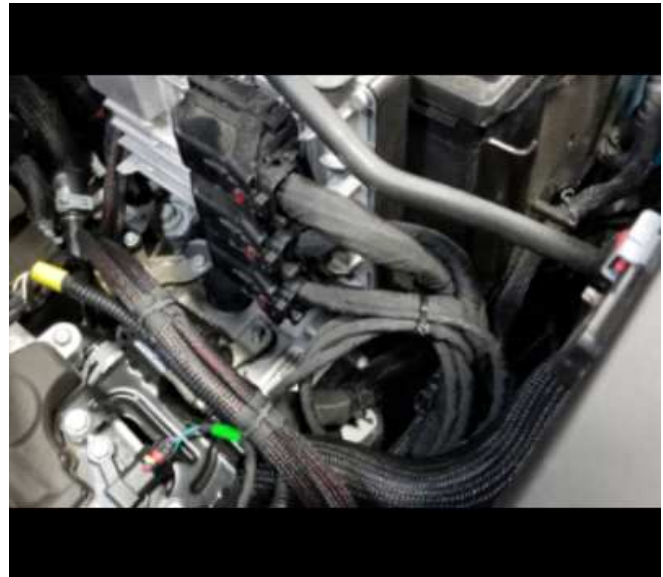
5549634

Note: Graphic shown above is LGX harness routing, with LCV being similar.

Important: It will be necessary to coil the extra wire length. Ensure the wire is tied back away from any sharp edges or moving parts that could cause damage to the harness.

28. Secure the new harness to the engine wiring harness using at least 5 or 6 tie straps.
29. Check and clear any DTC's, as necessary.
