**UPGRADE
BULLETIN:
200224REV**

**PRODUCT(S)
AFFECTED:**
American Coach
Dream, Eagle and
Revolution

SUBJECT:
Modifying the
Wire Harness
for the Keyless
Entry System

ISSUE DATE:
May 2020

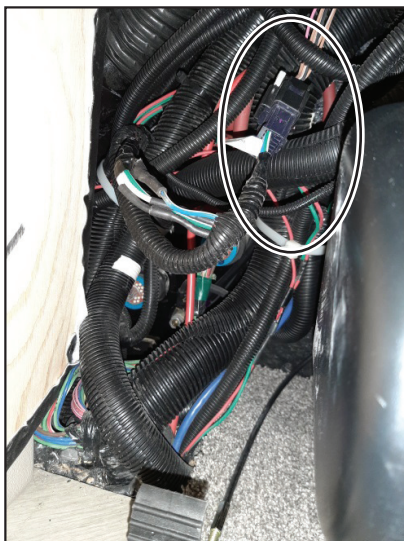
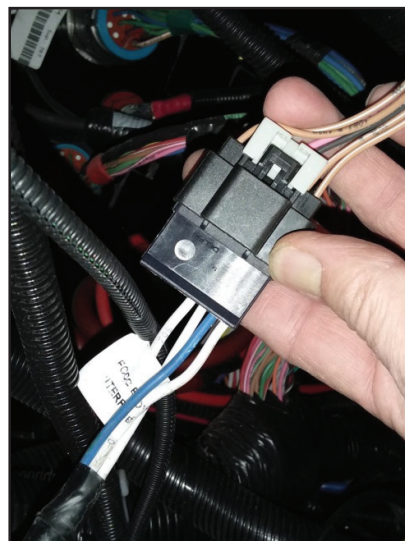
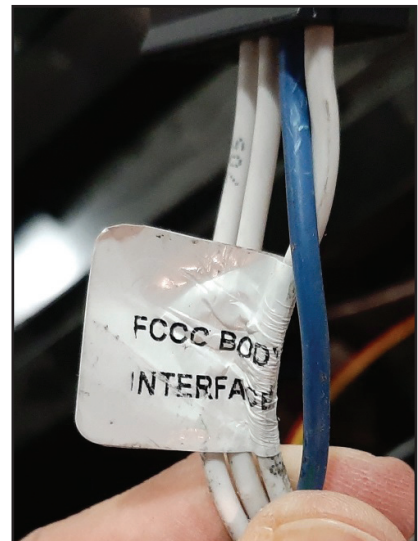
4. Turn off the ignition and remove the ignition key. Maintain control of ignition keys while work is performed. Attach a notice "DO NOT USE" to the ignition switch in order to avoid activation of the systems or starting of the motorhome.
5. Block wheels to prevent movement.
6. Locate and remove the black, vinyl wrapped access panel found to the left-hand side of the steering column, at floor level, see Figures 1 and 2.
7. In the area behind where the panel was removed, locate the OEM keyless entry connection near the steering column. It will be a 16-pin Packard connector with cavities A through D populated with the remaining positions empty. The harness will have a tag labeled "FCCC Body Builder Interface" near the connector and contain Circuits 088, 089, 705, and 706. See Figures 3-5 for clarifying information.

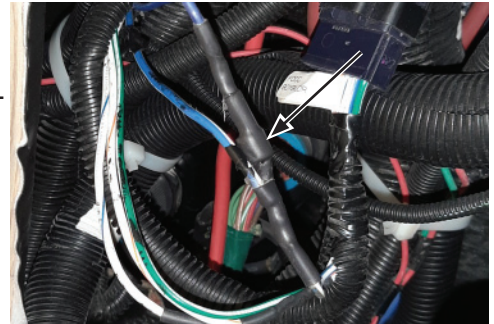
Figure 6

8. Once the correct connector and harness has been located, remove the wire loom and any tape from the harness approximately 6-8" from the connector in order to locate the diode connecting Circuit 089 (blue-white wire) to Circuit 053 (blue wire). See Figure 6.
9. If Circuit 053 (blue wire) has already been disconnected from the diode, take a clear photo and attach it to a draft claim. Submit using the inspection-only code listed on Page 4. If the Circuit 053 is still connected to the diode, proceed to the "Correction" procedures, Steps 10-14.
