**Transmission Symptom - Transmission Oil Leaks Out When Driving on Race Circuits:
Replacing Vent Line for Clutch Chamber (SY 130/19)**

Vehicle Types: **911 GT3 (991)/911 GT3 RS (991)**

Subject: **Vent line for clutch chamber**

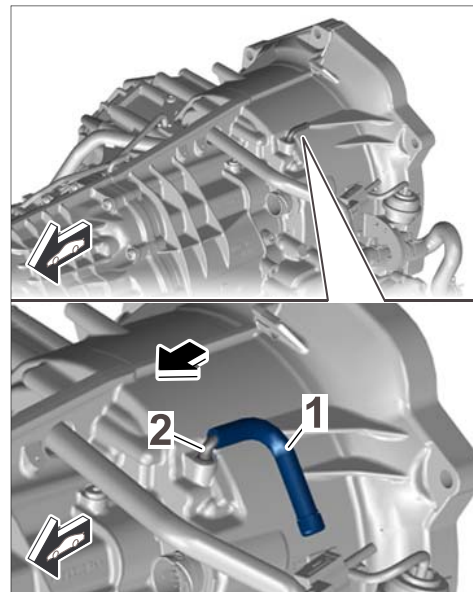
Vent line for clutch chamber

Symptom: Transmission oil leaks out of the vent line for the clutch chamber when driving on race circuits.

Cause: Highly dynamic driving on race circuits at high engine speeds causes oil foaming and can result in an oil leak from the PDK vent line on the clutch side in some cases.

Work Procedure: 1 Disconnect vent line for clutch chamber ⇒ *Vent line for clutch chamber -1-* from breather pipe ⇒ *Vent line for clutch chamber -2-*.
