**Solution K31126441**

**Title** Mack Chassis - Granite Models (GU, GR) - Hood Warpage: Hood Warped, Dented, Divot Near Center Of Hood - MY 2016 And Newer

**Mack Model** GU - Granite

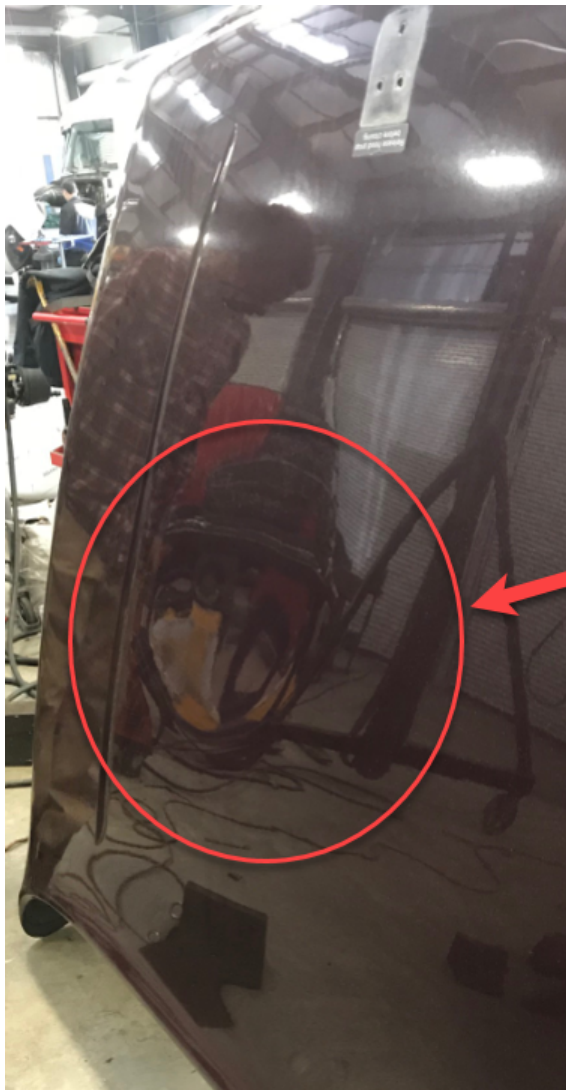
**Affected Area**

**Cause** Warpage of the hood may be experienced on certain Mack Granite chassis manufactured for model years 2016 and newer.

**Solution** Affected models will have an appearance similar to the one shown in the circled area in the example below.

It has been determined that an increase of lateral structural hood support is required to correct this issue.
