Technical Service Bulletin

90 Top view camera image: only the park aid lines are displayed

90 20 48 2048517/3 May 21, 2020. Supersedes Technical Service Bulletin Group 90 number 18-00 dated October 2, 2018 for reasons listed below.

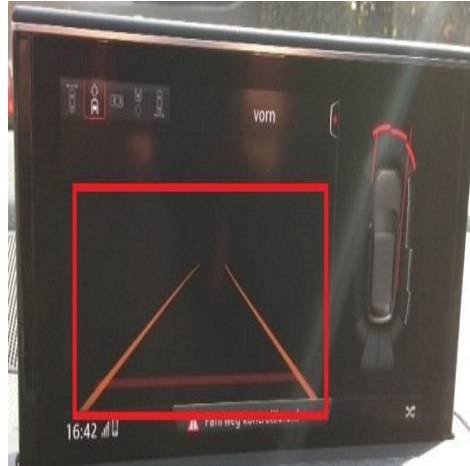
- The video feed from the exterior of the vehicle is not shown (Figure 1). Only the static outlines of the park aid are being displayed.

Figure 1. Only static lines are displayed.

The software needs to be updated.

1. Follow all instructions in the attached TSB 2011732: *00 Software Version Management (SVM), operating instructions.*
2. Update the overhead view camera module, J928 (address word 006C) using the SVM action code as listed in the table below if necessary.
3. Perform calibration of the overhead view camera system as outlined in the Elsa Repair Manual.
