Solution K07192247

Title Driveline Noise, Suspension Ride Height Too High, Suspension Will Not Exhaust - **Chassis Built 2016w01 And Newer**

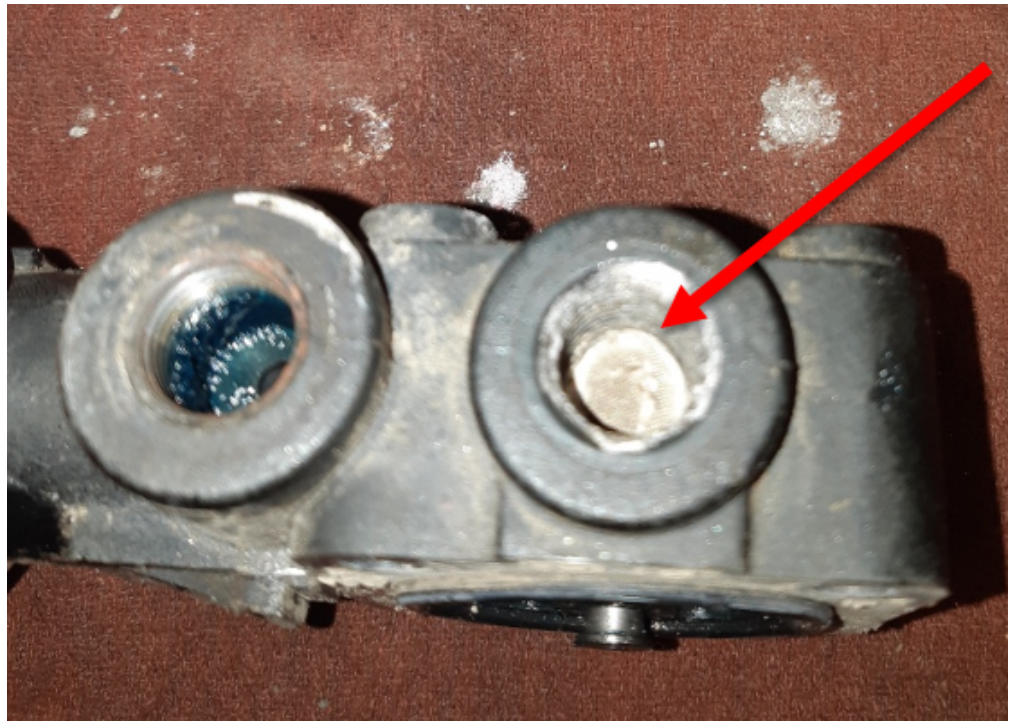
Solution The symptoms above may be caused by accumulation of debris in the exhaust port of the Barksdale leveling valve (corrosion, road salt, dirt, etc). The exhaust port allows air to be exhausted from the suspension system to maintain a level ride height.

1. Verify the unit is equipped with a Barksdale leveling valve and that it is clogged.

- 2. Replace the clogged Barksdale leveling valve.
- 3. Using the parts indicated below, create a 90 degree bend out of the exhaust port.
