Technical product information

Topic	Clicking noises from front corner(s)
Market area	Bentley: worldwide (2WBE),Hongkong-Macau (5HK)
Brand	Bentley
Transaction No.	2052853/5
Level	EH
Status	Approval
Release date

Bentayga

Clicking noise from front corner(s)

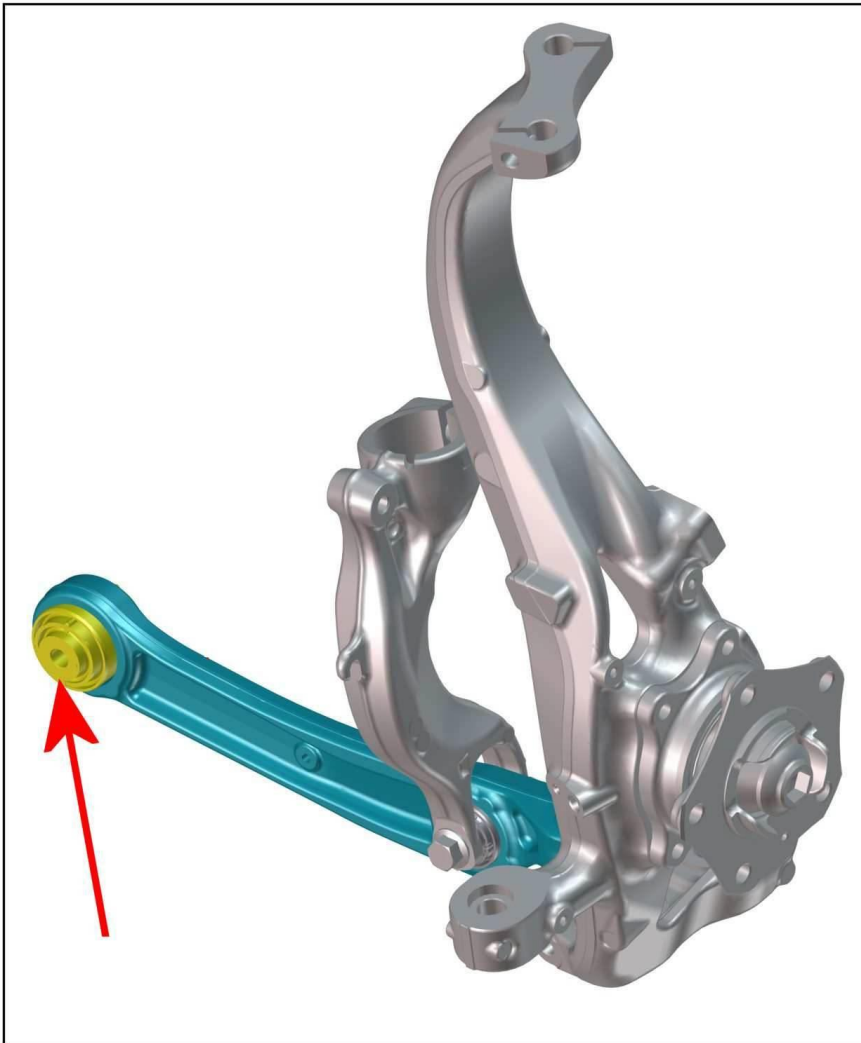
Figure 1

Symptom 1 - Single click from the front wheel corner(s) when the steering is moved from lock to lock whilst stationary

- If so then replace both front lower inner control arm bushes (Figure 1)

IMPORTANT: Please check the vehicle Repair History to confirm the inner bushes have not been previously replaced, if they have been replaced once before, You must then replace the complete arm, Do Not carry out the bush replacement procedure more than once (per lever)

IMPORTANT: Prior to starting this procedure ensure you have assembly lubricant part number G052566A2 this must be used when fitting the new replacement bushes, the lubricant should only be used when the bushes are replaced as per the instructions within TPI 2052853/-

Each bush should have 5ml of lubricant applied prior to fitment within the bush, the grease should remain present throughout the fitting/pressing in procedure as the grease aids the fitting process and is also crucial once fitted to eliminate any further noise issues *Please Note that x1 – 100 ml tube will be sufficient for use on 20 bushes (10 vehicles) – Do not order x1 tube of lubricant per each individual vehicle complaint*
