<b>Topic</b>	Bentayga W12 - Engine control modules - Software update - Emission service action (SC 20/07)
<b>Market area</b>	United States E05 Bentley USA and rest America (6E05)
<b>Brand</b>	Bentley
<b>Transaction No.</b>	2058667/2
<b>Campaign number</b>	EB49
<b>Note</b>	
<b>Type</b>	
<b>US code</b>

### Bentayga W12

## Repair instructions

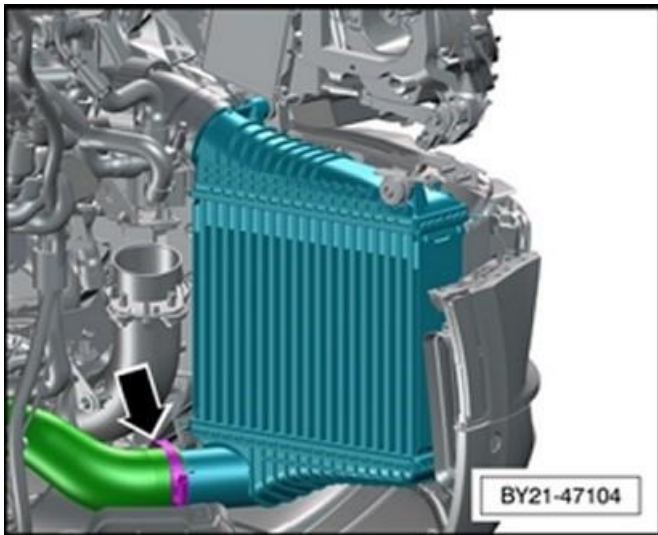
NOTE: The software also reduces the excess build up of engine oil within the charge air cooler system

- Referring to Figure 1 - Remove the right and left hand lower charge air cooler pipes, any oil found in the charge cooler/pipes should be drained off, any remaining oil residue should be cleaned from the charge coolers and pipes
- Refit the lower charge air cooler pipes
