Field campaign

Topic	Bentayga W12 - Engine control modules - Software update - Emission service action (SC 20/07)
Market area	United States E05 Bentley USA and rest America (6E05)
Brand	Bentley
Transaction No.	2058667/4
Campaign number	EB49
Note	
Type	
US code

Bentayga W12

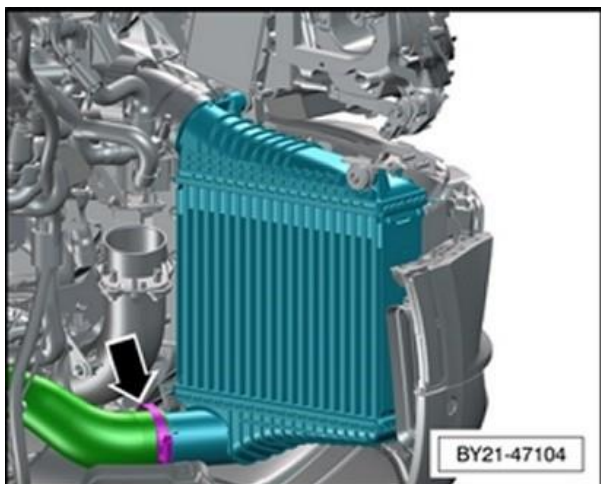
The software also reduces the excess build up of engine oil within the charge air cooler system

IMPORTANT: A specific level of oil residue is expected in a charge air cooler, however if any amount of oil is found within the charge air coolers OR any of the previously mentioned symptoms within the Customer statement/workshop findings section are evident the operative must determine which section is applicable

- Referring to Figure 1 - Remove the right and left hand lower charge air cooler pipes, any oil found in the charge cooler/pipes should be drained off, any remaining oil residue should be cleaned from the charge coolers and pipes
- Refit the lower charge air cooler pipes

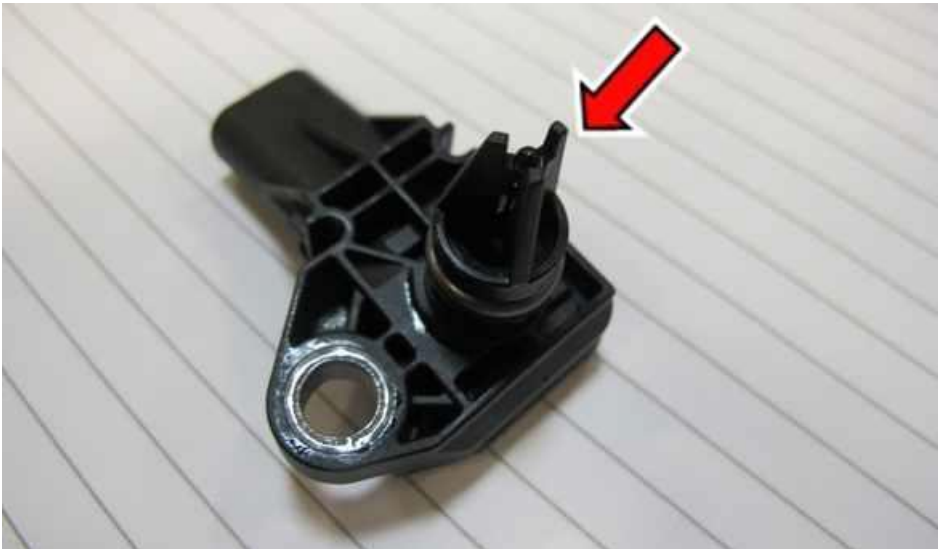
Figure 2

- Check the fault memory of both engine control modules for either of the following DTC's

"P010600: Manifold Absolute Pressure or Bar. Pressure Sensor Circuit Range/Performance"

"P2A0B00: Manifold Absolute Pressure Sensor "B" Circuit Range/Performance"

If either of the DTC's are stored, remove the relevant sensor (G429 or G71) and check for oil contamination in the sensor (Figure 2). If found to be contaminated replace the affected sensor - Refer to the ETKA parts catalogue

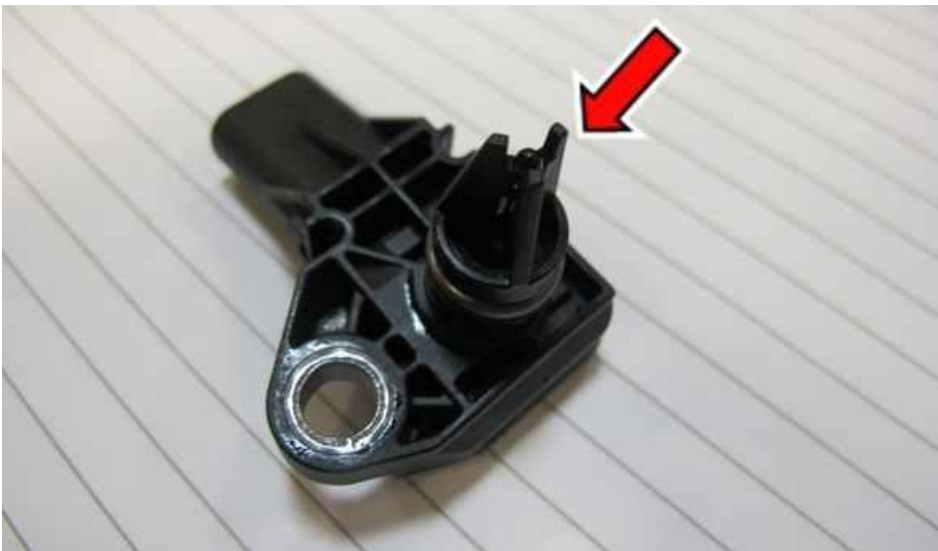
Figure 2

- Check the fault memory of both engine control modules for either of the following DTC's

"P010600: Manifold Absolute Pressure or Bar. Pressure Sensor Circuit Range/Performance"

"P2A0B00: Manifold Absolute Pressure Sensor "B" Circuit Range/Performance"

- If either of the DTC's are stored, remove the relevant sensor (G429 or G71) and check for oil contamination in the sensor (Figure 2). If found to be contaminated replace the affected sensor - Refer to the ETKA parts catalogue
