# SERVICE BULLETIN

Classification: EL20-008a	Reference: NTB20-016a	Date: May 18, 2020
------------------------------	--------------------------	-----------------------

## RADIO INTERMITTENTLY REBOOTS DURING AUDIO PLAYBACK VIA BLUETOOTH CONNECTED IPHONE

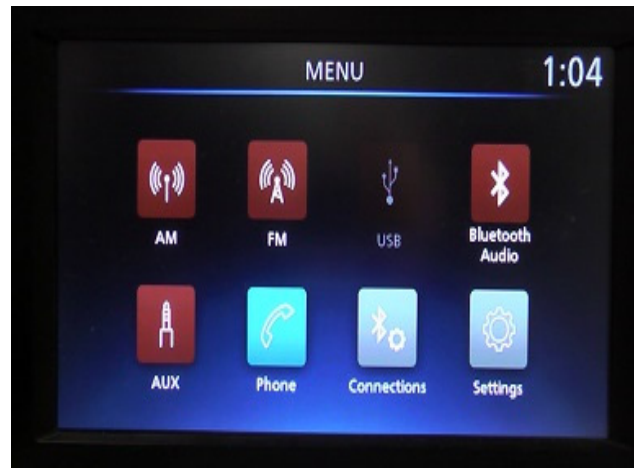
Figure 14

- Reprogramming is not complete until the audio unit reboots and returns to the main MENU screen (Figure 14).
- If the screen turns OFF (blank black screen), and remains OFF for longer than one (1) minute, press the volume knob (power button) or turn the screen back ON before proceeding to step 23.

**NOTICE** To prevent damage to the AV control unit, do NOT remove the USB drive unless the audio unit has rebooted and the main MENU screen, as shown in Figure 14, is displayed.
