SERVICE BULLETIN

Classification: AT20-004	Reference: NTB20-038	Date: May 19, 2020
-----------------------------	-------------------------	-----------------------

2020 TITAN; DTC P288B STORED IN THE TCM

APPLIED VEHICLES: 2020 Titan and Titan XD (A61)

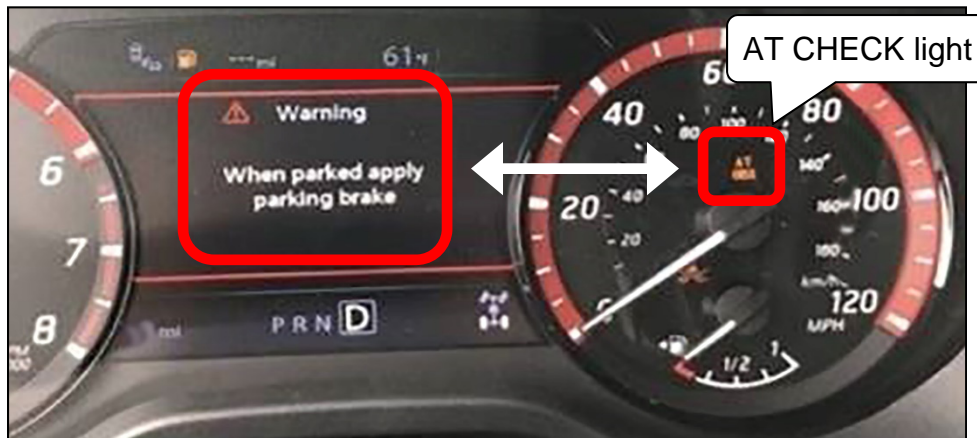
Figure 1

DTC P288B (PARK LOCK SOLENOID) is stored in the TCM.

- The following warnings turned ON in the vehicle information display and speedometer (see Figure 1).

- Confirm the current transmission control module (TCM) part number.
- Reprogram the TCM, if applicable.
