### PIP5504D Diagnosing Fishbite Chuggle Misfire Feeling Or Shudder Vibration, With A Light Tip In

#### Models

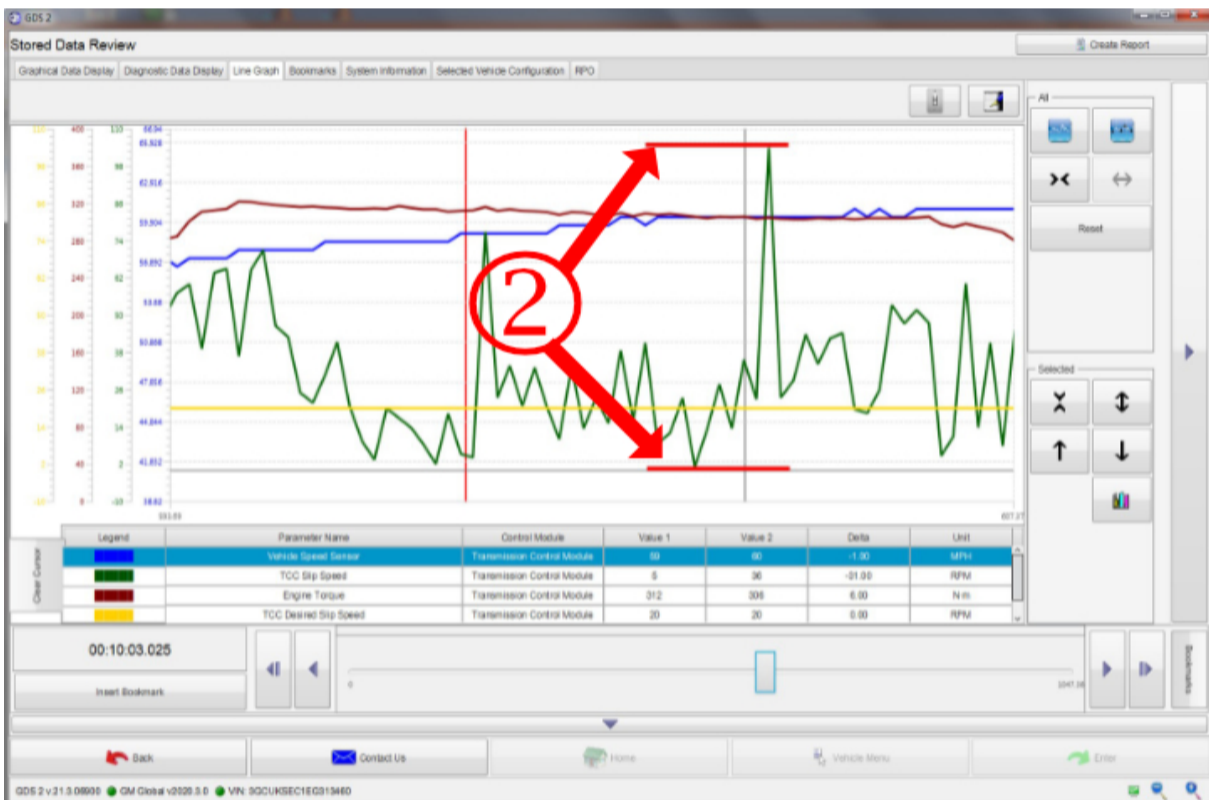
### Callout 2

GDS2 data showing TCC slip peak to peak erratic near 0 RPM to over 100 RPM in a short time is an example of a damaged torque converter clutch.

TCC SLIP CONTROL TEST RESULT	TCC rpm slip peak to peak (at steady throttle)	ACTION	Note
Normal (Callout 1)	Below 20 rpm.	Do nothing.	
Damaged (Callout 2)	Near 0 to 100 rpm - erratic.	Inspect transmission further	Inspect transmission pan magr for excessive metal accumulati
Degraded (Callout 3)	Near 60 rpm - repeating.	Flush transmission fluid.	Shudder, surge, fish bite likely.
