# Preliminary Information

## PIP5598B Diagnostic Tip: Possible Crank No Start Or Extended Crank No Codes

Involved Region or Country:	North America
Condition:	Possible Crank No start or Extended Crank No Codes
Cause:	Possible exhaust camshaft reluctor out of phase

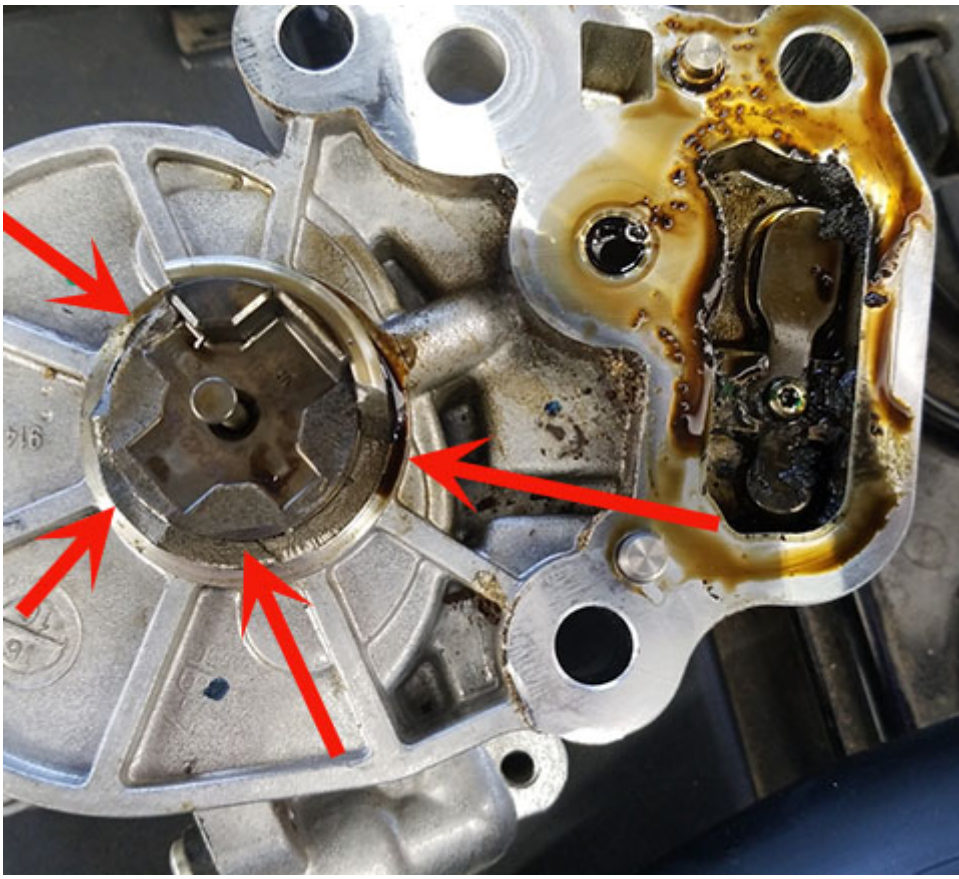
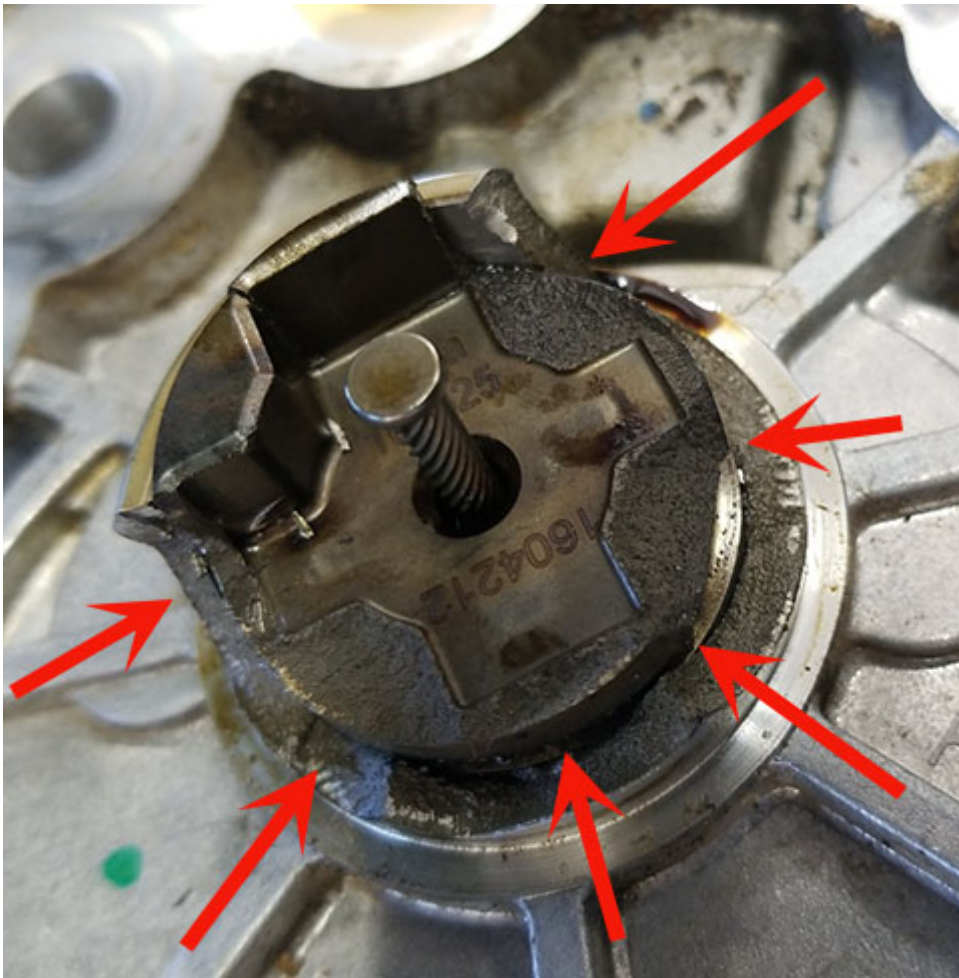
Remove cam cover assembly and perform steps below to confirm exhaust camshaft reluctor orientation. During disassembly the vacuum pump drive lugs should also be inspected for damage. (Photo below show damaged vacuum pump drive lugs)

If you find the vacuum pump drive lugs are broke and/or the exhaust camshaft retractor is out of position then replacement of the exhaust camshaft and vacuum pump will be required.

**Note:** If needed, It will also be necessary to locate and remove the broken vacuum pump drive lugs and other metal debris during repairs.

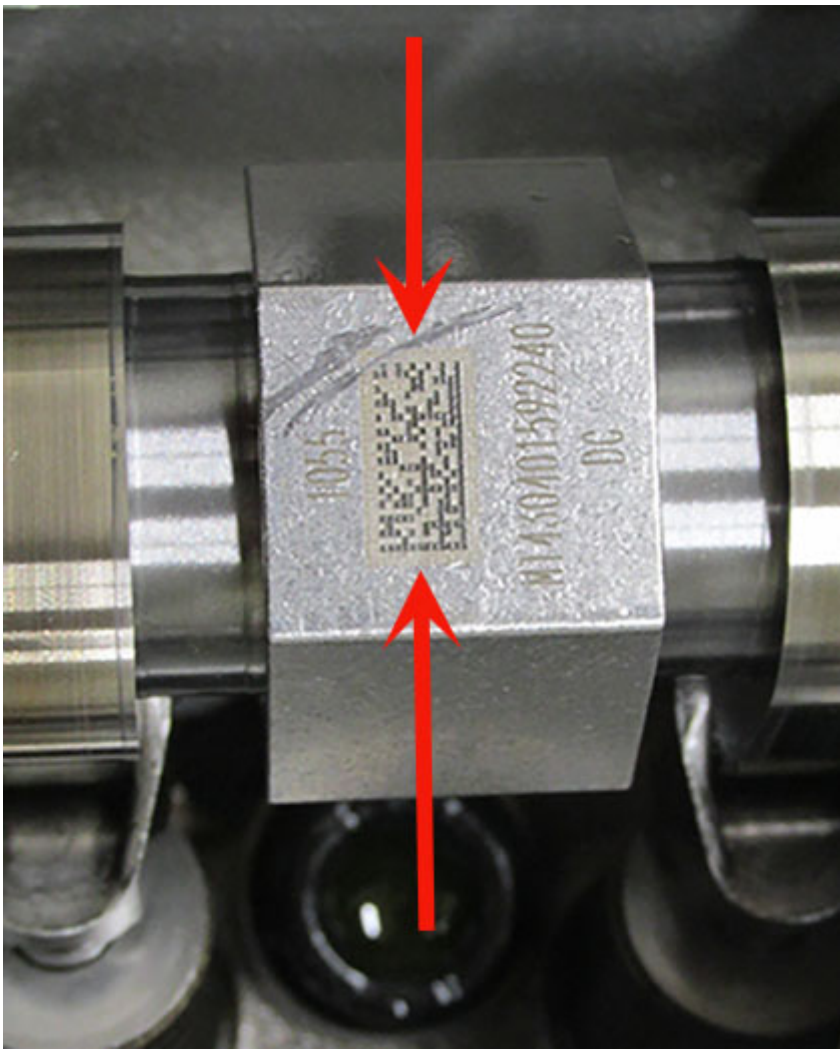
Rotate the exhaust camshaft to position the 2D matrix marking on the camshaft hex in the 12"o'clock position.  
(Reference photo below for 2D marking.)

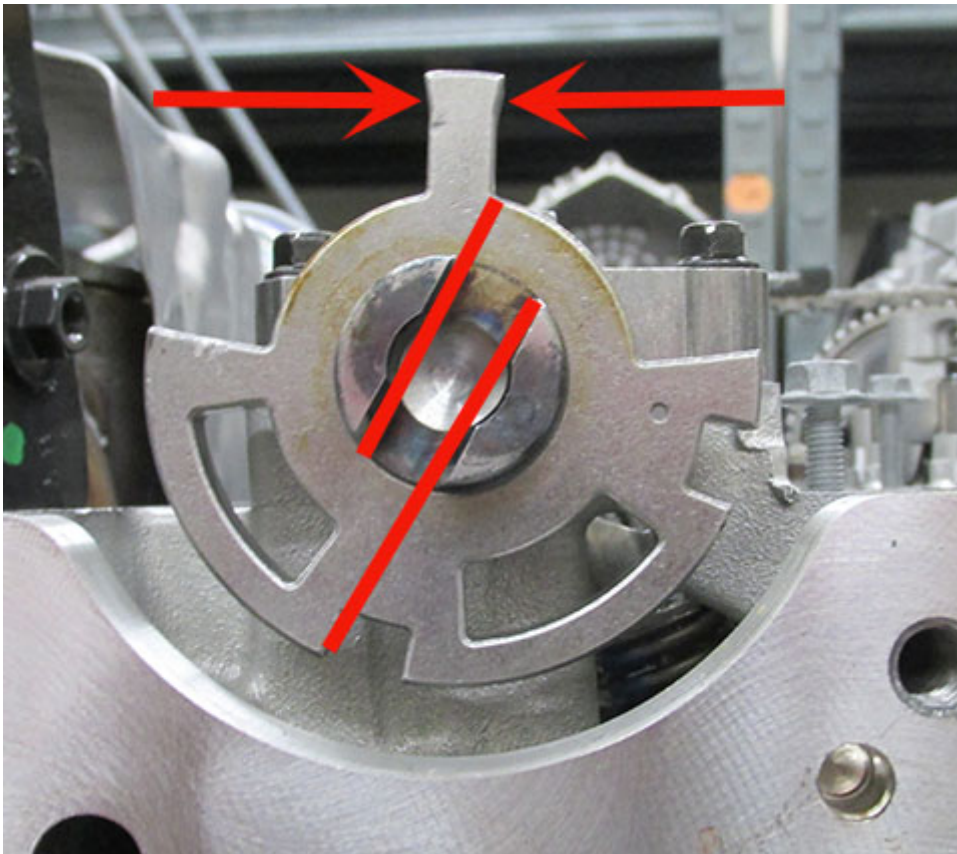
Once the exhaust camshaft 2D matrix has been positioned at 12"O'clock. Verify the small tang located on the camshaft reluctor ring (Arrows below showing tang on reluctor) is inline with the 2D matrix marking. Also shown are additional reference points used to verify exhaust cam reluctor orientation to camshaft.

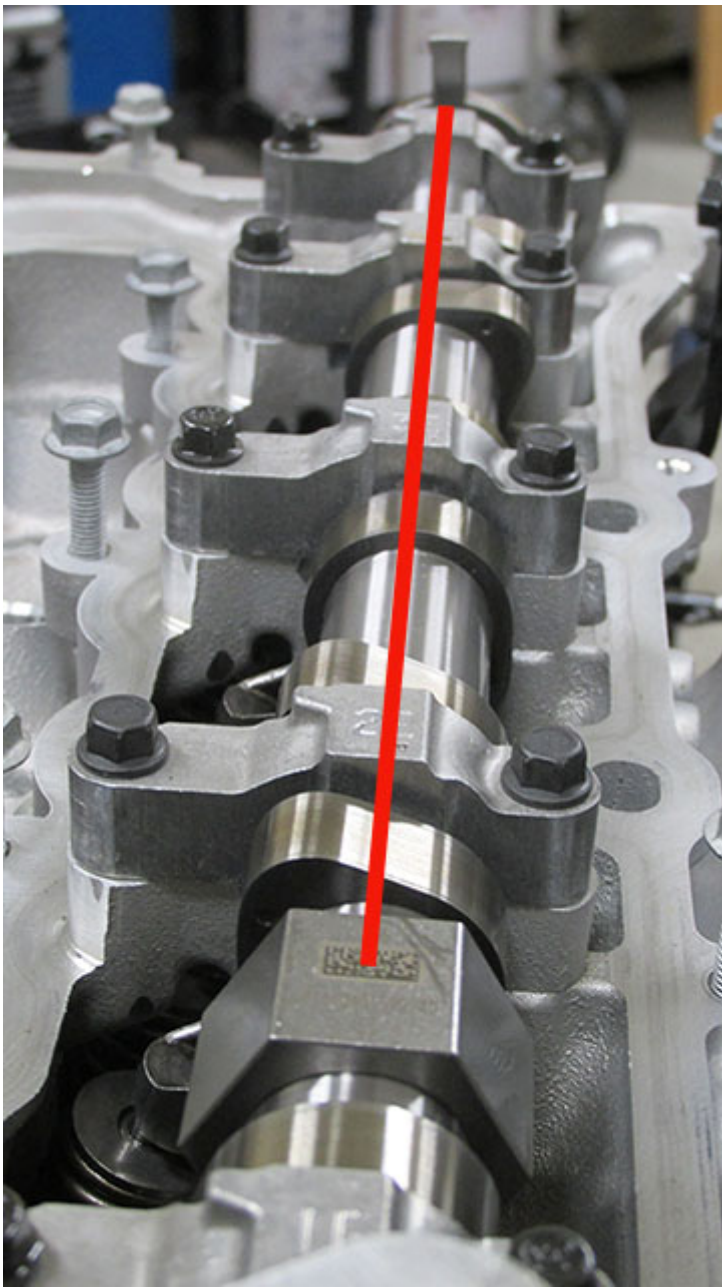
Photo below is showing the proper relationship between the 2D matrix marking and the small tang on exhaust cam reluctor wheel.
