AfterSales Diagnostic Sheet

MAS002203

DMTL doesn't work- Engine Warning Light (MIL, Malfunction Indicator Light) ON on Cluster.

Models: M157/M156/M161 Gasoline starting from MY17, DMTL-equipped..

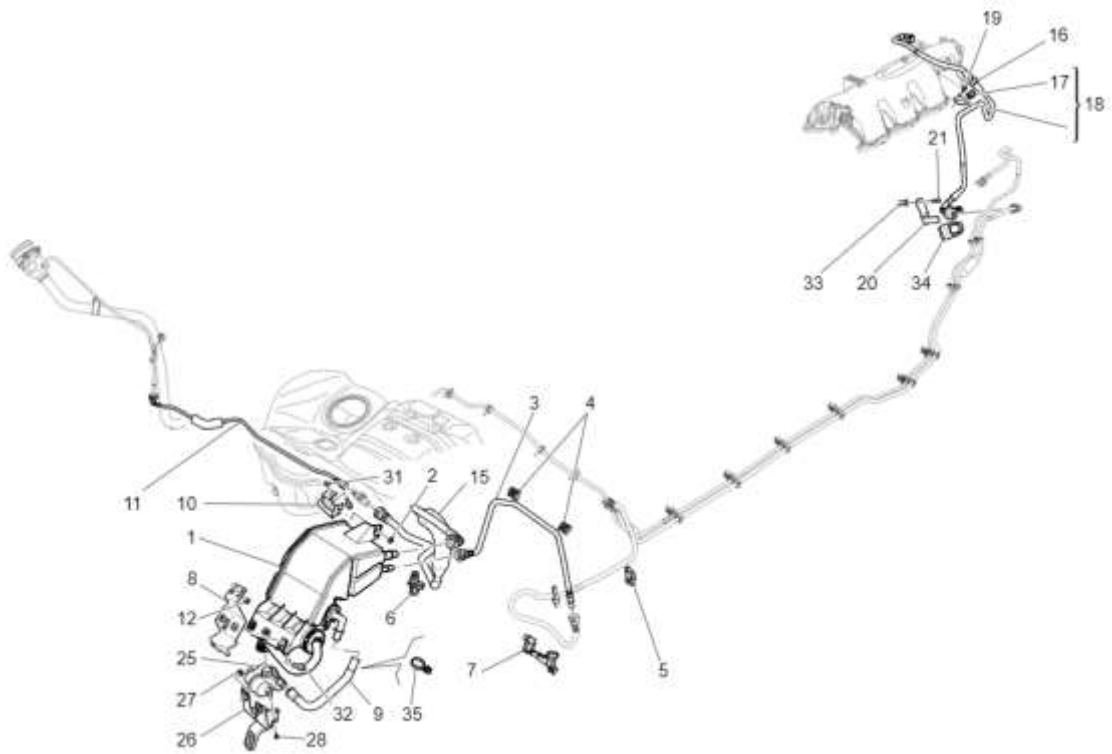
Figure 1: Fuel vapour recirculation system on Sedan models.

14. Verify that all the components of the Fuel vapour recirculation system are properly fitted and well connected. These include connection pipes, DMTL, Canister, air filter, tank, fuel filler neck (Figure 1, Figure 2) or possible leakage/ obstruction of all system (a smoke test is advisable for this purpose). Take pictures of the observed anomalies, if any.

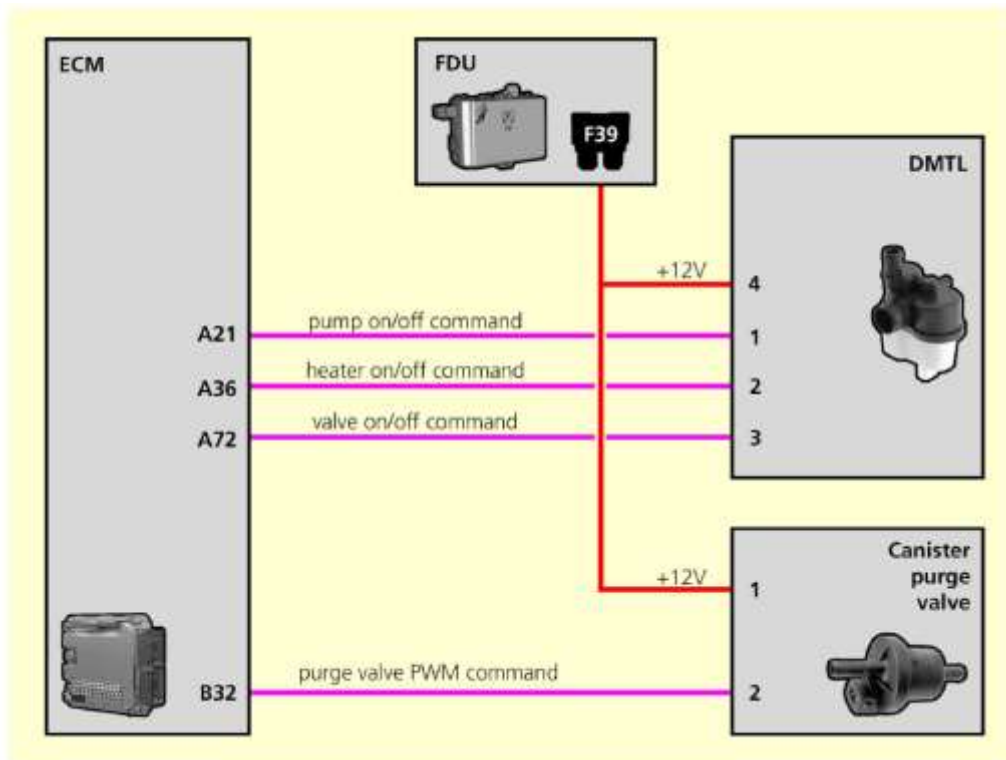
Figure 3: - Connection diagram of the evaporative emissions control system.

- Check the Purge connector integrity (Figure 4; Figure5), make sure there is no mark of oxidation and that pin tightness is secure and good.
 - Check the fuse F39 integrity in FDU box and Purge valve wiring harness integrity (Figure 3): absence of short circuits to Power Supply or Ground and absence of open circuits. Perform these checks with KIN in OFF position and disconnected battery power supply.

- Check at pin 1 (Figure 3) of the Purge Connector the power supply of 12V is present, with KIN in RUN position.
5. Repair as necessary possible electrical issues.

(Figure 3): absence of short circuits to Power Supply or Ground and absence of open circuits. Perform these checks with KIN in OFF position and disconnected battery power supply.

- Check at pin 4 (Figure 3) of the DMTL connector the power supply of 12V is present, with KIN in RUN position.
17. If there is issues at previous steps repair as necessary or proceed replacing defected components and then go to step 19.

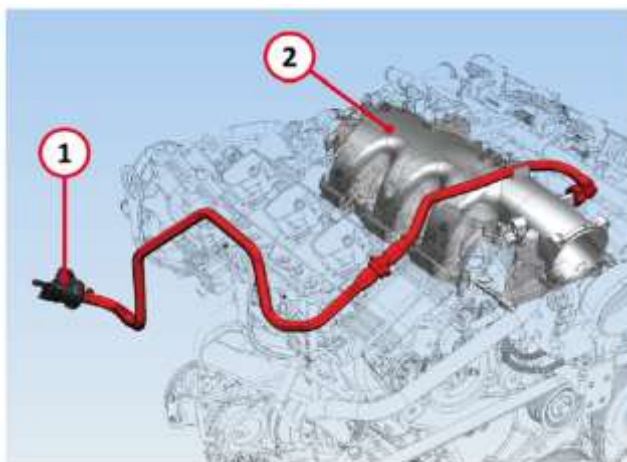
Figure 4: - Canister Purge valve on Sedan Models.

3. If either or both the DTC P0496 or P0497, those related to a Purge valve malfunction (Figure 4; Figure5), are not stored on ECM go to step 9.
4. If either or both the DTC P0496 or P0497 are stored , regardless of whether other DTCs at the same time, perform the following electrical checks on wiring harness:

7. If there still is mechanical issues at previous step proceed with Purge valve replacement and again perform the Active Diagnosis “Canister purge valve 1” via MD/MD EVO in order to check if the new Purge valve is working properly.
