Technical Service Bulletin

39 Bevel box separation point is leaking

39 20 31 2059759/1 June 12, 2020.

Model(s)	Year	VIN Range	Vehicle-Specific Equipment
Q3	2015 - 2020	All	Quattro

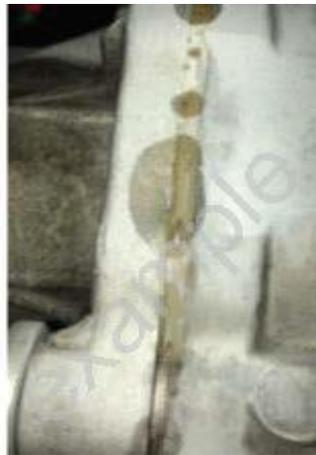
- The customer statement can be confirmed.
- The oil leak can be seen along the case seam of the bevel box (Figure 1), on the passenger side of the propeller shaft on side that faces the engine. It should be in-between the two bolts in the picture below marked with arrows (Figure 2). These bolts connect the bevel box to engine bracket (Figure 3 Position 1).

Figure 1. Bevel box case seam leak location.

1. Remove the bevel box according to the Elsa repair manual.
2. Thoroughly clean the bevel box in the area of the case seam (Figure 1) and the two housing bolts holes (Figure 2 and Figure 3).

Tip: The old sealant must be completely removed, for example, with a scraper or knife.

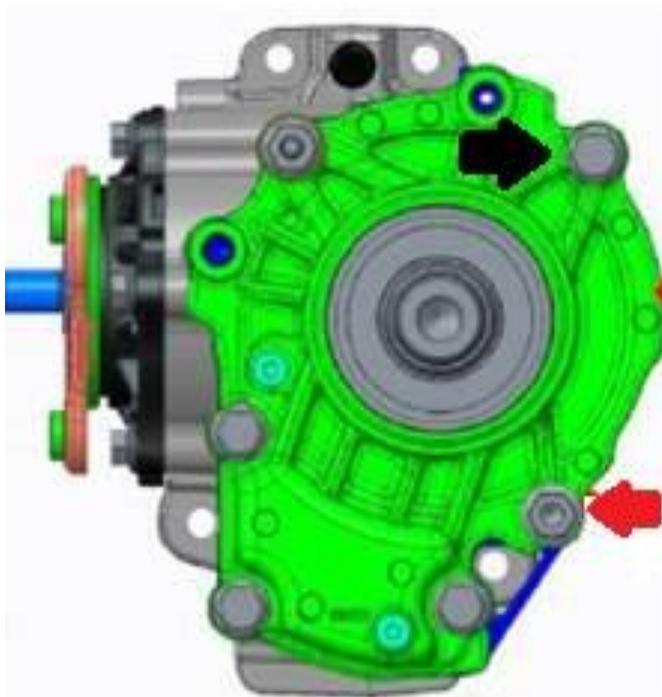
Figure 2. Bolt locations.

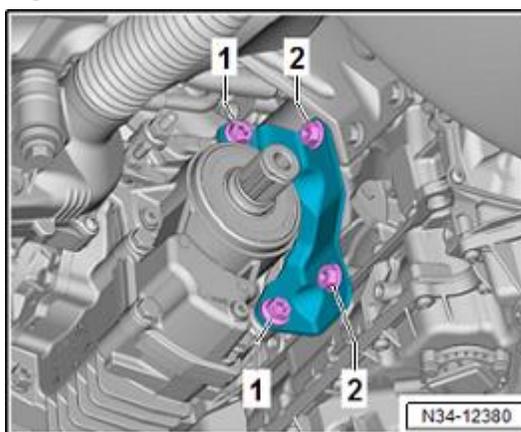
Figure 3. Bolt locations position # 1.

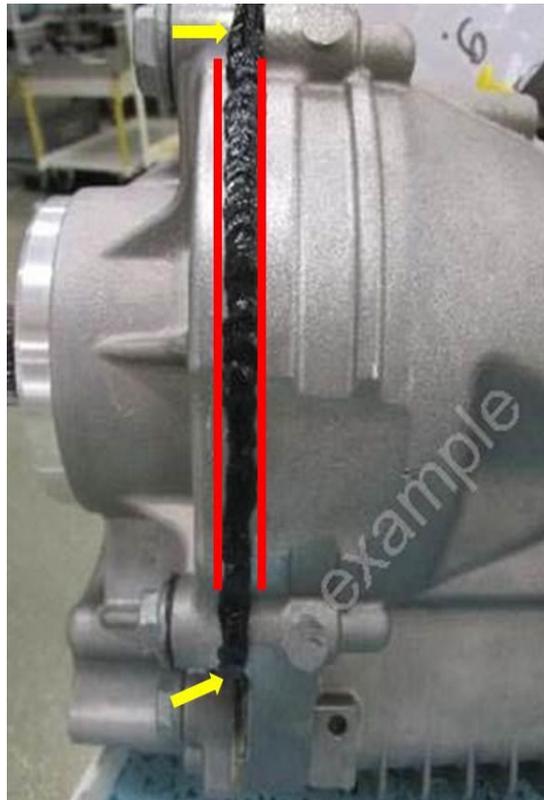
Figure 4. Silicone sealant application.

3. Apply silicone sealant (part number D 174 003 M2) to the case seam (Figure 4, yellow arrows). Apply a continuous seam of the silicone with a width of about 10 mm (Figure 4, red lines) and a height of about 3 mm.

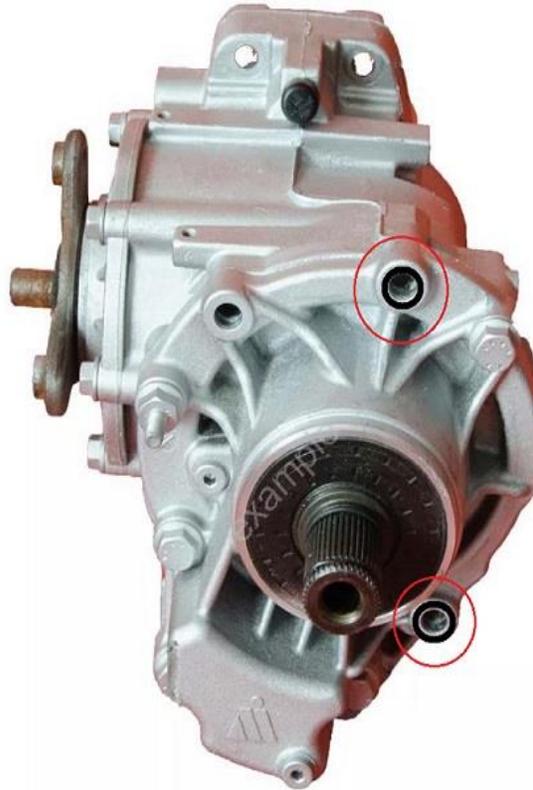
Figure 5. Silicone sealant at bolt holes.

4. Apply silicone sealant (part number D 174 003 M2) continuously to the holes of the housing bolts just before installation (Figure 5, red circles).

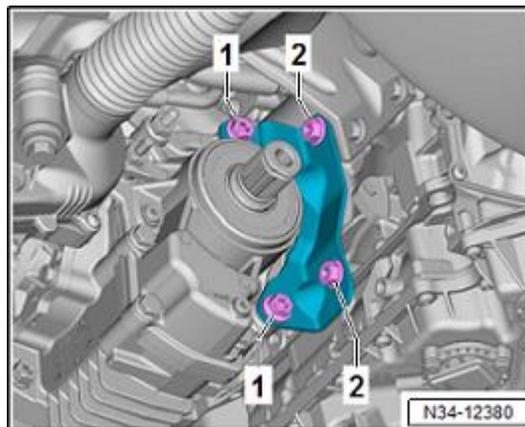
Figure 5. Bolts and engine bracket.

5. Continuously apply the silicone sealant to the shoulder of the removed housing bolts just before installation to form a seal at the engine bracket (Figure 6, position 1).
