Emissions Service Action

Code: 37K8

Subject	Transmission Control Module (TCM)																																						
Release Date	June 04, 2020																																						
Affected Vehicles

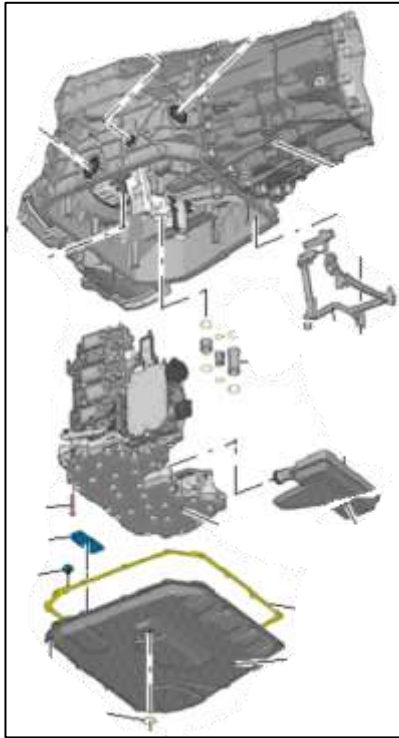
Repair Overview

What is the issue? Transmission control module (TCM) software designed and certified for a similar model/model year was used in vehicles affected by this action. It is undetermined whether there could be an impact to emissions.

- Update mechatronic (TCM) software or replace mechatronic.
