Service Action

Code: 97DZ

Subject	Transmission Wiring Harness																												
Release Date	June 09, 2020																												
Affected Vehicles

Subject: Service Action 97DZ – Transmission Wiring Harness

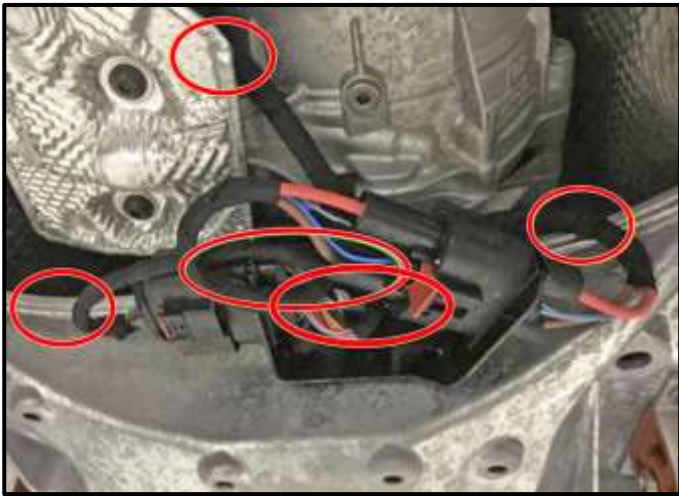
Inspect transmission wiring harness for damage:

- Thoroughly inspect the transmission and body side wiring harness and routing near the areas shown.

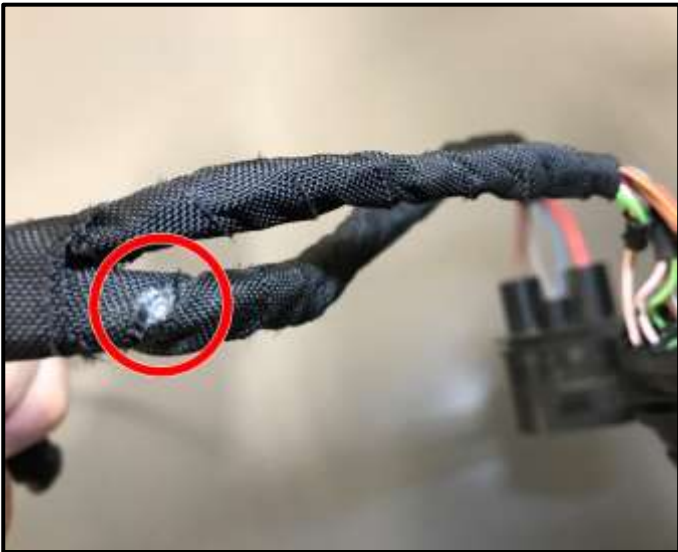
- Pay very close attention to all areas making contact with any bracket or mount. Harness damage may be very subtle and even a light chaffing could lead to faults.
- Repair wiring as needed per the repair manual.
 - See ELSA Repair Manual: *Repair manual > Electrical System > Electrical Equipment General Information > 97 Wiring > Wiring Harness and Connector Repairs*
- Ensure the repairs are staggered as needed to:
 1. Avoid large bunches of repairs in the harness.
 2. Avoid a repair at a critical flex point, e.g. over the transmission cross brace.
