Service Bulletin

Bulletin No.: 19-NA-220

Subject: Loss of Propulsion, Malfunction Indicator Lamp (MIL) Illuminated - DTC P0A3F and/or P1B03 Set

Brand:	Model:	Model Year:		VIN:		Engine:	Transmission:
		from	to	from	to		
Chevrolet	Bolt EV	2017	2020	-	-	All	All

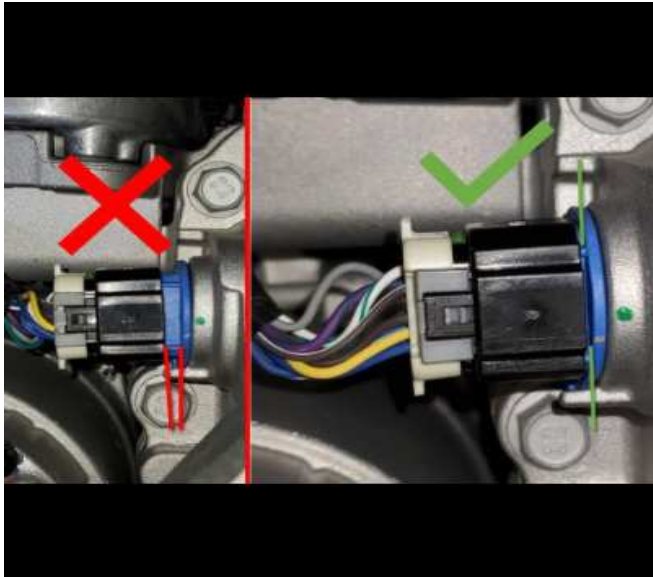
5518453

Ensure that the connector is fully seated.

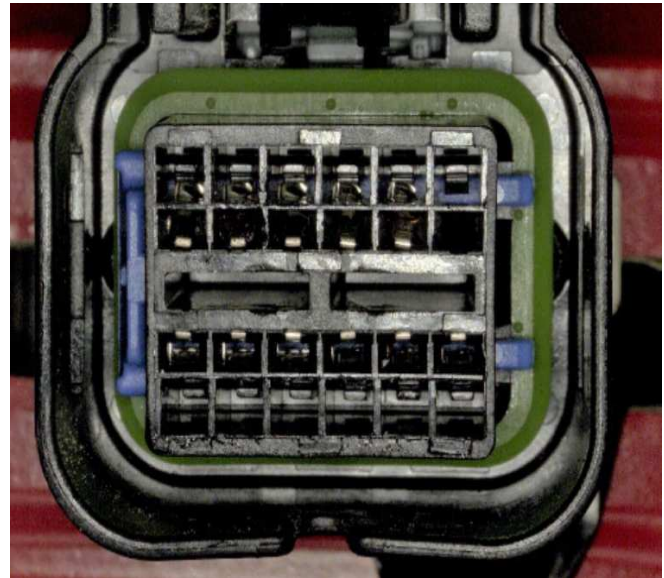
5409321

Example case of damaged terminals. Terminals do not need to have visible damage to set DTCs P0A3F and P1B03.

Correction	<p>Replace the Engine Harness.</p> <p>Due to the sensitivity of resolver (motor position sensor) circuits, replacing the connector with a terminated lead is not permitted per SI document ID 4583435. These diagnostic codes result in a loss of propulsion event on the vehicle.</p> <p>Exercise care when connecting the new harness to X2 on the transmission by aligning the connector bodies and not attempt to install at an angle.</p>

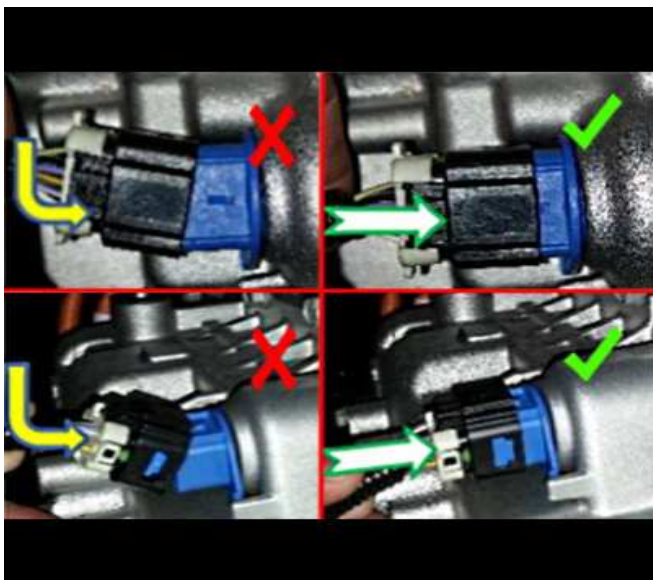
5409322

Showing both proper and improper alignment of the X2 connector.
