Service Bulletin

Bulletin No.: 20-NA-107

Subject: Information on Propeller Shaft Grease

Brand:	Model:	Model Year:		VIN:		Engine:	Transmission:
		from	to	from	to		
Cadillac	CT4	2020	2020	-	-	2.0L (LSY), 2.7L (L3B) or 3.0L (LGY)	-
	CT5

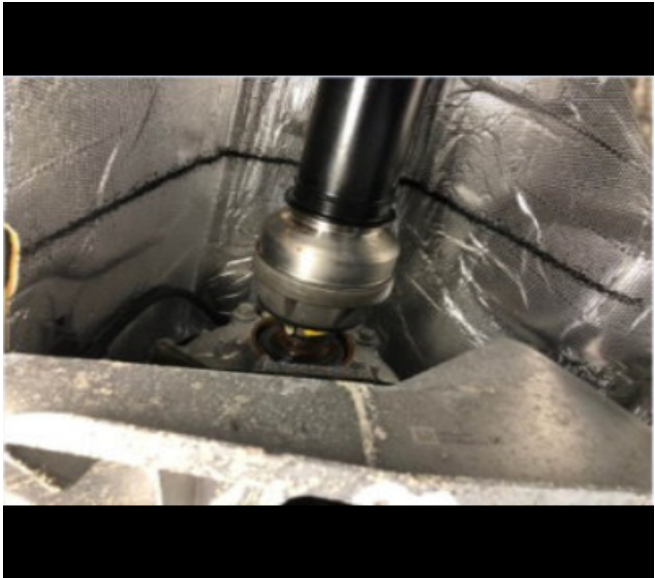
Involved Region or Country	North America, Europe, Middle East, China, Cadillac Korea (South Korea)
Condition	Some technicians may find grease coming from the propeller shaft.
Cause

<p style="text-align: right; font-size: small;">5607656</p> <p>This condition may be caused by normal grease expulsion from the propeller shaft.</p>
Information	<p>Note: Do Not replace any parts for this condition.</p> <p>This grease expulsion under these conditions is normal and does not cause any significant loss to the joint.</p>
