Service Bulletin

Bulletin No.: 15-06-01-002J

Subject: Engine Misfire/Tick Noise, Malfunction Indicator Lamp (MIL) Illuminated - DTC P0300 Set

Models: 2015-2019 Cadillac Escalade
2016-2019 Cadillac CTS-V
2014 Chevrolet Silverado 1500
2014-2019 Chevrolet Corvette
2015-2018 Chevrolet Silverado
2015-2019 Chevrolet Suburban, Tahoe
2016-2019 Chevrolet Camaro
2019 Chevrolet Silverado LD
2014 GMC Sierra 1500
2015-2018 GMC Sierra
2015-2019 GMC Yukon, Yukon XL
2019 GMC Sierra Limited
Equipped with 5.3L Engine (RPOs L83, L8B) or 6.2L Engine (RPOs L86, LT1, LT4)

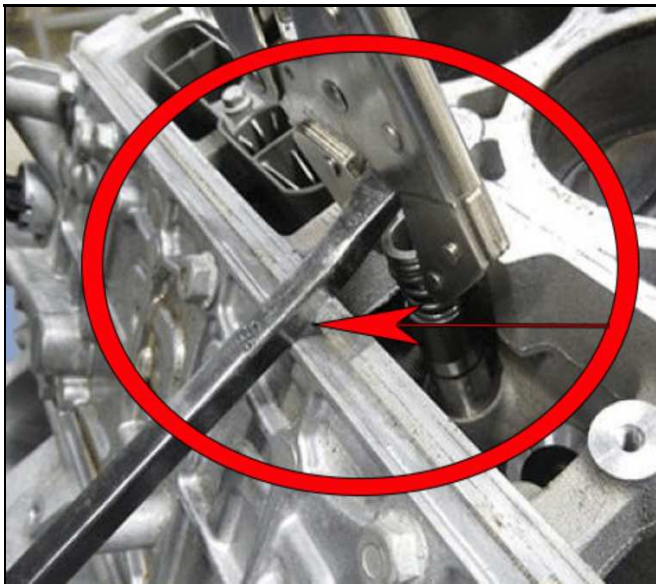
4921302

Note: Be sure **NOT** to pry on the sealing surface of the block, as shown in the illustration above.

2. Use vice grips with a small pry bar.
