**Body Lashing Plug Installation**

**USA**

**Vehicle Exterior**

**Body Structure**

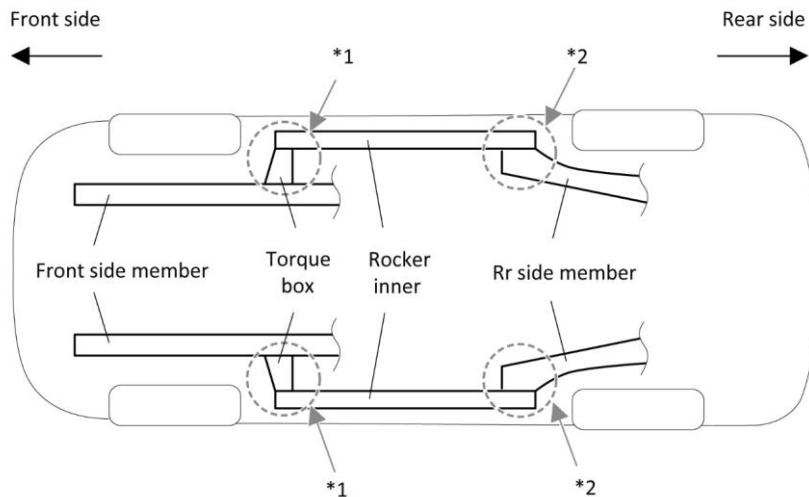
- Unibody vehicles commonly have lashing holes on the under body used for securing the vehicle during logistics
- The lashing holes are intended to be plugged during Pre-Delivery Service (PDS)
- The plugs are
  - Required for anti-corrosion purposes
  - Usually located in the glove box prior to PDS
- The number of plugs may be different based on model and production location

*1	Torque box hole or Rocker inner hole	*2	Rr side member hole or Rocker inner hole
----	--------------------------------------	----	--

- Reference Fig.1 below to identify the location of the lashing holes
- Closely follow the PDS Check Sheet for each model to ensure the plugs are installed
