Technical Service Bulletin

91 MIB2 High: Navigation data read error/reboots, DTC B126CF0 and/or B126CF1 stored in the information module

91 20 78 2057052/3 June 18, 2020. Supersedes Technical Service Bulletin Group 91 number 20-37 dated February 20, 2020 for reasons listed below.

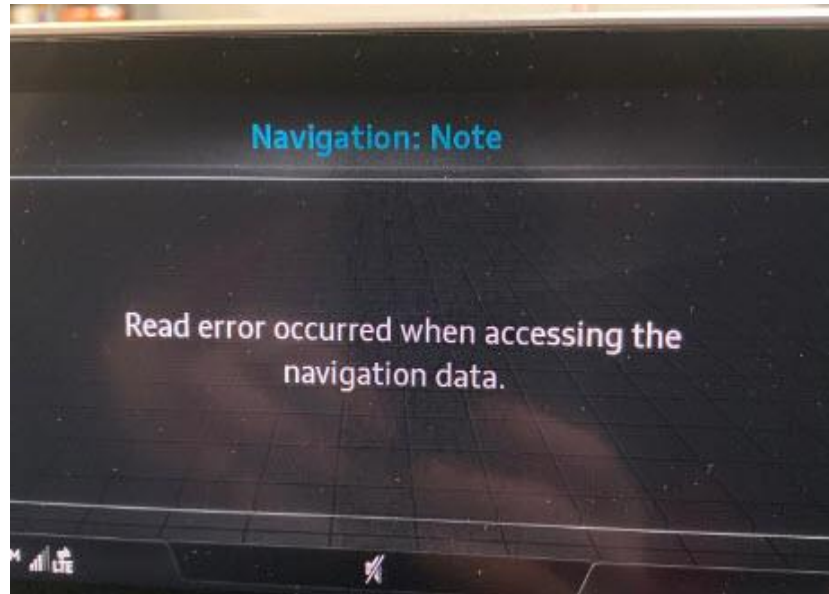
- The MMI shows the message “Read error occurred when accessing the navigation data” after initialization (Figure 1).
- The MMI reboots constantly.

Figure 1. The error message is shown on initialization.

If the navigation map database is corrupted during an online update, the message from Figure 1 is displayed and the navigation system is unavailable. The DTC B126CF0 is entered into the information electronics, J794 (address word 005F).

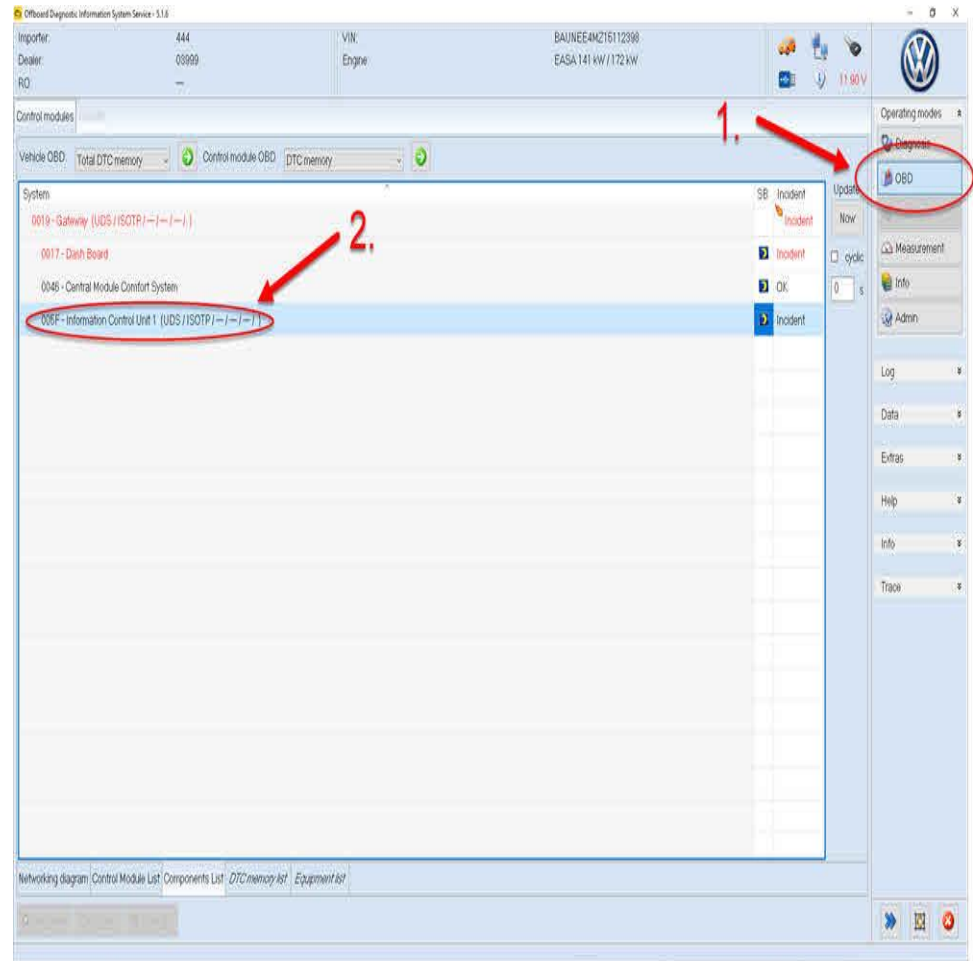
Figure 2. Select the 005F module.

1. In ODIS, please select “OBD” (1). Then select the 005F – Information Control Unit 1 (2) (Figure 2).

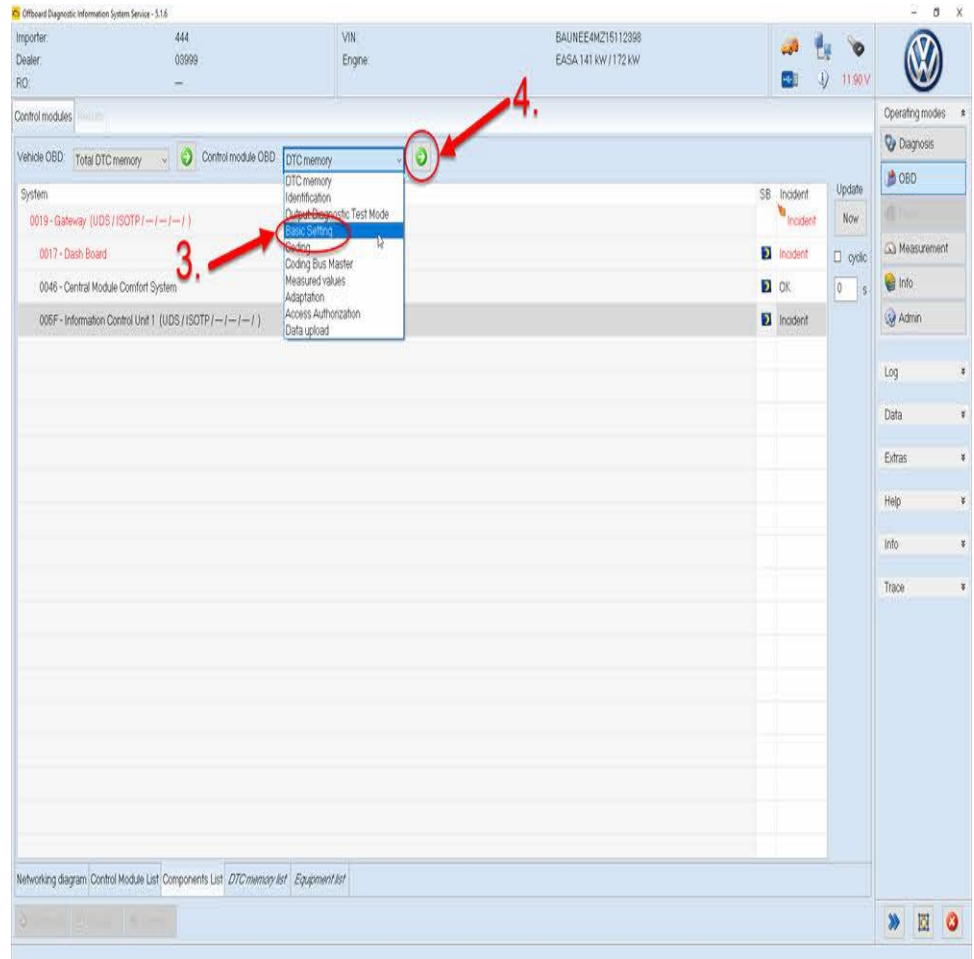
Figure 3. Select the basic settings.

2. In the drop-down menu “Control module OBD”, select “Basic Settings” (3), then click on the arrow to the right (4) (Figure 3).

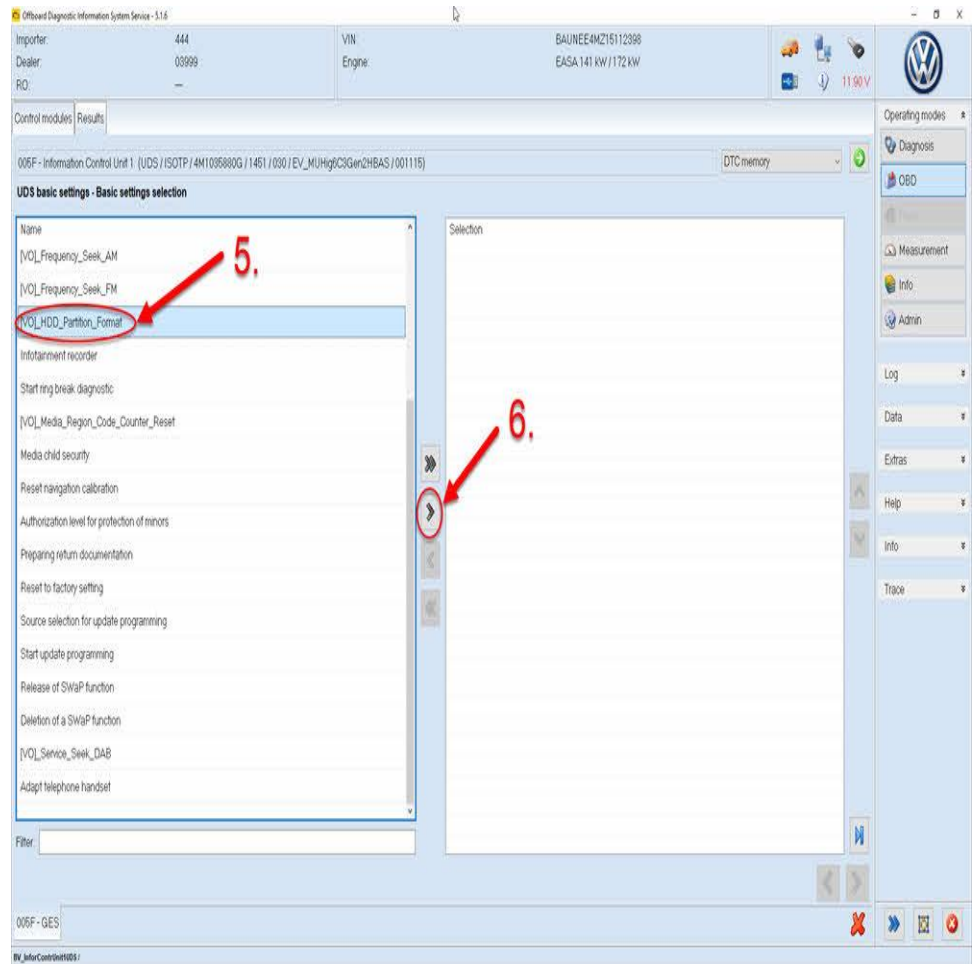
Figure 4. Select the basic setting.

3. In the list on the left, select “[VO]_HDD_Partition_Form at” (5), then click the single right-pointing arrow in the center (6) (Figure 4).

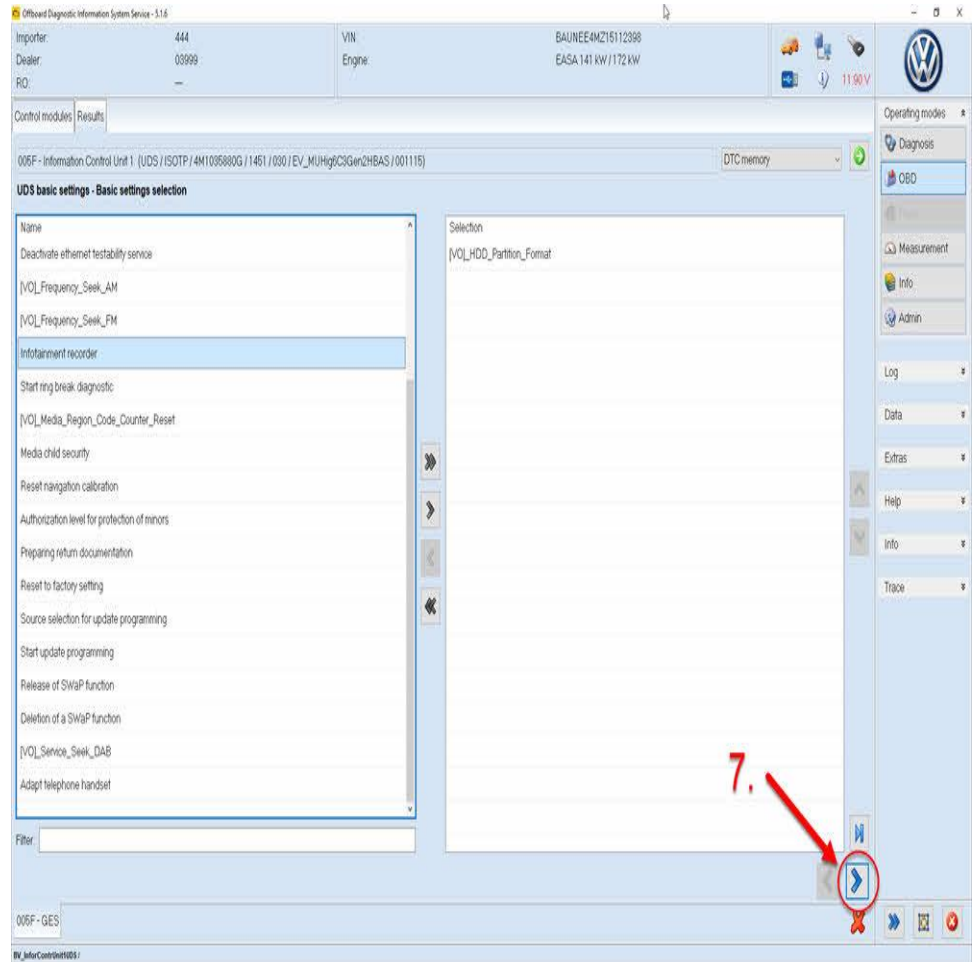
Figure 5. Select next.

4. Hit the “Next” button on the bottom right (7) (Figure 5).

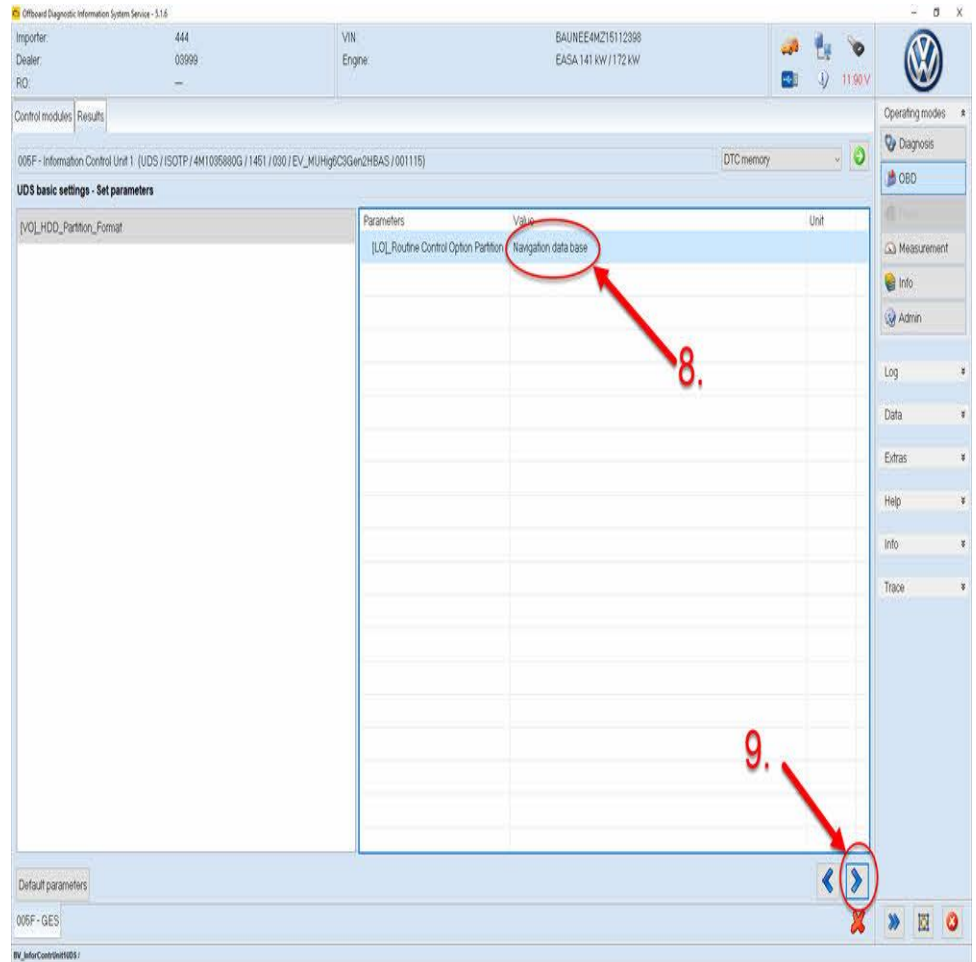
Figure 6. Navigation data base partition.

5. Make sure that the value for the parameter “[LO]_Routine Control Option Partition” says “Navigation data base” (8), then click “Next” (9) (Figure 6).

Tip: Make sure that the “Navigation data base” is selected. An incorrect selection in this step might render the control module/unit nonviable.

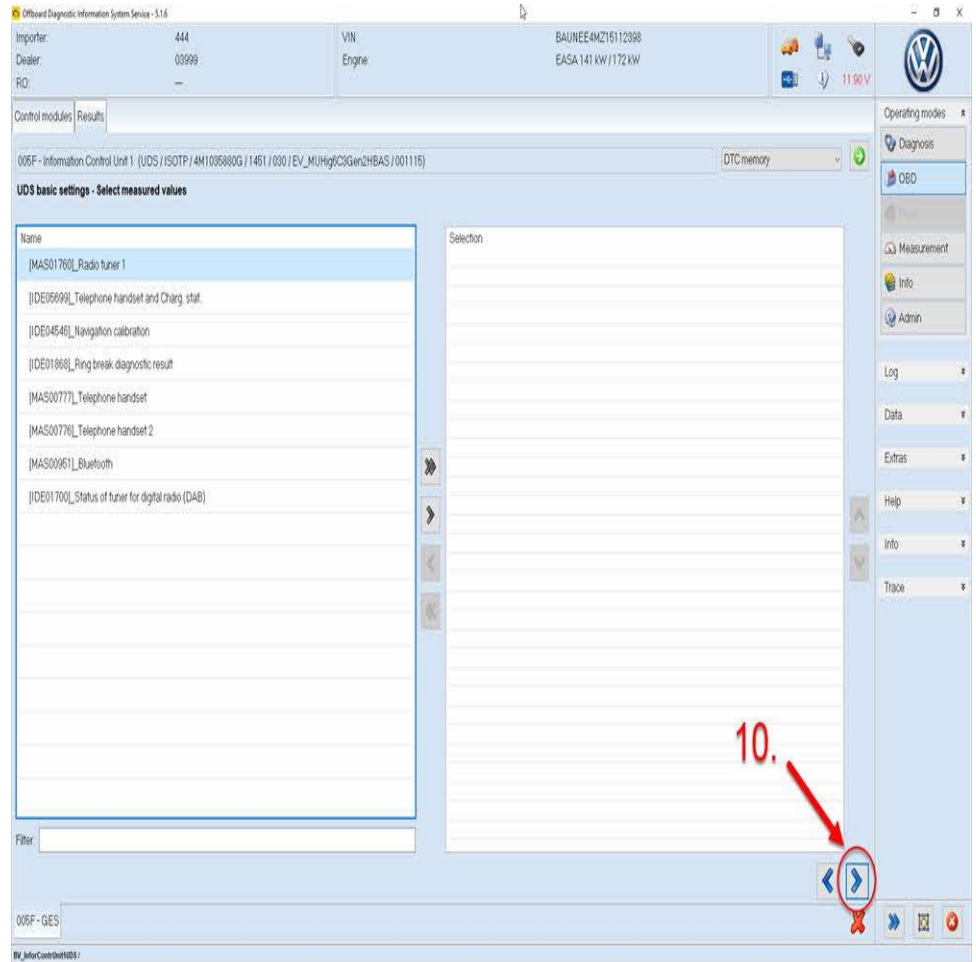
Figure 7. Select next.

6. Click “Next” one more time (10) (Figure 7).

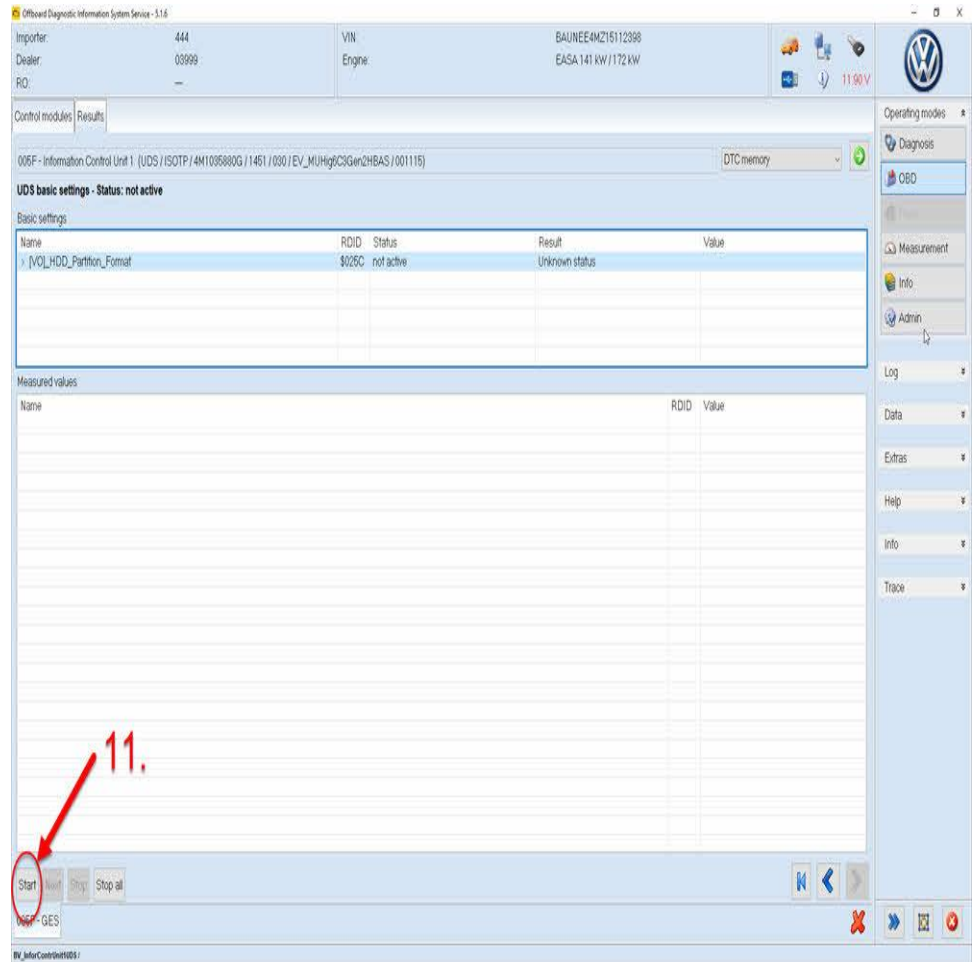
Figure 8. Execute the basic setting.

7. Select “Start” (11). The basic setting should complete within a few seconds (Figure 8).
