Technical Service Bulletin

91 SOS warning displayed in instrument cluster, DTCs B105313 and B153313 stored in the data bus diagnostic interface

91 20 79 2054630/2 June 19, 2020. Supersedes Technical Service Bulletin Group 91 number 19-55 dated April 25, 2019 for reasons listed below.

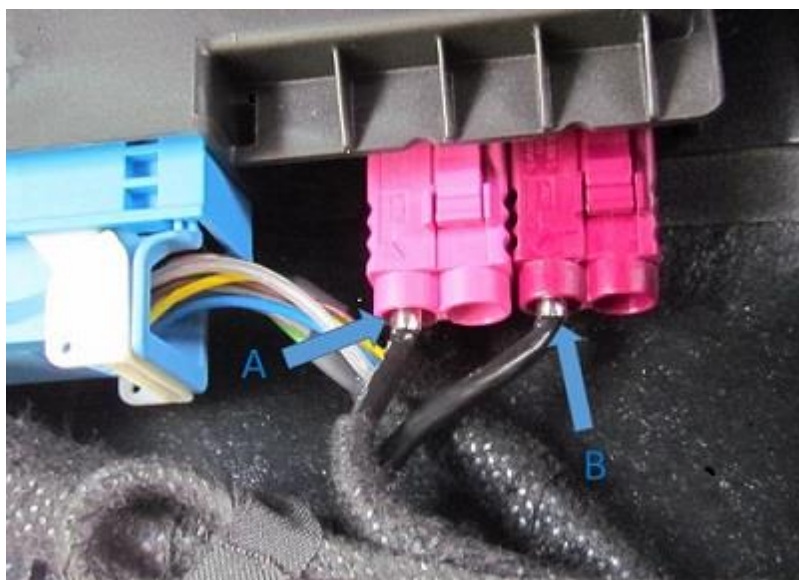
Figure 1. GSM antenna location reference at the data bus on board diagnostic interface, J533 (address word 0019).

DTC Reference Table			
DTC	Measured Value Diagnostic Address 0019	Cable Position (Figure 1)	Vehicle PR-Codes
B105313 GSM antenna Open circuit	Antenna for telephone status 0x24E2	A	IW3 IW5 + 4GR IW5 + 4GY

B153313 GSM antenna 2 Open circuit	Status of antenna 2 for phone 0x1836	B	IW3 IW5
---------------------------------------	--	---	------------

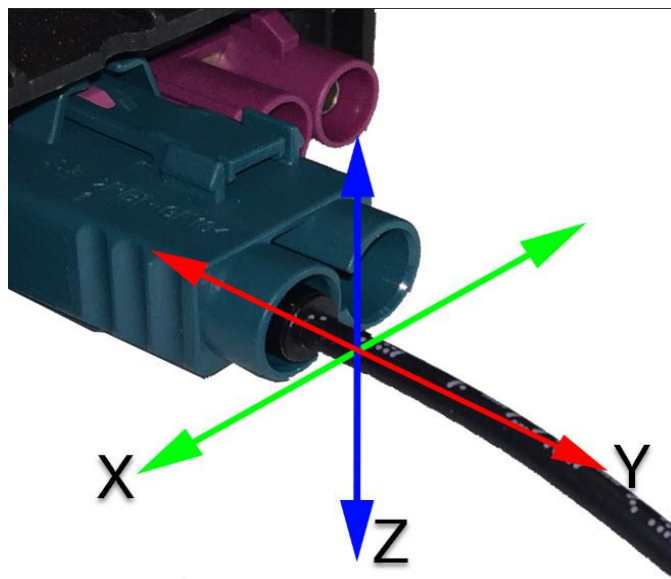
Figure 2. Coaxial cable X, Y, and Z axis.

- View the applicable measured value from the overview table above.
- Lightly pull, or push the applicable coaxial cable along its respective X, Y, and Z axis (Figure 2).
- As the fault detection is not real time, hold the cable in each position for 5 seconds and observe the measured value (Figure 3).

3. If a fault is detected during step 2 (“Open Circuit”), replace the contact on the wire harness at the data bus on board diagnostic interface, J533 (address word 0019) utilizing the VAS 6720.
