# Product Upgrade Bulletin 200515REV

**PRODUCT(S) AFFECTED:**  
American Coach  
Dream and Revolution

**SUBJECT:**  
Inspection /  
Correction  
of Aqua-Hot  
Exhaust Pipe &  
Chrome Tip

**ISSUE DATE:**  
June 2020

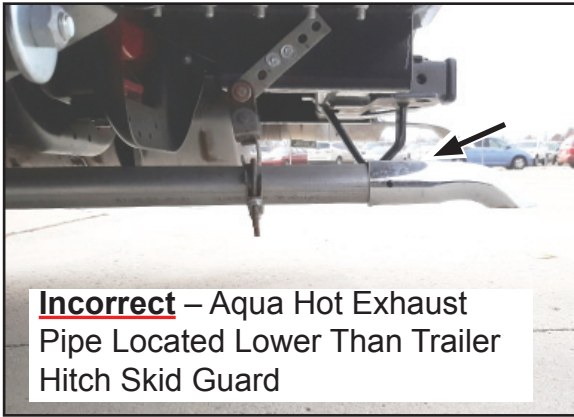
Figure 1

Compare your findings to Figures 1 and 2 to determine whether the installation is correct:

- a) If the Aqua-Hot exhaust is located higher than the skid guard, the installation is correct and no further work is required. Attach photos to a draft claim in A.D.N. and submit as “Inspected/Not Defective” using the repair code on Page 5.
- b) If the Aqua-Hot exhaust is located lower than the skid guard, it will need to be replaced. Continue to the REPAIR PROCEDURE beginning at Step 5 on Page 3.
