TECHNICAL SERVICE BULLETIN

4WD - Intermittent Grinding Noise While Driving

20-2189
01 June 2020

Ford 2013-2018 Expedition
2013-2018 F-150
Lincoln 2013-2018 Navigator

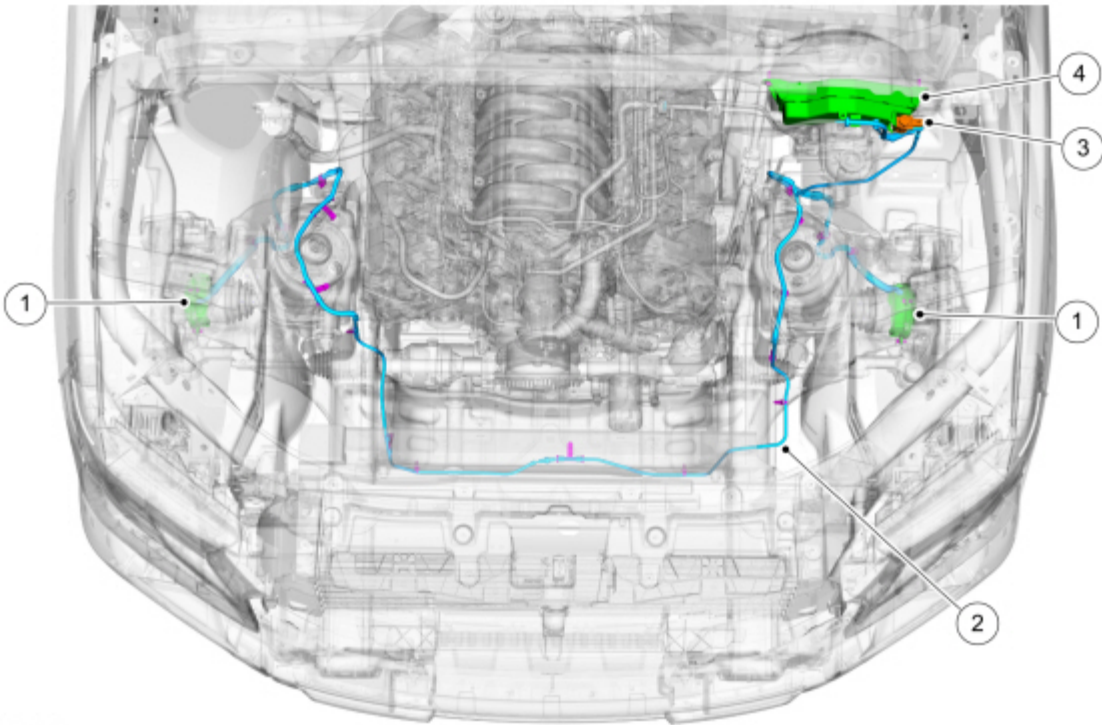
Figure 1

2. Inspect the IWE vacuum hoses. Refer to Workshop Manual (WSM), Section 308-07A. Are there any disconnected or damaged vacuum hoses? (Figure 1)

(1). Yes - reconnect or replace the vacuum hose as required. Refer to WSM, Section 308-07A.

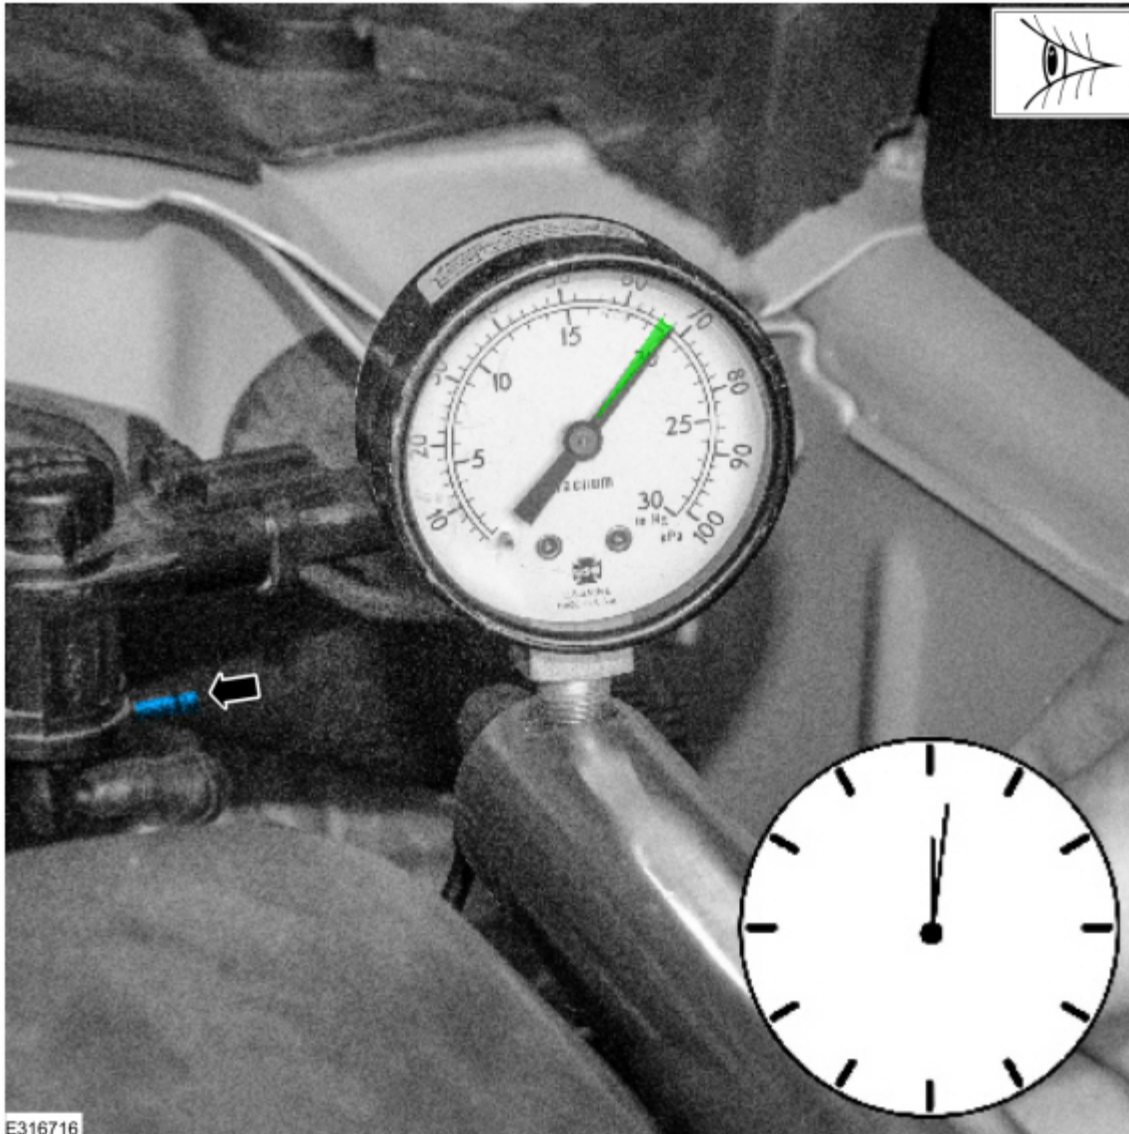
Figure 2

3. Replace the vacuum check valve located near the vacuum reservoir. Refer to WSM, Section 308-07A.
4. Disconnect the vacuum line to the IWEs at the vacuum solenoid.
5. Connect a hand vacuum pump to the IWE vacuum supply line and apply 508 mm-Hg (20 in-Hg) of vacuum. Does the vacuum drop more than 12.5 mm-Hg (0.5 in-Hg) per minute? (Figure 2)
 - (1). Yes - proceed to Step 6.
 - (2). No - connect the IWE vacuum supply line to the solenoid and proceed to Step 10.

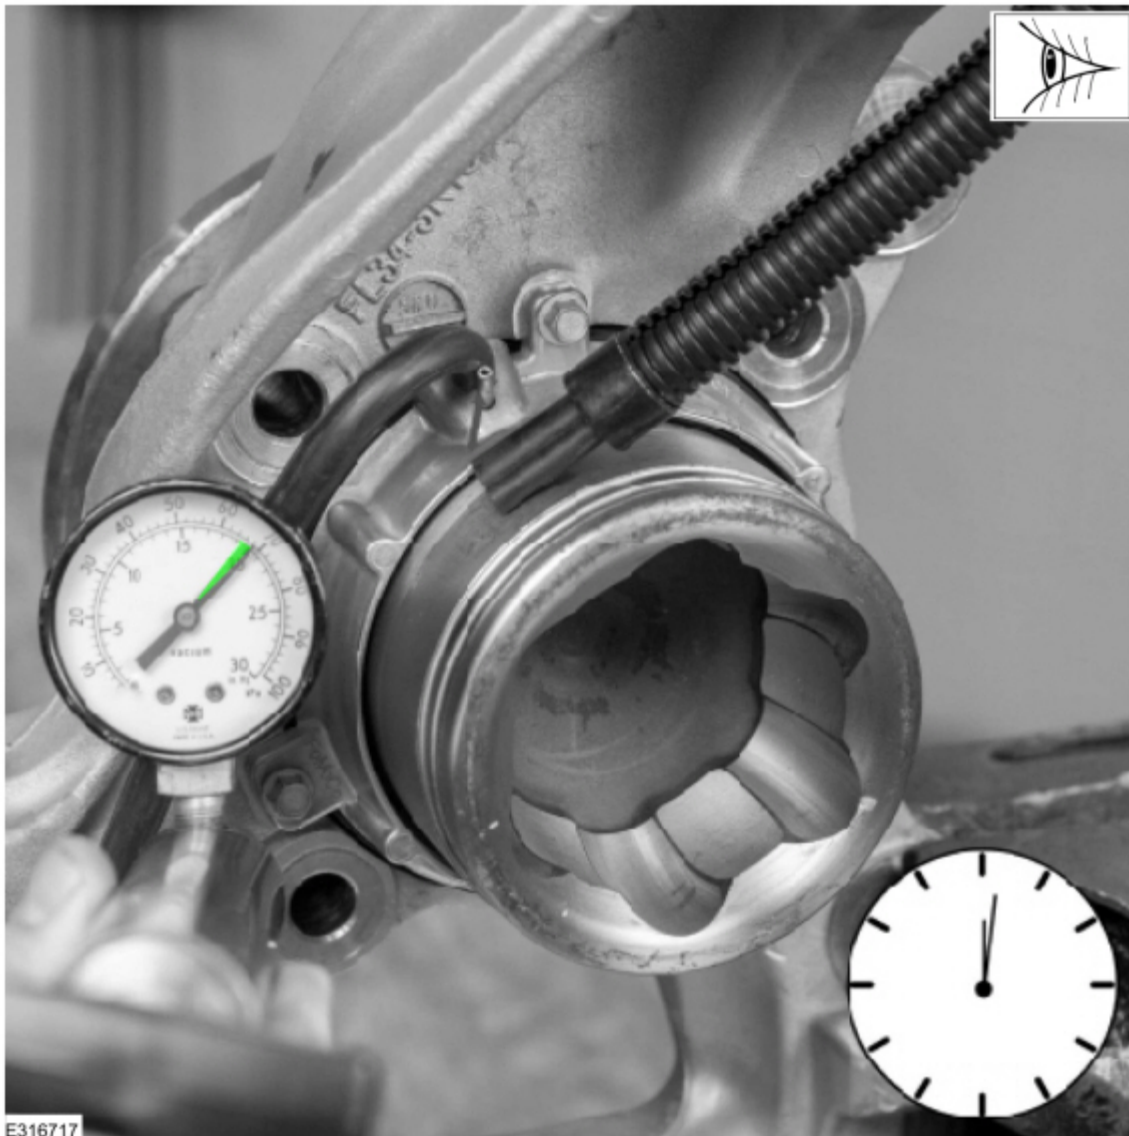
6. Using a hand vacuum pump, apply 508 mm-Hg (20 in-Hg) of vacuum to each IWE, one at a time, and monitor the vacuum gauge. Does the vacuum drop more than 12.5 mm-Hg (0.5 in-Hg) per minute? (Figure 3)

- (1). Yes - proceed to Step 8.
- (2). No - proceed to Step 7.

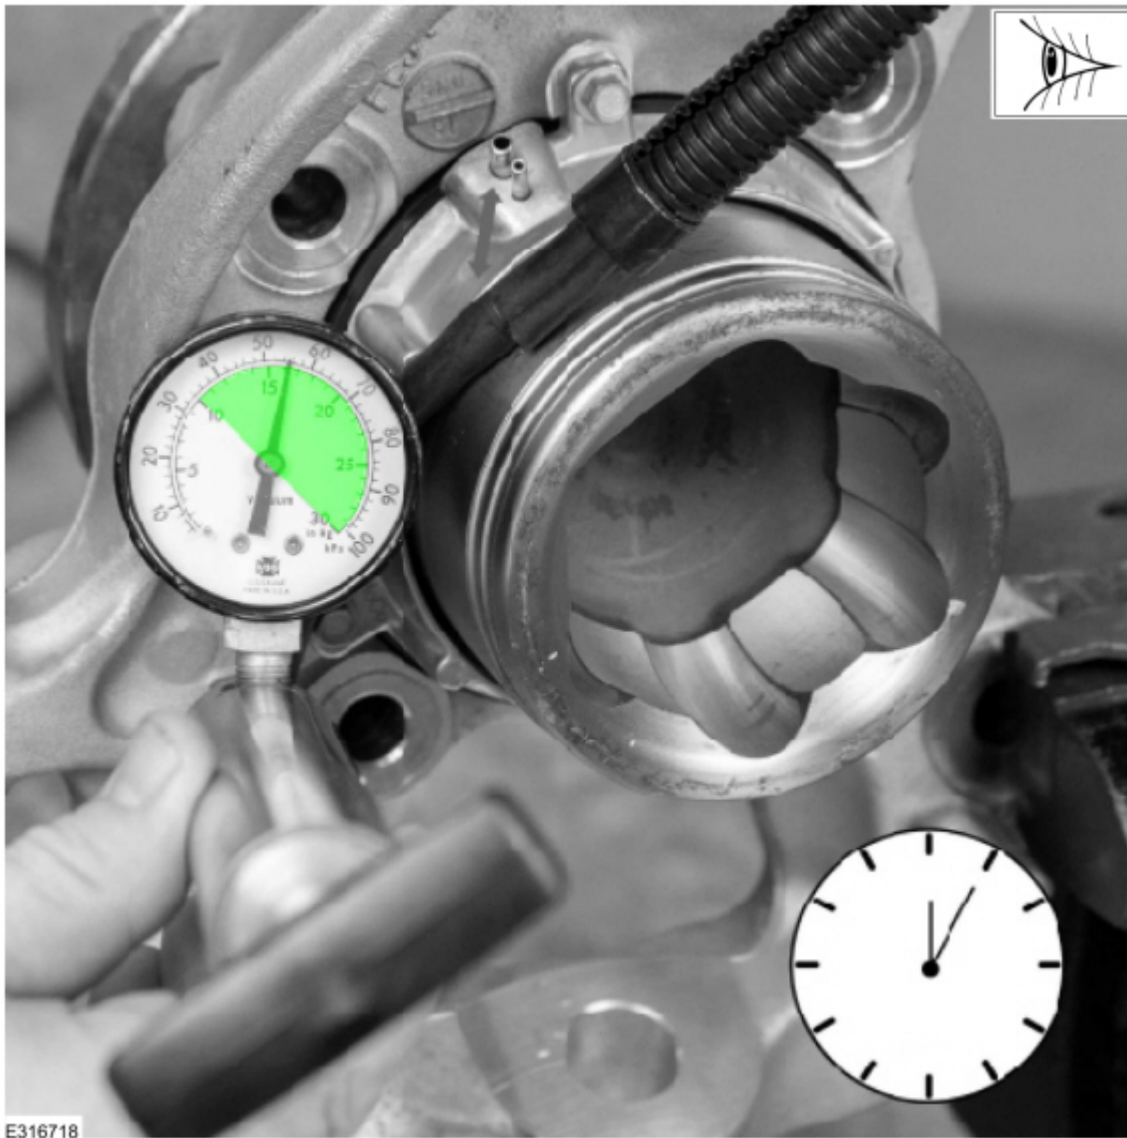
Figure 4

- (2). No - replace the IWE assembly. Refer to WSM, Section 308-07A. Proceed to Step 12.
10. Test the IWE vacuum supply lines.
 - (1). Disconnect the vacuum supply line at the left or right IWE and connect a vacuum gauge to the supply line as shown in Figure 4.

11. Is the vacuum at both left and right supply lines greater than 254 mm-Hg (10 in-Hg)?

(2). No - replace the vacuum lines between the solenoid and IWEs. Refer to the WSM, Section 308-07A. Proceed to Step 12.
