# Ferrari North America

## Technical Information

Date: June 2020  
 Bulletin #: 2668  
 Campaign #:   
 Supersedes: 2344  
 Section: 3

Subject: Replacing CCP pressure sensors

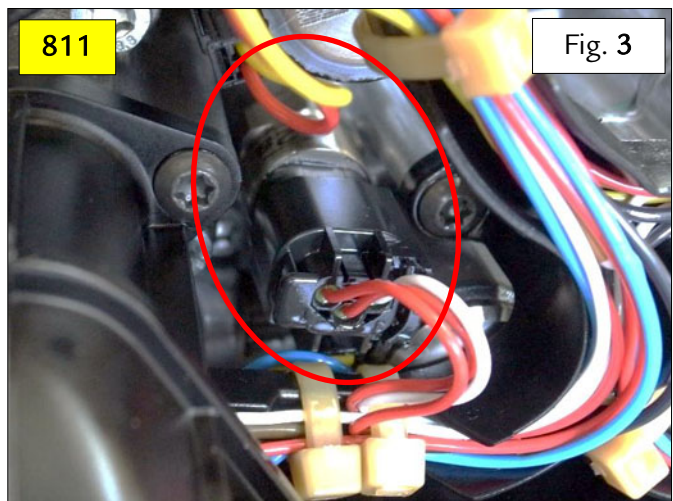
- 811 - Clutch pressure sensor C1 – Fig. 3.

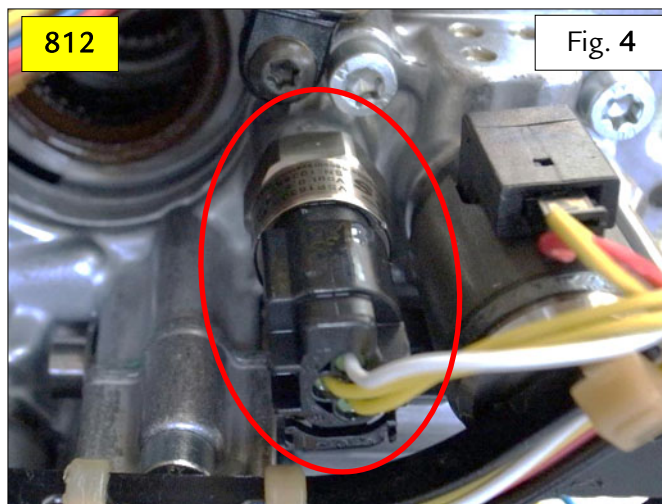
- 812 - Clutch pressure sensor C2 - Fig. 4.

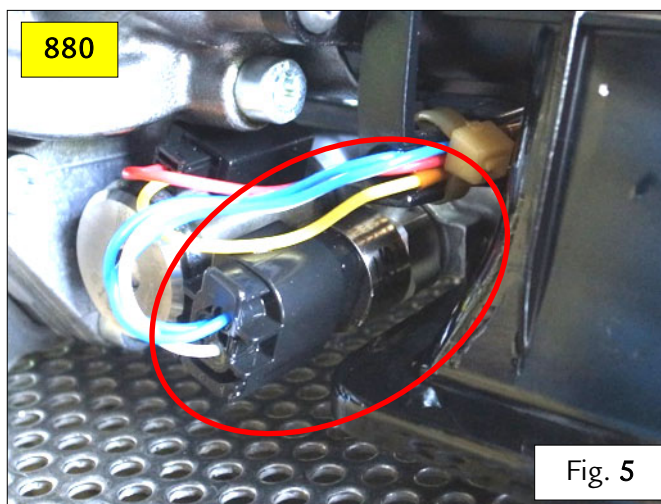
- 880 - System pressure sensor - Fig. 5.

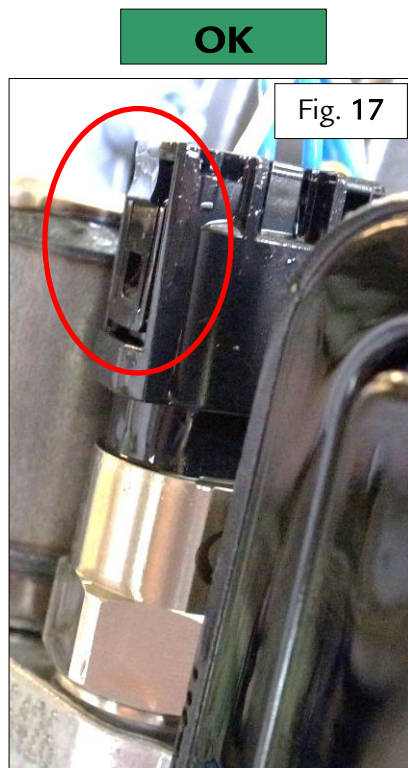
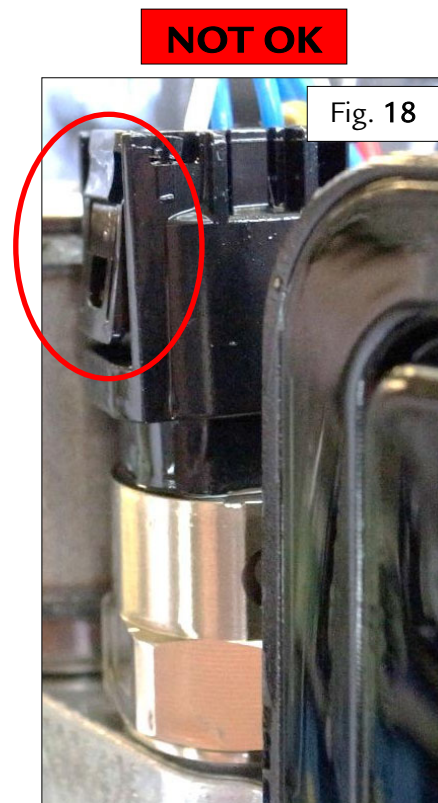
- The connector is only installed correctly (**OK**) if the retainer clip is fastened completely onto the sensor as shown in Fig. 17.

Note: Fig. 18 shows an example of an **INCORRECTLY** installed connector (**NOT OK**), with the connector fitted into the seat but with the retainer clip not fastened correctly.

Make sure that the retainer clip of the connector is fastened correctly onto the sensor.

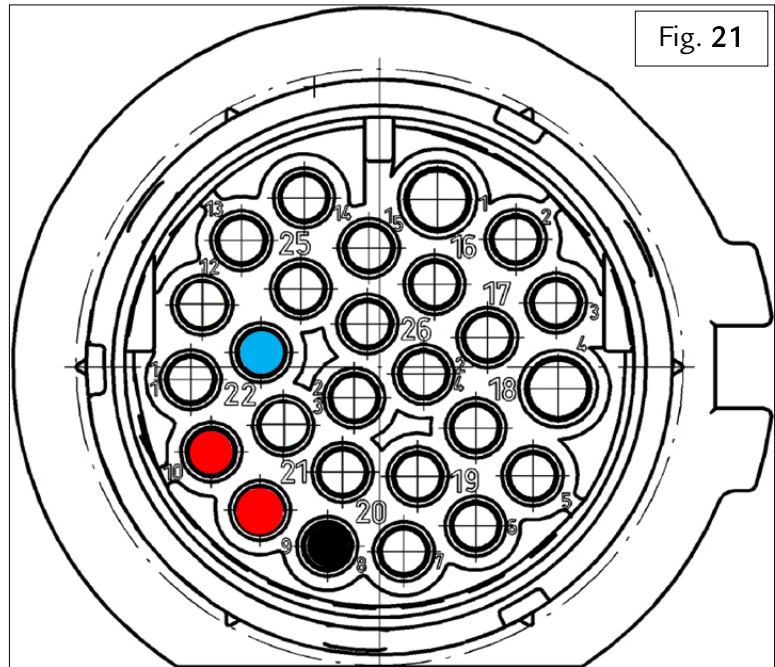
- Apply a voltage of  $5 \pm 0.1$  V to pin 10 (red), after connecting to pin 9 (red) (POWER) – Fig. 21.
- Connect the negative wire of the voltmeter to pin 8 (black) (GND) – Fig. 21.
- Connect the positive wire of the voltmeter to pin 22 (blue) (SIGNAL), and read the value – Fig. 21.
- For the sensor to function correctly, the output voltage measured must be between 0.44 and 0.56 V.

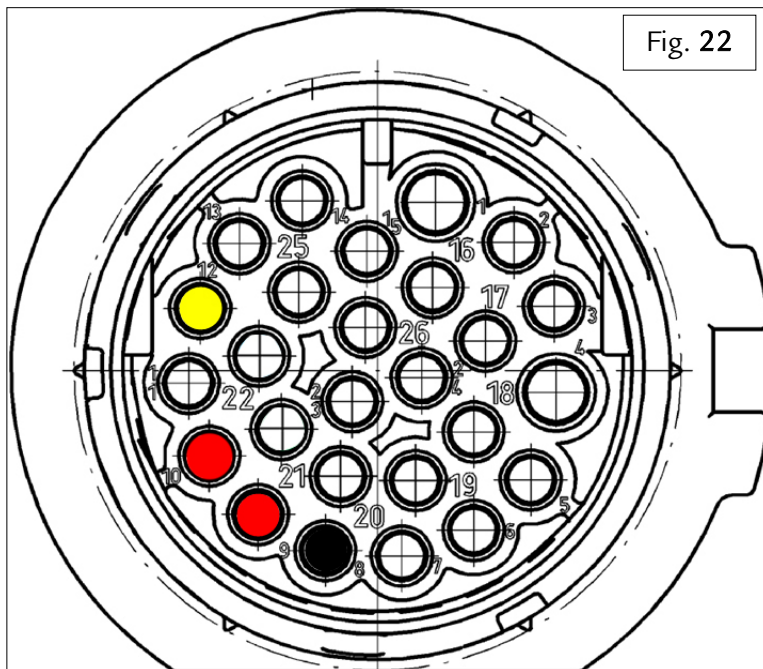
- Apply a voltage of  $5 \pm 0.1$  V to pin 9 (red), after connecting to pin 10 (red) (POWER) – Fig. 22.
- Connect the negative wire of the voltmeter to pin 8 (black) (GND) – Fig. 22.
- Connect the positive wire of the voltmeter to pin 12 (yellow) (SIGNAL), and read the value – Fig. 22.
- For the sensor to function correctly, the output voltage measured must be between 0.44 and 0.56 V.

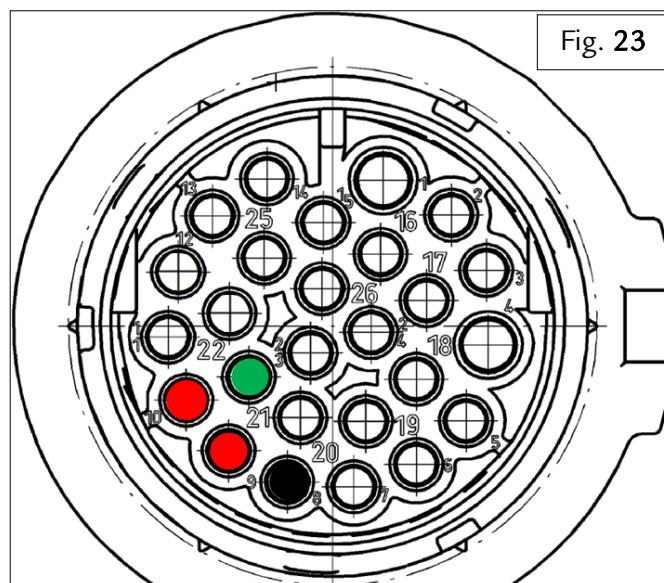
- Apply a voltage of  $5 \pm 0.1$  V to pin 9 (red), after connecting to pin 10 (red) (POWER) – Fig. 23.
- Connect the negative wire of the voltmeter to pin 8 (black) (GND) – Fig. 23.
- Connect the positive wire of the voltmeter to pin 21 (green) (SIGNAL), and read the value – Fig. 23.
- For the sensor to function correctly, the output voltage measured must be between 0.44 and 0.56 V.
