| Release Date | 06/23/2020 | Technical Service Bulletin | |
| 91X4 UPDATE | | | Audi |
| MMI Software Update – (NVLW) | | | |

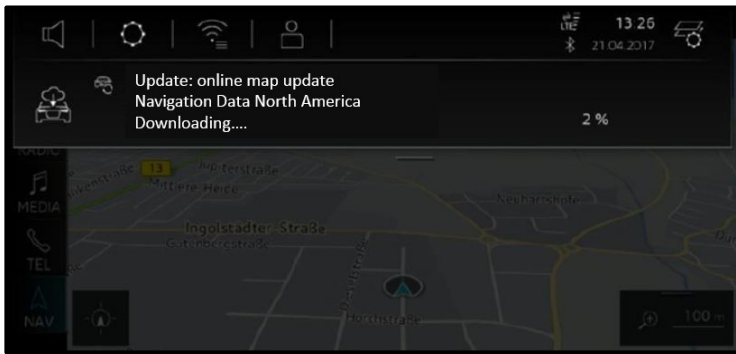
If the infotainment system happens to be in a navigation data download mode (“Downloading...,” as shown), please interrupt this by activating the slider for privacy mode (Home > Settings > Privacy settings > Activate privacy).

Please ensure that you deactivate privacy mode again after the software update is complete.

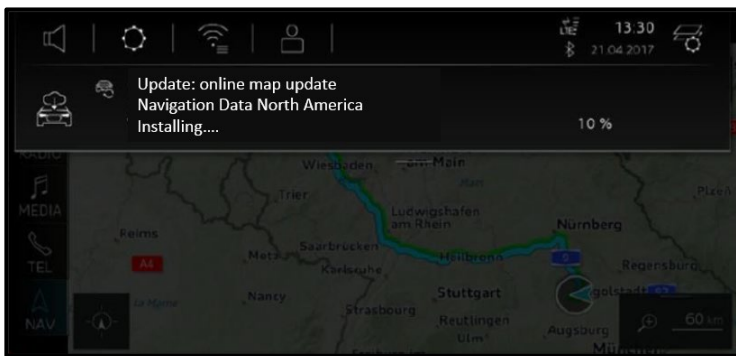
If the navigation database update is already being installed (“Installing...,” as shown), please wait and ensure that the installation is fully complete before continuing with the 91X4 software update.

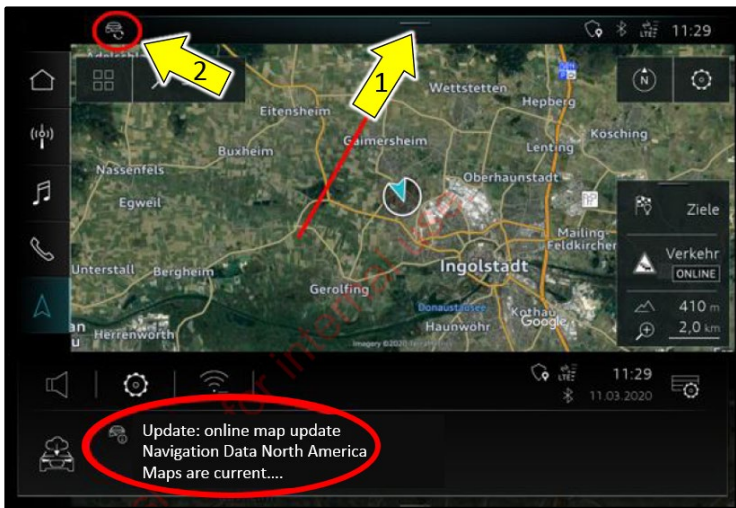
If a navigation database update is already complete, it is very important to confirm this manually in the notifications center of the MMI.

To do so, pull the notification center downwards <arrow 1> and confirm the completion (“Maps are current...,” as shown).

The 91X4 software update can only be started when the icon at the top left <arrow 2> is no longer visible.

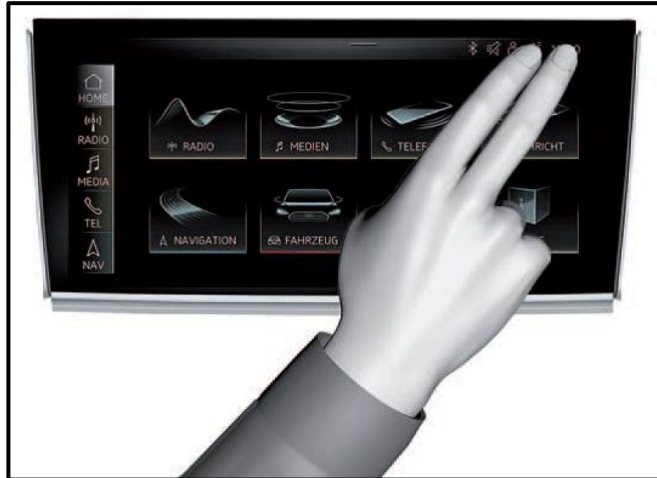
In the event the update cancels, perform the update via the red engineering menu by touching the screen with two fingers in the top right corner

After the manual successful update perform the SVM code again so that the ODIS tester can make the necessary configuration and report the new vehicle configuration to the SVM server.
